# **Air Accident Investigation Unit Ireland**

**FACTUAL REPORT**

**Schleicher, ASW 19 B, EI-GLV**

**27 July 2019**

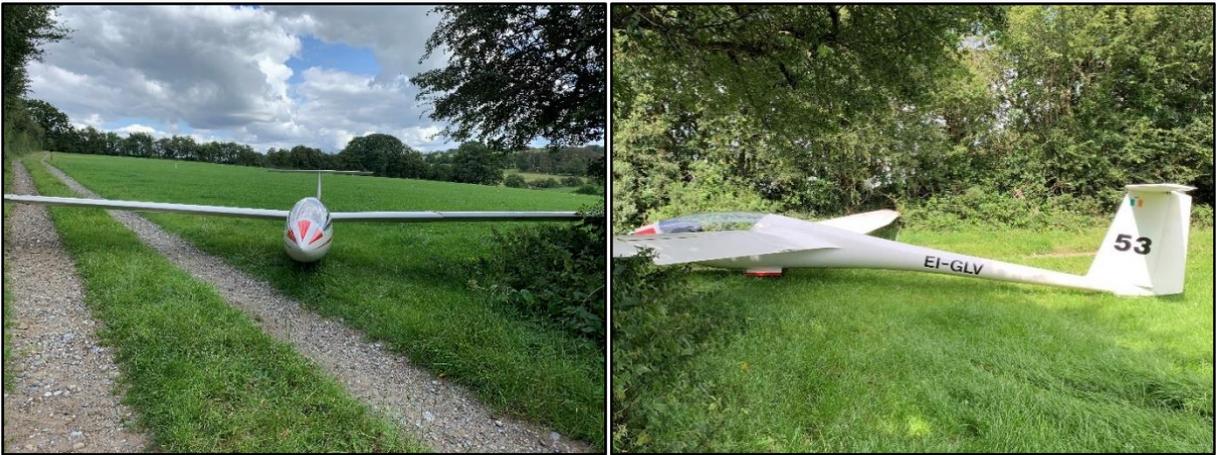
The Pilot stated that when the glider had descended to an estimated height of 1,000 ft above ground level (AGL), he commenced the search for a field to complete an out-landing<sup>6</sup>. The Pilot informed the Investigation that the glider was at an estimated height of 300 ft AGL when a suitable field was identified. However, during the approach he judged that the glider would be unable to clear the line of trees forming the near boundary of that field, and therefore, *'a turn was made in the valley'* and the glider was landed *'uphill'* in the field short of the trees. The Pilot informed the Investigation that *'due to the tree line and the short field I was unable to stop before hitting the trees in the corner'*. The flight time was recorded as one hour and 19 minutes. The final resting position of the glider is shown in **Photo No. 1** and **No. 2**.

**Photo No. 1 and No. 2:** Final position of EI-GLV

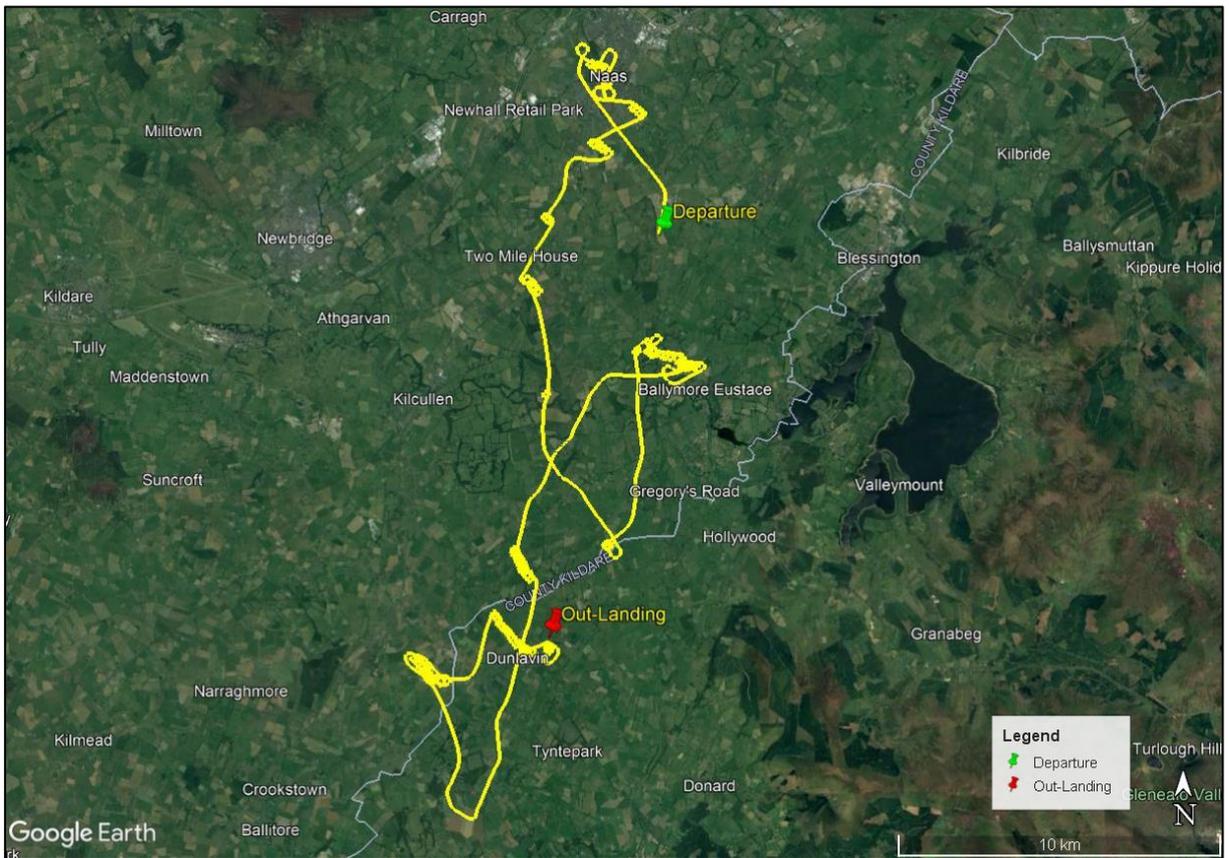
**Figure No. 1:** The recorded flight track

While there was no requirement for a flight recorder to be fitted, the Pilot used a gliding logging tool to record the flight and provided the file to the Investigation. **Figure No. 1** contains an overview of the recorded flight track.

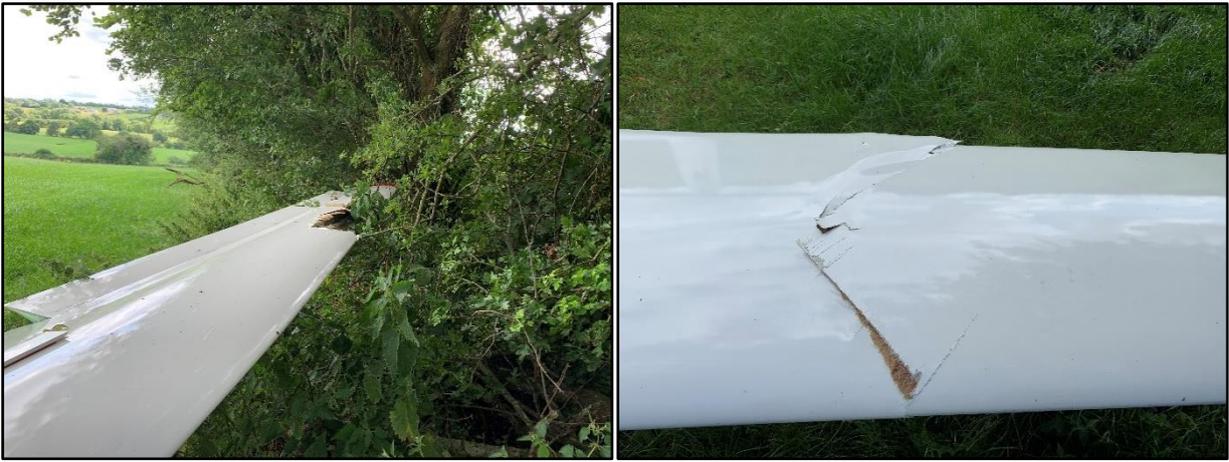
Photographs taken prior to the recovery of the glider and provided to the Investigation (**Photo No. 3, 4, 5 and 6**) indicate that the glider had sustained substantial damage. The left wing had impact damage at the leading edge forward of the aileron and a chord-wise crack with associated delamination of the skin was visible inboard of the airbrake. The right wing also had leading edge damage, close to the wingtip and a chord-wise crack with associated delamination of the skin outboard of the airbrake. Scuff marks were visible on the right-wing upper surface close to the wing root and on the left side of the fuselage close to the left wing-root.

**Photo No. 3 and No. 4:** Damage to the left wing

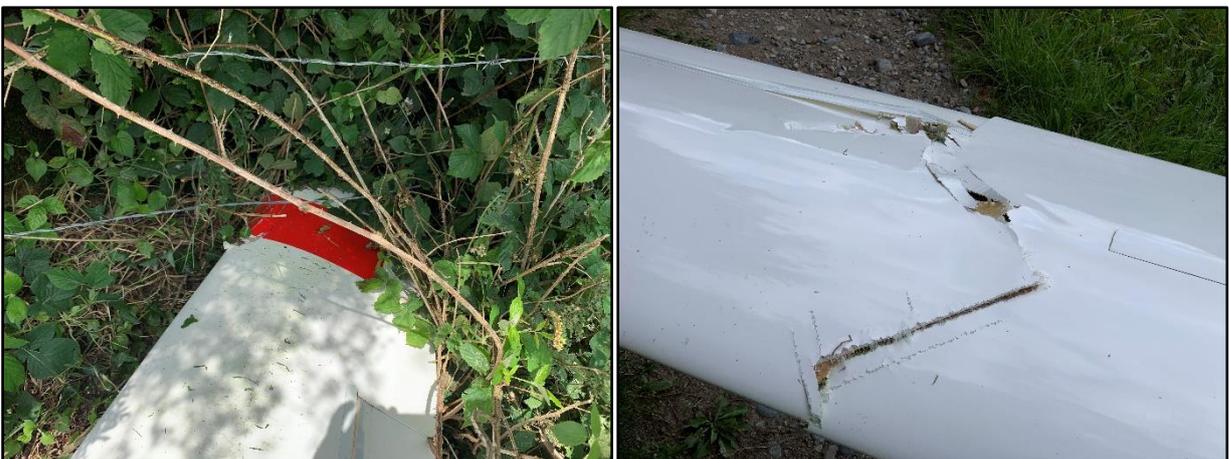
**Photo No. 5 and No. 6:** Damage to the right wing

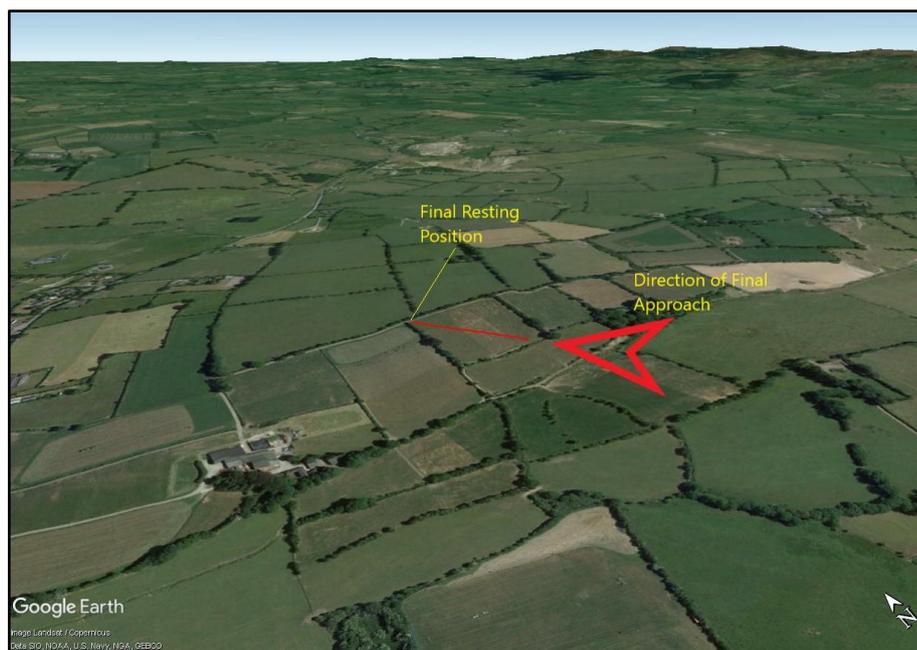
**Figure No. 4:** Landing field

The Pilot described the landing field (**Figure No. 4**) as 'grass farmland' with an uphill slope in the direction of landing and a 'poor' but dry surface condition. Photographs taken by the Pilot after landing showed that the field had been subdivided into three parts using an electric fence supported on plastic-covered stakes which remained upright in the post-occurrence photographs. A farm access track ran east-west inside the northern boundary of the field. The distance from the western-most electric fence to the final resting position of the glider was measured by the Pilot in the direction of landing and found to be 61 m. The elevation of the field in the northwest corner is approximately 617 ft (188 m).
