Air Accident Investigation Unit Ireland

FACTUAL REPORT

**Axis Comet 3 Paraglider
Nine Stones, Mt. Leinster, Co. Carlow**

9 July 2022

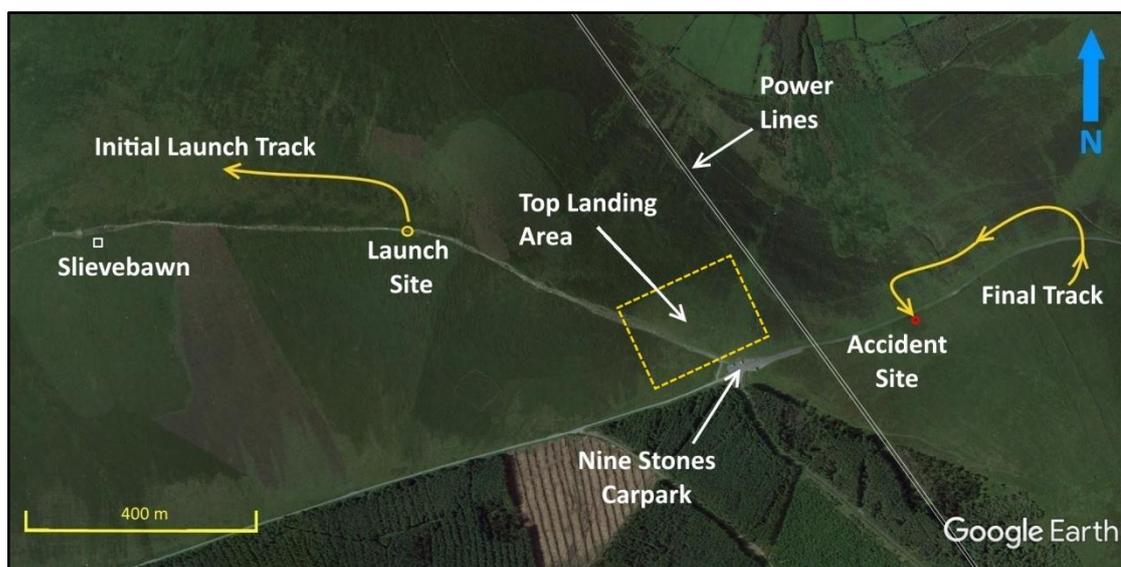
At 16:32 hrs, the paraglider was launched from a point approximately 600 metres (m) northwest of the Nine Stones car park. The flight lasted for just over one hour, during which the paraglider was flown between Slievebawn and an area approximately 600 m east of the car park (**Figure No.1**).

Figure No. 1: Diagram showing relevant features of the area in which the flight took place
