Technical report

IN-053/2021

Incident involving a Boeing 737-8AS aircraft,
registration number EI-DLH, on 10 December
2021 at Santiago Airport (La Coruña, Spain)

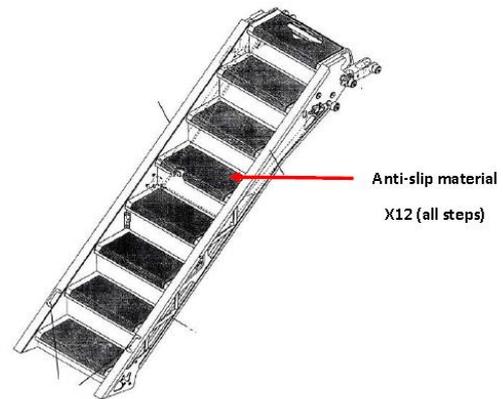
1. The stair treads are covered with a non-slip material: specifically, 3M Safety Walk 710 - Coarse⁴.

Although Ryanair's manuals also allow the use of the 3M Safety Walk 610 - General Purpose non-slip material⁵, the stairs of the aircraft in question are equipped with the former.

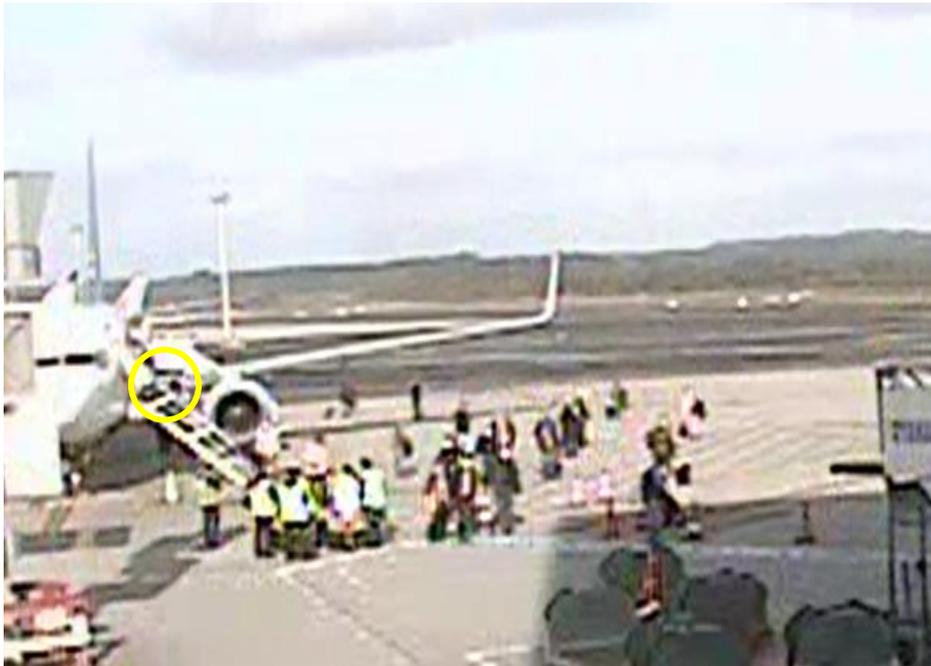
Figure 2: Passenger descending the stairs moments before the fall

The incident was captured by the airport's cameras. However, it is not clear from the footage exactly how the passenger fell:

Even though the aircraft has warning signs on the stair risers and door frame advising passengers to hold onto the handrail when walking down the stairs, and despite the fact that Ryanair communicated this advice in English before proceeding to disembark the passengers, the injured passenger - who is of Spanish nationality - walked down the stairs while holding a suitcase in one hand and a coat in the other, and therefore did not hold onto the handrail.

As both of his hands were full, he was unable to grasp the handrail upon losing his balance.

The investigation has determined that the cause of the incident was the passenger descending the stairs with a suitcase in one hand and a coat in the other, which was not in accordance with the operator's disembarkation instructions..

We believe that the disembarkation procedure should be made more rigorous: during disembarkation, the cabin crew should make sure that passengers have one hand free to hold on to the handrail when descending the forward stairs of the aircraft. A recommendation along these lines was issued to Ryanair in Report A-020-2021.
