# **Air Accident Investigation Unit Ireland**

**PRELIMINARY REPORT**

**BRM Aero, Bristell NG5, G-OJCS**

**13 June 2019**

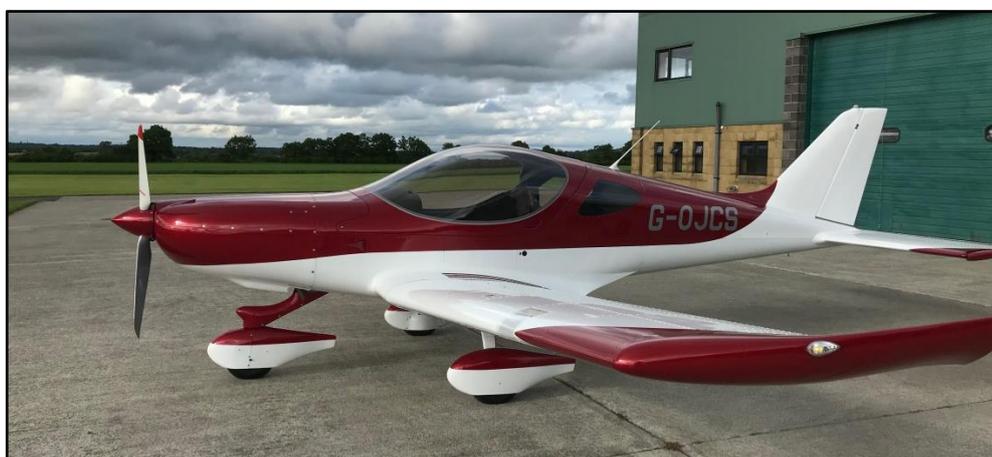
G-OJCS was a home-built light aircraft of all-metal construction (**Photo No. 1**). It had an enclosed cockpit with two seats, in a side-by-side configuration. It was equipped with a fixed tricycle landing gear and a Rotax 912ULS four-stroke engine.

**Photo No. 1:** The accident aircraft (file photo)
