# **Air Accident Investigation Unit Ireland**

**PRELIMINARY REPORT**

**Rollason D.62B Condor, EI-BDX  
Duncormick, Co. Wexford  
6 October 2019**

**AAIU Report No: 2019-011**  
**State File No: IRL00919054**  
**Report Format: Preliminary Report**  
**Published: 8 November 2019**

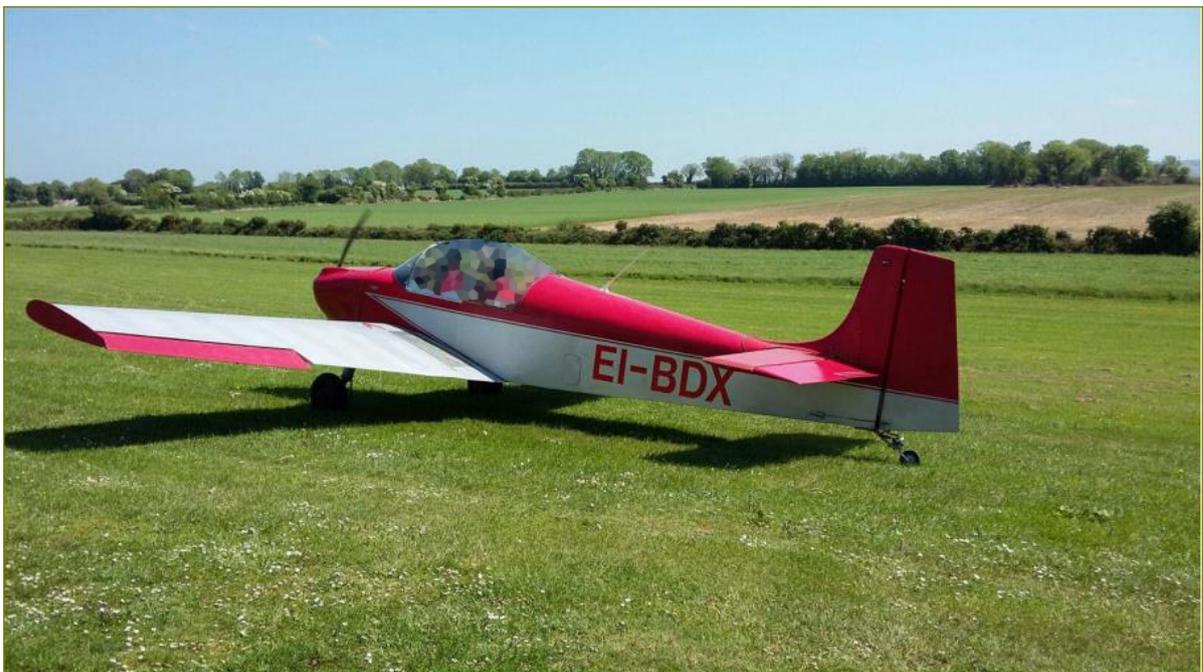
EI-BDX was constructed from wood and fabric by Rollason Aircraft and Engines Ltd, at Croydon Airport, Surrey, United Kingdom, in 1965, and powered by a Rolls-Royce O-200A engine (**Photo No. 1**). It had an enclosed cockpit with two seats, in a side-by-side configuration. The aircraft was a "tail wheel aircraft", meaning that it had two main undercarriage legs, one under each wing, and a steerable tail wheel (under the tail of the aircraft). A modification (WAR 160) was available to install wing flaps on the D.62B, but this modification had not been incorporated into EI-BDX.

**Photo No. 1:** The accident aircraft (file photo)
