AAIU Report No: 2011-001
State File No: IRL00911002
Published: 10/01/2011

**AIR ACCIDENT
INVESTIGATION UNIT**

PRELIMINARY INCIDENT REPORT

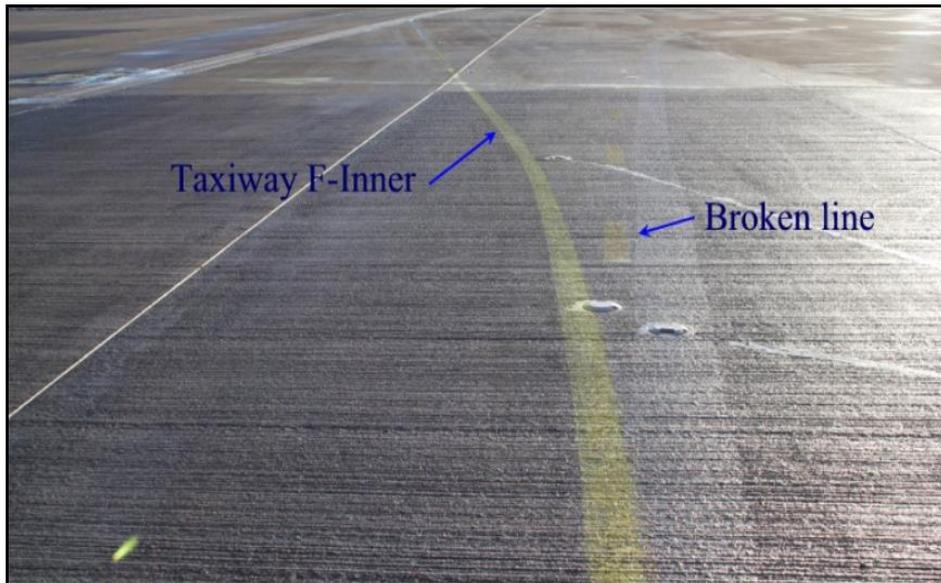
An AAIU Inspector surveyed the location of the occurrence at approximately the same time on the morning following the occurrence. Conditions were similar to the previous morning, with a low sun and damp pavements. **Photo No. 1**, taken in the direction of travel of the taxiing aircraft into the sun, shows the continuous yellow line representing the centreline of Taxiway F-Inner with the broken line to its right. For clarity, **Photo No. 2** shows the same area, but with the sun behind the camera. The Investigation was informed that the broken line represented a disused temporary taxiway which had been in use during engineering works.

Photo No. 1: Taxiway F-Inner and Broken Line - Direction of Taxi

The Dublin Airport Authority (DAA) should remove the broken yellow line between Taxiway F-Inner and F-Outer at the earliest opportunity. It is further recommended that any similar lines which may exist, representing disused taxiways, should also be removed. ([IRLD2011001](#))

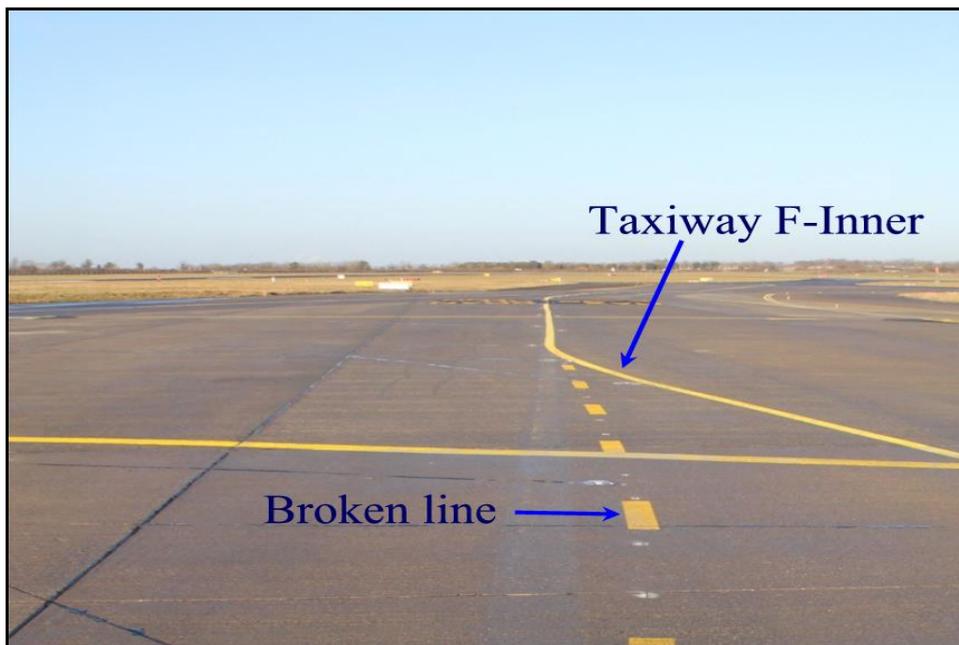
Photo No. 2: Taxiway F-Inner and Broken Line – Opposite Direction of Taxi
