FINAL REPORT

AAIU Formal Report No: 2005-015

Operator:	Celtic Airways
Manufacturer:	Fokker
Model:	F 27 – 500
Nationality:	UK (Callsign ECY 4065)
Registration:	G-ECAT
Location:	Sligo Airport (EISG), Ireland N541648 W0083557
Date/Time (UTC):	2 November 2002 @ 17.02 hrs

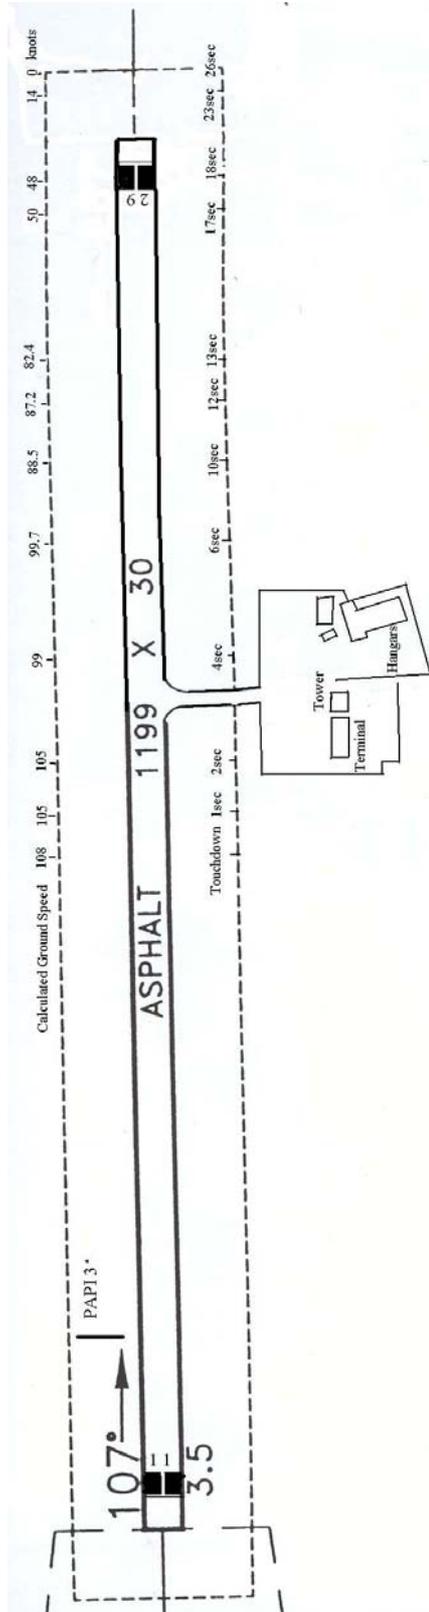
APPENDIX C

The point at which these forces return to normal were found to coincide with the point at which the heading ceased turning and this was taken as the point where the aircraft came to rest. The final deceleration was in the region of 8 ft/sec/sec and existed for 294 metres (967 ft). The total landing roll therefore, was 753 metres (2470 ft). The position at which the aircraft came to rest was measured as 50.5 metres from the runway pavement. This would indicate that the aircraft touched down about 460 metres from the threshold of RWY 11 (**Appendix C**).

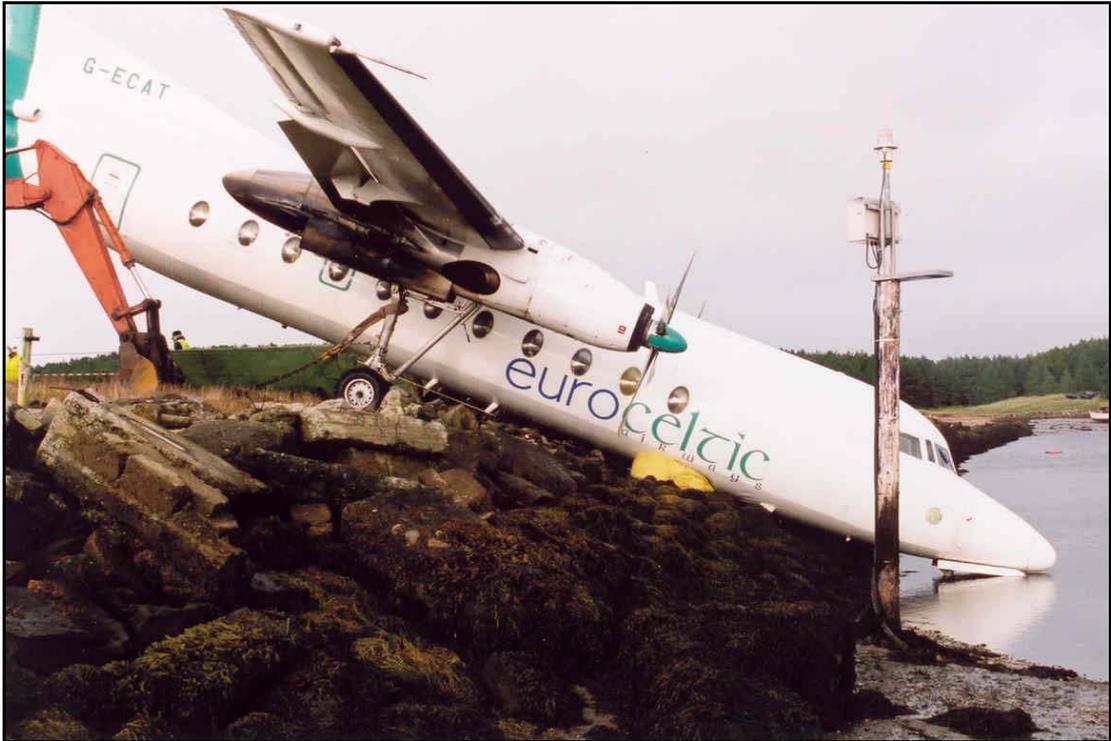
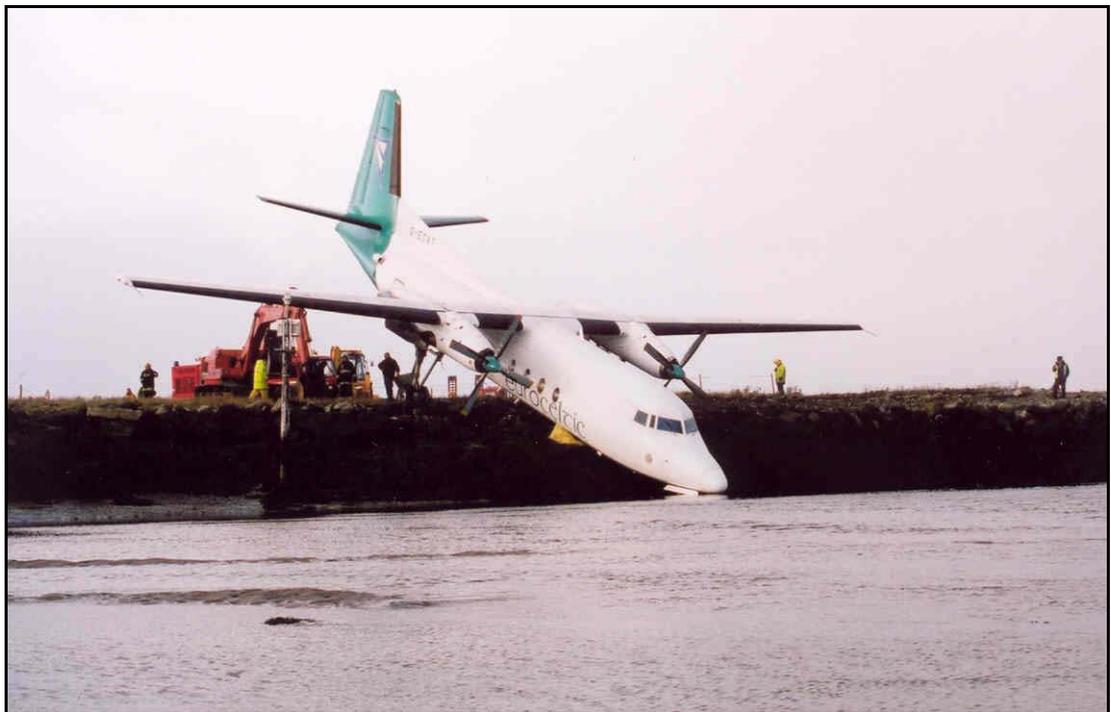
APPENDIX D

It was noted that both propellers had suffered light tip damage, consistent with the propellers making ground contact as the aircraft's nose sank.

The underside of the aircraft suffered extensive puncture damage, which was consistent with the nose sinking, thereby bringing the underside into contact with the stone embankment. When the aircraft came to rest, the nose wheel was not in ground contact.

Final resting position of G-ECAT at half-tide mark.
