FINAL REPORT

AAIU Synoptic Report No: 2010-014

Aircraft Type and Registration:	Cessna 206G Stationair, EI-HOG
No. and Type of Engines:	1 x Rolls Royce Allison 250-C20S
Aircraft Serial Number:	U20605745
Year of Manufacture:	1980
Date and Time (UTC):	15 March 2009 @ 14.20 hrs
Location:	Clonbullogue Airfield (EICL), Co. Offaly N53° 14.59', W007° 07.24'
Type of Flight:	Aerial Work - Parachute drop
Persons on Board:	Crew - 1 Passengers - 0
Injuries:	Crew - 1
Nature of Damage:	Substantial damage to aircraft
Commander's Licence:	Private Pilot Licence (PPL) Aeroplanes
Commander's Details:	Male, aged 68 years
Commander's Flying Experience:	3,500 hours, of which 17 were on type
Notification Source:	Dublin ATC Watch Manager
Information Source:	AAIU Field Investigation

SYNOPSIS

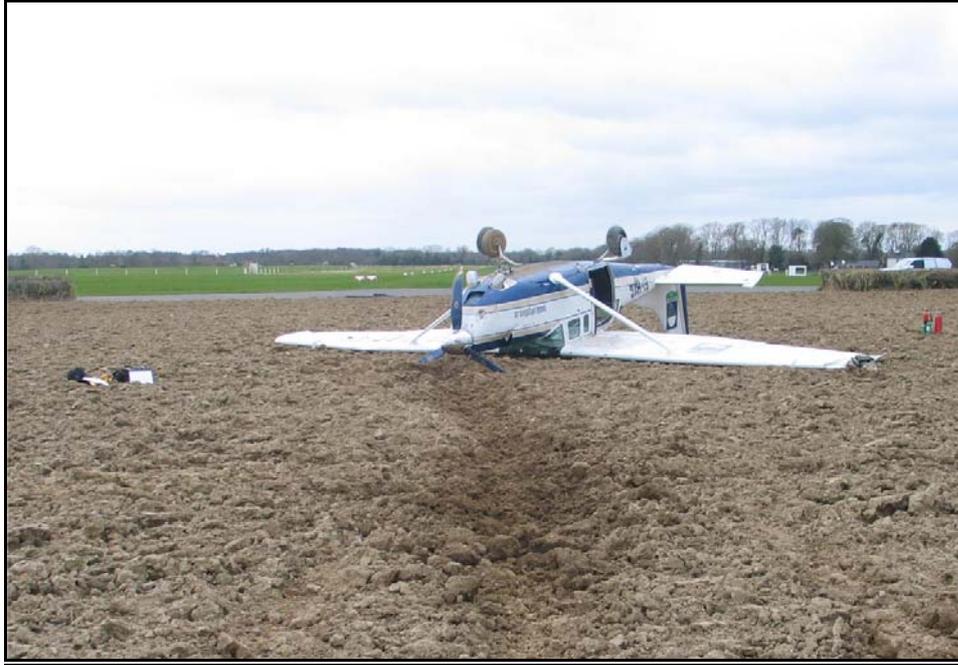
The Investigation team arrived at the scene within two hours of the accident occurring. The accident site was 136 m from the threshold of RWY 27 at EICL (**Photo No. 1**). The Investigation was informed that this field had been ploughed between one and two days previously. The aircraft was found intact but inverted with the nose wheel drag brace and steering linkage fractured. The propeller blades were bent backwards consistent with striking the ploughed earth at low RPM in an unfeathered position.

Photo No. 1: Showing initial impact mark with runway threshold in the background

On checking the accident site the witness marks revealed that, having touched on at a low speed, the nose wheel dug in to the soft soil. The resulting retarding force on the nose leg assembly was sufficiently below the centre of gravity to invert the aircraft. Consequently, the damage to the aircraft was less than might be expected. Witness marks on the propeller indicated that the propeller was rotating at low speed. As the propeller had not been manually feathered and was consequently freely rotating, the propeller witness marks are consistent with the Pilot's report that the engine had stopped before impact.

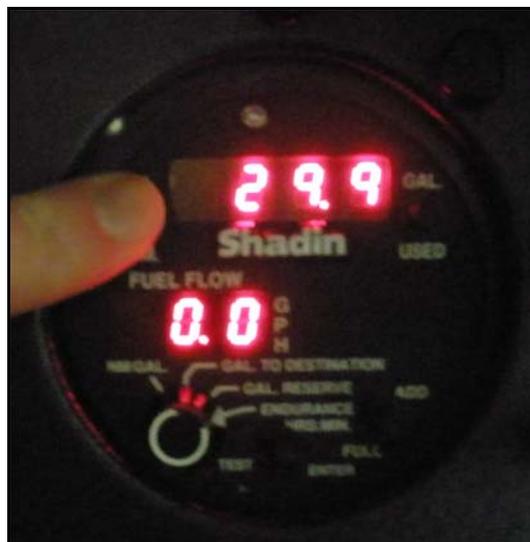
The aircraft was recovered to an upright position and transported to an adjacent hangar. On inspection, the Investigation found that the integral wing fuel tanks had not been damaged in the accident. The aircraft's electrics were powered up and readings obtained from the Shadin Fuel Meter (**Photo No. 2** and **Appendix A**) and the fuel tank gauges (**Photo No. 3**). Whereas the tank gauges showed almost empty, the totaliser showed an estimated 29.9 USG of fuel still on board the aircraft.

Photo No. 2: Shadin Fuel Flow Meter (totaliser) reading post accident

Following the accident the Investigation found that the totaliser displayed 29.9 USG although the tanks were empty. The Shadin fuel flowmeter system relies on the pilot inputting the fuel quantity on board the aircraft and, after the engine is started, this fuel quantity is reduced by the fuel flow to the engine, which is measured by rate and time.

Therefore, it relies on an accurate initial fuel quantity input by the pilot and subsequently on accurate calibration of the sensor k-factor, or the rate of fuel flow to the engine. Accordingly, the flow meter totaliser became more inaccurate the longer the engine was running, as it under read fuel consumption by 19%. The installation of an unapproved totaliser gauge, in addition to the lack of k-factor calibration, is likely to have caused this gross under-reading fuel consumption.

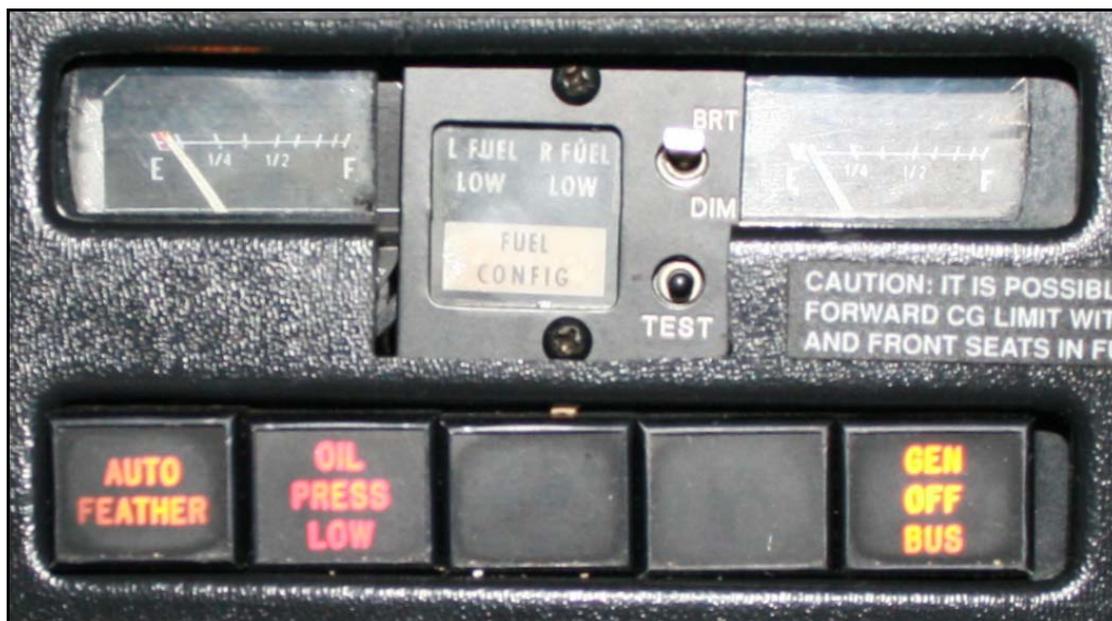
The fuel tank contents indicators showed almost but not quite empty and the fuel low quantity warning lights were found to be inoperative (**Photo No. 3**). When the Investigation accessed the module containing these lights, it found that the connector at the rear of the module was disconnected from its wiring loom, and that the calibration/normal switch was in the calibration position. It was not possible to say definitively whether the connector had become detached during the impact sequence or had been detached earlier.

Photo No. 3: Fuel Gauges and Annunciator panel

When the loom was re-connected to the module it was found that the warning lights illuminated permanently even though the fuel level in both tanks was well above the low-level threshold. This fault appeared to be caused by an electrical short circuit. Again, it could not be definitively established if this defect was caused by the impact. It should be noted that the position of the calibrate/normal switch does not affect the accuracy of the fuel tank gauges or fuel low level warnings.

The Investigation found that, on post-accident inspection, the connector on the rear of the low quantity-warning module was disconnected. Although it was not possible to ascertain when the disconnection occurred, the fact that the Pilot did not observe a low quantity warning prior to or following the initial engine power loss lends credence to the probability that the module was disconnected before the accident.

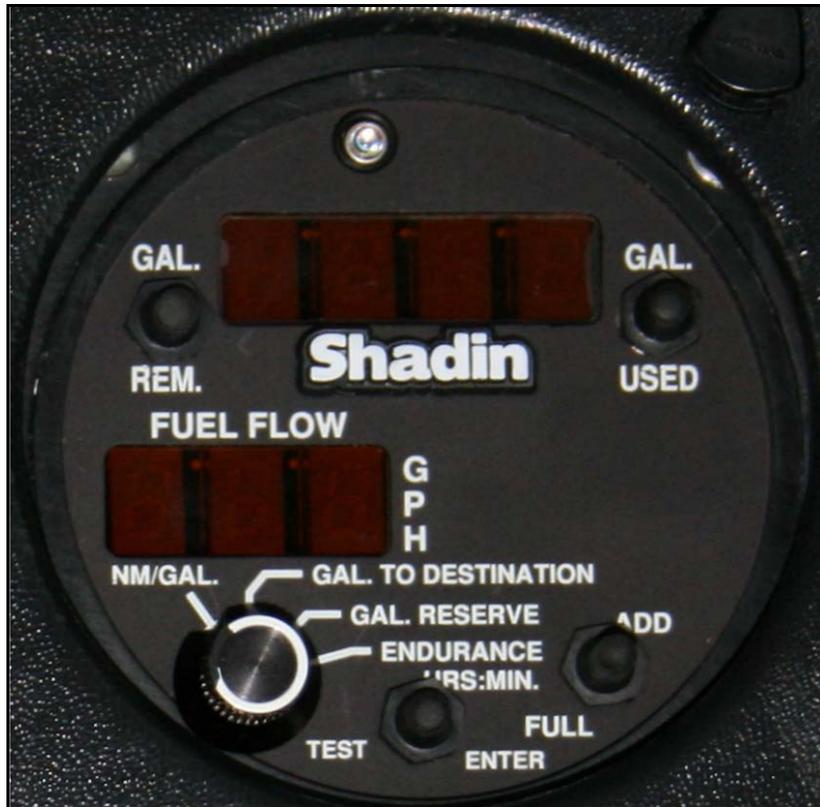
Appendix A

A logbook entry in September 2006 recorded the installation of a "Shadin fuel flow gauge (p/n⁵ 910531P) and transducer (p/n 680526A)". The Investigation established that this gauge p/n was not approved by Soloy for this installation. The approved gauge (Soloy p/n 700-1030-1 or 700-1030-3 with the equivalent Shadin p/n 910517 or 910517P) included a read-out of fuel temperature and indicated fuel quantity in pounds rather than USG. The presence of an unapproved gauge was not identified in the United States Export Certificate of Airworthiness (C of A) or by the IAA prior to issue of the C of A.

An incorrect fuel flow transducer was recorded in a logbook entry as having been fitted to the aircraft. On examination of the aircraft, the Investigation found that the correct transducer but an unapproved gauge were actually installed on EI-HOG. Although the incorrect logbook entry record was not a factor in the occurrence, there was an unapproved and inaccurate totaliser gauge installed. This incorrect installation had not been identified during various airworthiness inspections.

9. The fuel gauges had not been properly calibrated and were inaccurate.
10. The Shadin fuel flow gauge installed was not a Soloy STC approved part.
11. No record was found for calibration of the Shadin fuel flow sensor, which under read fuel consumption by approximately 19%.

Unapproved Shadin Fuel Flow gauge as installed in EI-HOG
