Air Accident Investigation Unit Ireland

ACCIDENT REPORT
Reims Aviation Cessna 172M, G-YORK
Ballyboy Airfield (EIMH), Co. Meath
8 May 2011

AAIU Report No: 2012-018
State File No: IRL00911040
Report Format: Synoptic Report
Published: 26/11/2012

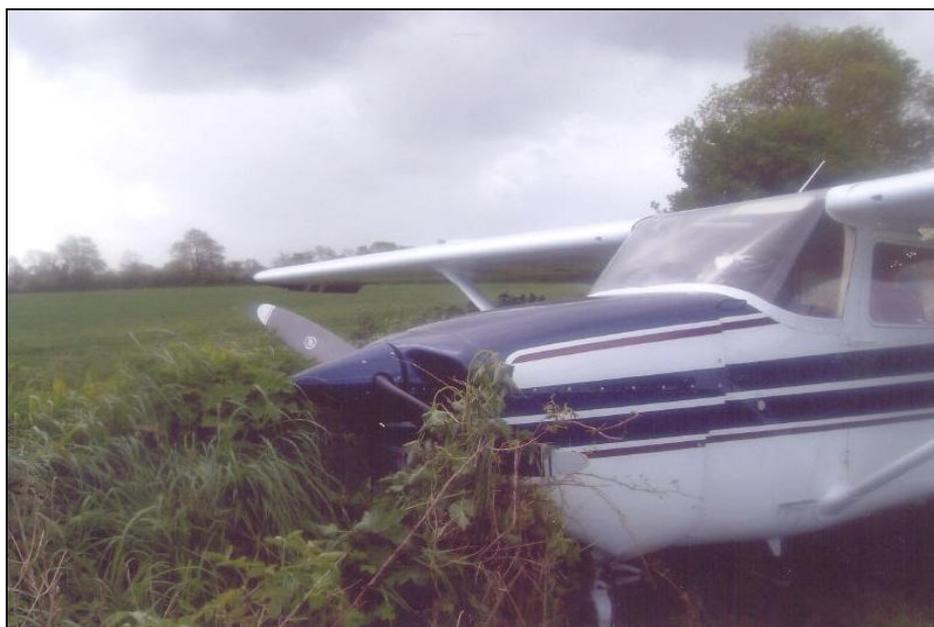
The aircraft impacted a tree stump embedded within the hedgerow (**Photo No. 1**) at a low power setting. The propeller stopped and the Pilot carried out shutdown checks, including fuel-off. He exited the aircraft unaided and without injury.

Photo No. 1: Final resting position of G-YORK (*Pilot's Photo*).

A technical inspection of the aircraft showed a bent propeller and substantial damage to the lower fire wall/front lower fuselage area.
