Air Accident Investigation Unit Ireland

**FACTUAL REPORT
INCIDENT TO
BOMBARDIER DHC-8-402, G-JEDR
Waterford Airport (EIWT), Ireland
05 June 2012**

AAIU Report No: 2012-019
 State File No: IRL00912062
 Report Format: Factual Report
 Published: 28 November 2012

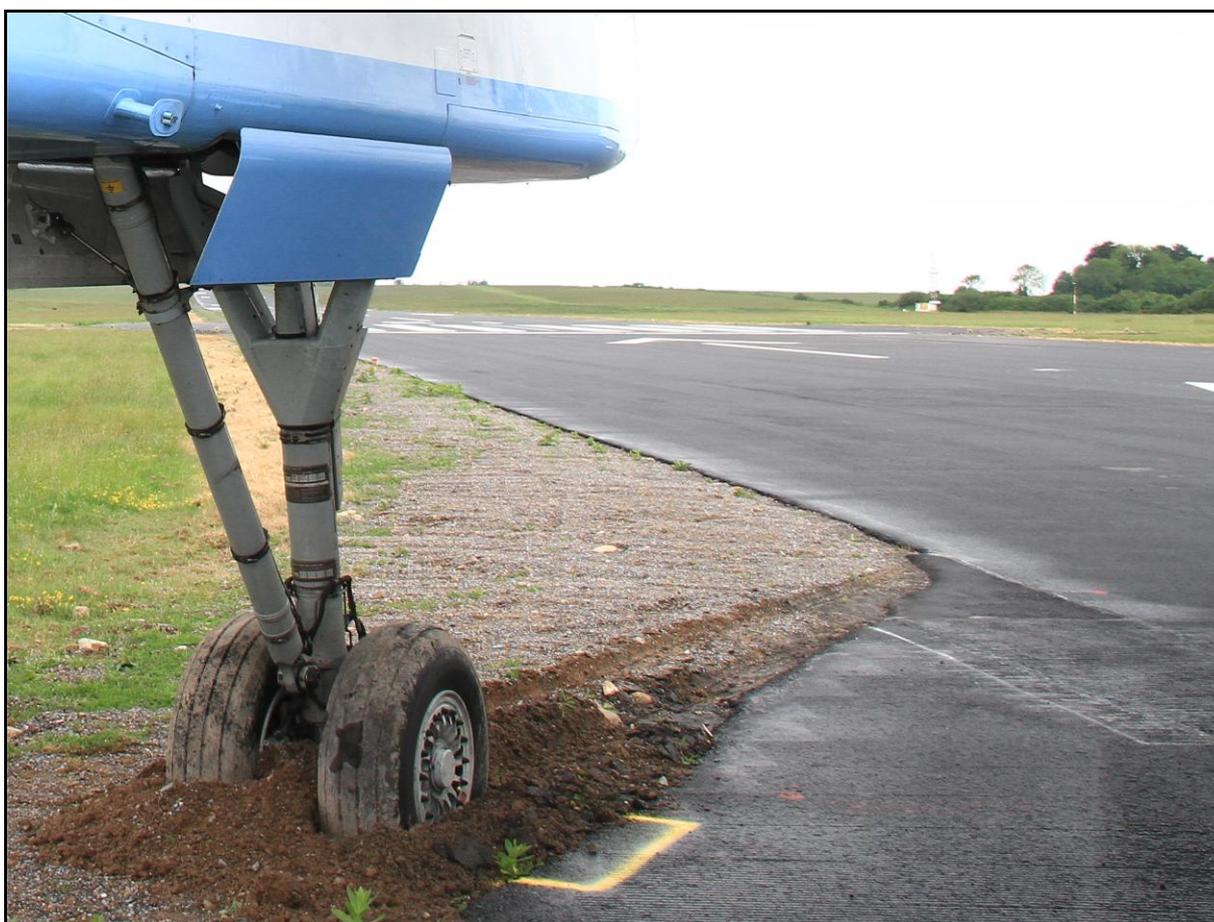
At the runway threshold, he made a right-hand turn with the intention of taxiing as close as possible to the edge of the turning pad. This strategy would also have allowed him easier alignment with the runway centre line when the 180° turn was completed and thus maximise the distance available for take-off. The Pilot stated that the taxi speed at the time was approximately 5 kts. He recalled the First Officer (F/O), who had a closer view of the pad's edge from his right hand seat, commenting that "*we are getting close to the edge*" and so no further right turn was made. The Pilot added that they felt no movement or vibration suggesting that they may have left the hard surface of the pad. Following the F/O's comment the Pilot initiated a left turn, at which point the aircraft came to a steady halt. The crew realised that the aircraft was stuck. The Pilot applied a small amount of power to see if the aircraft would move, but it did not.

He then asked the F/O to call ATC and request assistance. He also advised the cabin crew and passengers of their predicament. Airfield Operations requested the Pilot to shut down the No. 2 engine so that the right-hand main landing gear could be inspected (**Photo No. 1**). The Pilot did so, shutting both engines down. Shortly afterwards the passengers disembarked and were taken to the Terminal. The Pilot and F/O stayed with the aircraft until permission was given by the AAIU to move it from the soft ground to the apron.

Photo No. 1: Embedded right hand wheels with RWY 21 threshold in background.

This was the first time the Pilot had operated into EIWF. The lack of guidance lines on the threshold turning circle of RWY 21 and the fact that the Pilot was unaware that the diameter of the turning pad was more than adequate for a 180 degree turn, led him to being over cautious while entering the turn. As the Pilot was steering from the left hand side of the cockpit his ability to judge the position of the right hand wheels was impaired. This led to the aircraft being positioned too close to the edge of the pavement area and an inadvertent excursion from the hard surface on to soft gravel, thus becoming stuck. The slow speed at which this happened and the gentle nature of the retardation resulted in no damage to the aircraft.

1. Waterford Airport should provide turn pad guidance lines in accordance with the provisions of Annex 14. [IRLD2012007](#)
