# Air Accident Investigation Unit Ireland

**ACCIDENT REPORT**  
**BRM Land Africa, EI-ECW**  
**Bréandroim, Co. Galway**  
**24 March 2012**

AAIU Report No: 2012-020  
 State File No: IRL00912033  
 Report Format: Synoptic Report  
 Published: 29/11/2012

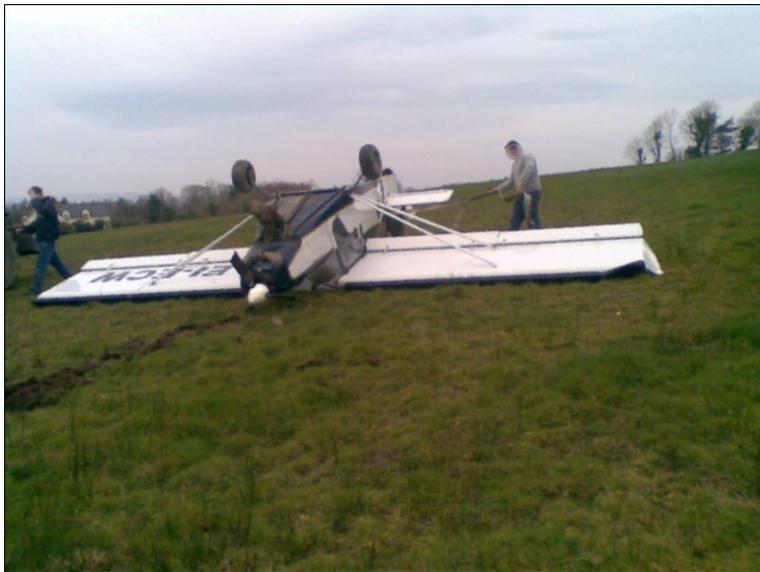
EI-ECW was normally based at the Pilot's private airstrip at Corr Na Móna, Co. Galway. From here he flew to Bréandroim, also in Co. Galway, with the intention of landing in a field adjacent to his son's house. The short flight was routine. The selected landing field had a significant uphill gradient, in the intended landing direction. The touchdown was made without any bounce but the aircraft rapidly dug in, fracturing the nose leg at the attachment to the fork bracket. This bracket folded up behind the nose leg; all three propeller blades then sheared due to ground contact. Due to the dug-in nose leg and forward inertia, the aircraft pitched forwards on its nose and came to rest in the inverted position (**Photo No. 1**).

**Photo No. 1:** Final resting position of EI-ECW (*Pilot photo*)

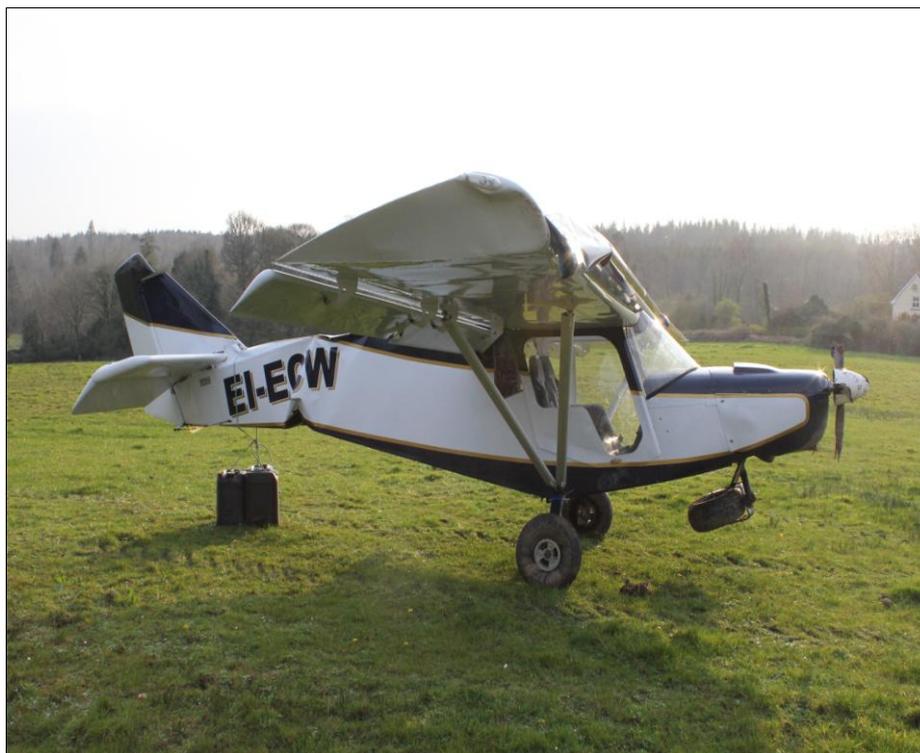
An Inspector from the AAIU travelled to the scene the same day. The aircraft was inspected having been recovered to an upright position. Damage included the shearing of the nosewheel fork bracket which pulled across three of the retaining bolts. All propeller blades were fractured. The starboard wing was twisted and the aft fuselage broken across two frames (**Photo No. 2**).

**Photo No. 2:** Aircraft recovered to upright position

This was the Pilot's first landing at the site at Bréandroim, which would no doubt have presented a challenge to any pilot without significant experience in STOL operations. Faced with a short landing run and uphill slope, the landing flare would have been difficult to judge without practice. Due to the nature of the landing site, it is understandable that the Pilot may have inadvertently applied brake prior to touchdown. Directional control was compromised as the aircraft skidded. The probable application of brake, soft ground and slope resulted in excessive load being placed on the nose leg assembly due to rapid deceleration. The assembly failed at the weakest point, the bracket attaching the nose wheel fork to the leg assembly.

5. The nose leg fork attachment failed due to excessive loads on the component during deceleration.
6. Although the aircraft came to rest inverted, adequate restraint was provided by the 4-point safety harness resulting in no injury to the Pilot.

The probable application of brake, the combination of soft ground and the upslope resulted in excessive loads being placed on the nose leg causing failure.
