# Air Accident Investigation Unit Ireland

**FACTUAL REPORT  
ACCIDENT TO  
Pegasus Quantum 15-912, EI-ERE  
Mullingar Airfield, Co. Westmeath  
6 November 2011**

## FINAL REPORT

AAIU Report No: 2012-021  
 State File No: IRL00911098  
 Report Format: Factual Report  
 Published: 04/12/2012

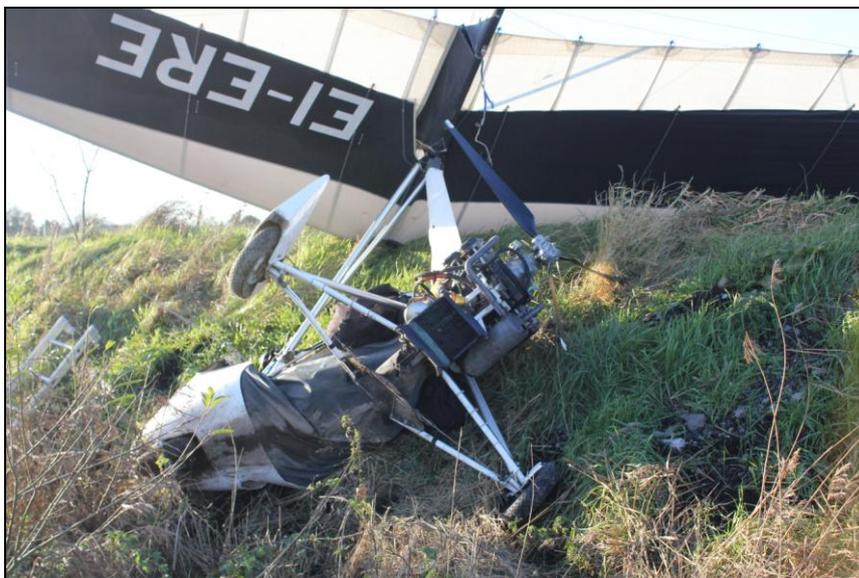
The microlight aircraft was attempting to land at Mullingar Airfield which was waterlogged at the time. Following touchdown deep into the very short runway, braking action was poor due to the wet surface. The Pilot applied power to go-around but the aircraft came into contact with wire fencing at the departure end of the runway. The aircraft impacted heavily in a ditch a few metres beyond the runway's end. The Pilot was seriously injured in the impact.

**Photo No. 1:** Final resting position of aircraft. Note ladder bottom left.

The microlight aircraft was substantially damaged. The keel beam, sternpost, rudder bar, right undercarriage drag brace and propeller blades were damaged. The Flight Permit for EI-ERE was valid until 27 June 2012.

Pilots intending to operate into this site would be well advised to inspect the strip prior to flight, to note the hazards present in the event of an overrun in either landing or take-off direction. The presence of the wire fence was not noted by the airfield owner as a hazard as aircraft usually clear it, whether landing or taking off, by a good margin. The Investigator-in-Charge suggested to the airfield owner that he take steps to remove the wooden posts and remaining wire fence at the end of the runway.
