Air Accident Investigation Unit Ireland

**FACTUAL REPORT
ACCIDENT TO
RANS Inc. S-6 COYOTE 2, Microlight, G-MYGH
Enniskean Airfield, Co.Cork
06 April 2012**

AAIU Report No: 2012-23
State File No: IRL00912038
Report Format: Factual Report
Published: 20/12/2012

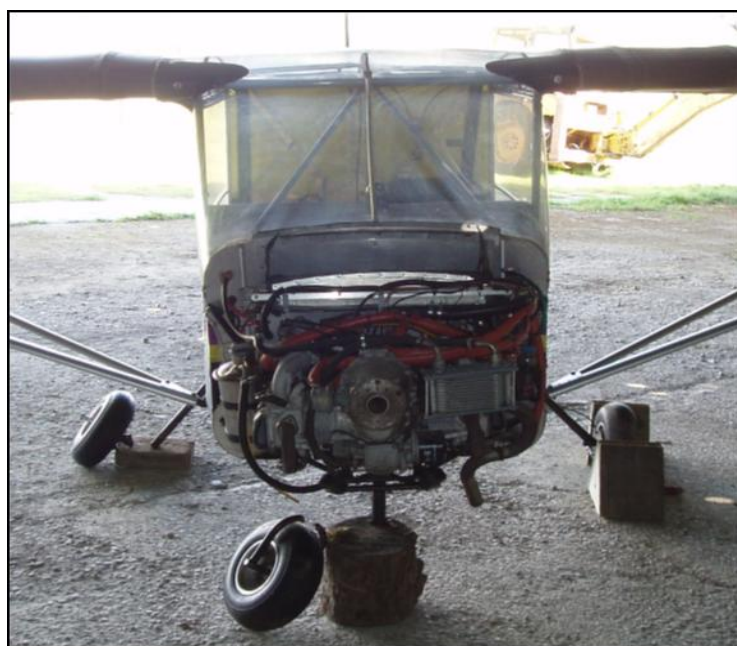
Following the accident, the Pilot supplied photographs to the Investigation which showed that both the nose wheel and the right hand main wheel had separated (**Photo No. 1**). There was also some damage to the engine cowling.

Photo No.1: Damage to Aircraft (photo by the Pilot)

The Pilot was unprepared for a down-draft which resulted in the aircraft's right hand wheel getting caught in an electrified fence and a consequent heavy landing, which resulted in damage to the aircraft undercarriage and engine cowling.
