Air Accident Investigation Unit Ireland

FORMAL REPORT

**Avions de Transport Regional 72-212,
EI-SLM
Shannon Airport
17 July 2011**

AAIU Report No: 2013-008

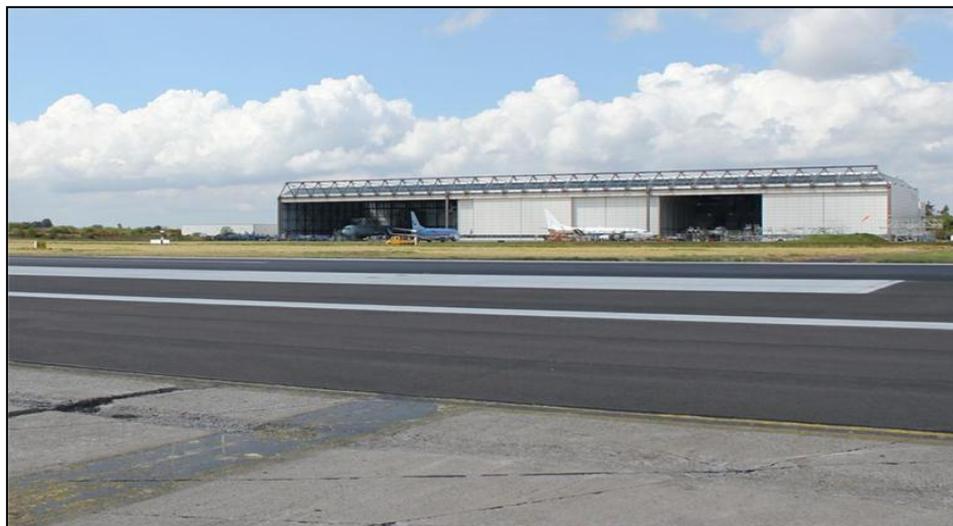
Photo No. 1: Hangar from opposite the TDZ aiming point

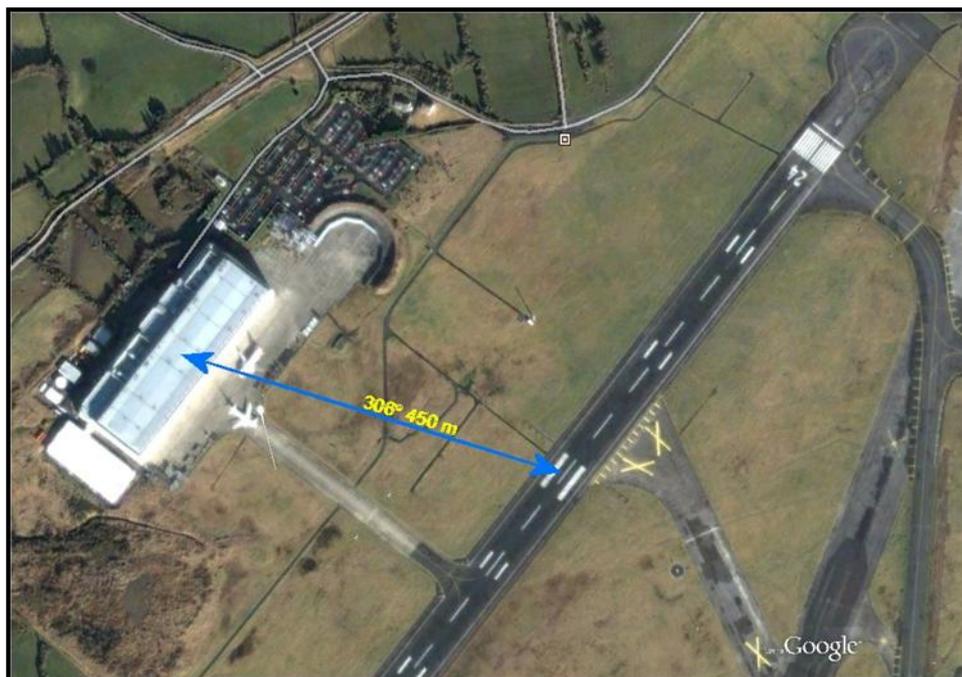
Graphic No. 1: Hangar relative to the TDZ RWY 24

The Investigation therefore concludes that, depending on the prevailing atmospheric conditions at the time (wind velocity, turbulence, turbidity and instability), the wake effect can locally augment turbulence at the TDZ of RWY 24. The continued reports of turbulence recorded by pilots over the years lend validity to the assumption that the wake effect of the Hangar has a local effect at the TDZ of RWY 24 in strong winds between west and northwest and therefore the turbulence caution is considered warranted.

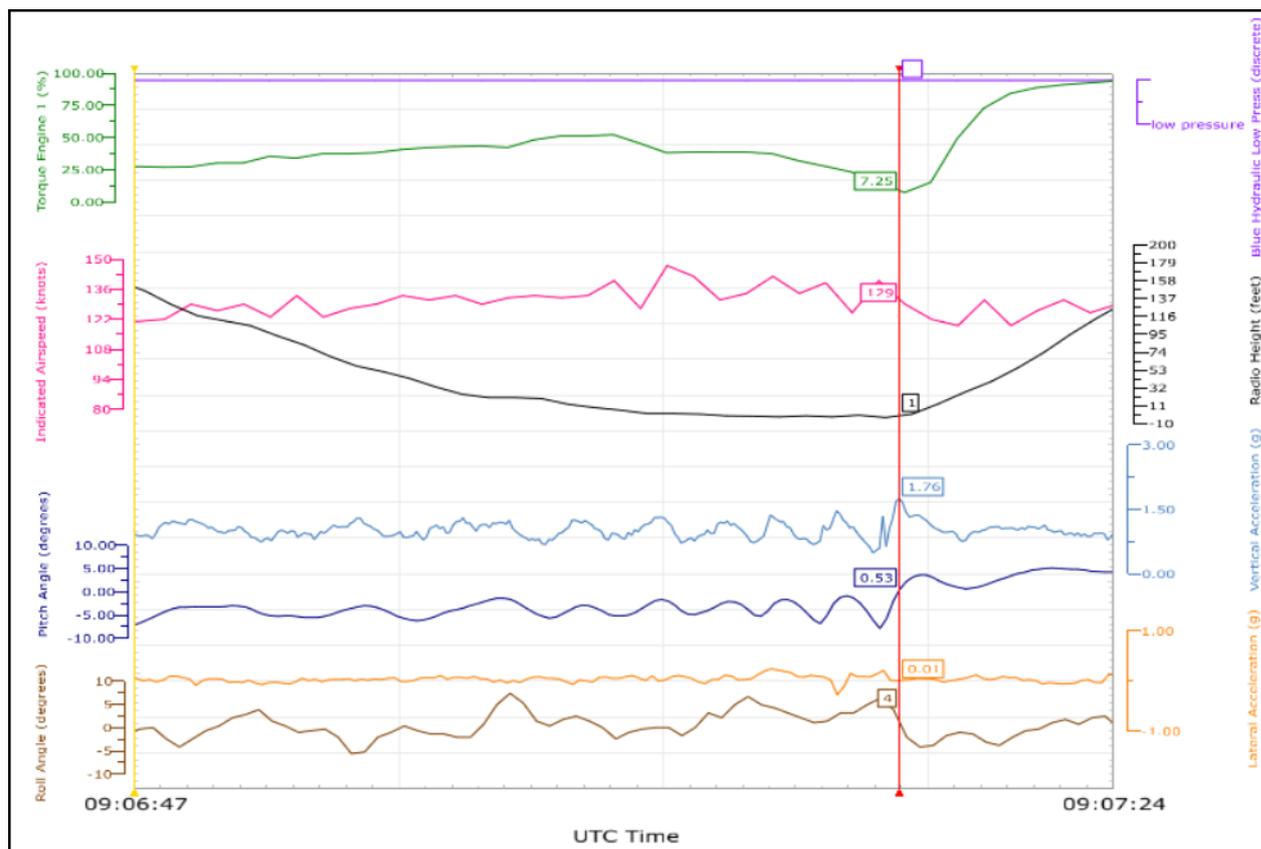
The DFDR recorded that, at a height of -3 ft following two bounces at 2 second intervals, an elevator input of -5.4° caused a nose-down pitch angle of -7.9° resulting in a 1.34 g-spike in vertical acceleration. The pitch of the aircraft then rose immediately to +0.5° in 0.7 of a second, at which point, a second g-spike of 1.76 g occurred. The DFDR Weight on Wheels (WOW) discrete, which samples once per second did not record main gear ground contact.

Graphic No. 2: DFDR Recording of First Approach

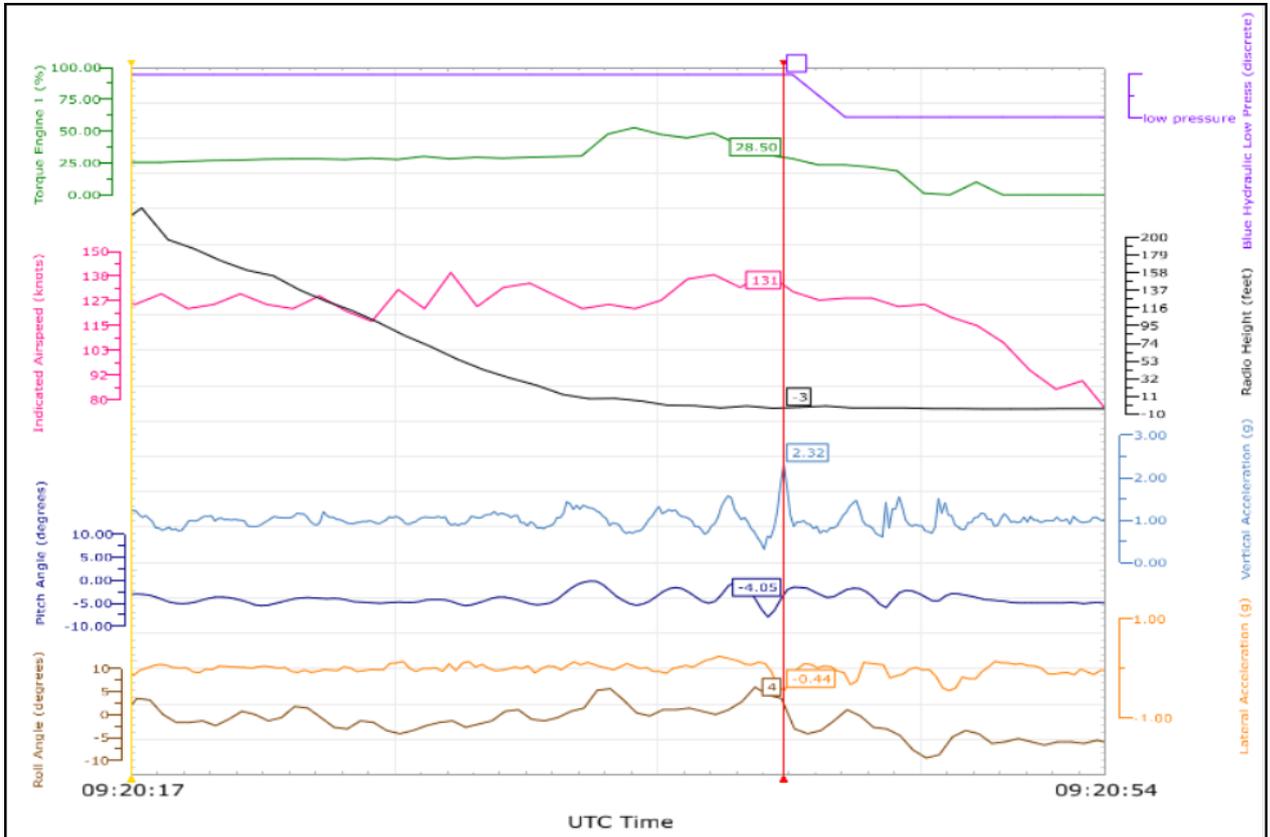
The DFDR then recorded that, at a height of -3 ft, an elevator application of -10.4° caused a nose-down pitch angle of -8.0°, the airspeed at the time being 131 kts. A 2.32 g-spike in vertical acceleration followed immediately. Blue system hydraulic failure was recorded almost immediately. The DFDR subsequently recorded 3 further positive g peaks before the main gear WOW discrete indicated that main wheels of the aircraft were on the ground.

Then, nose down inputs were recorded on the right control column during both approaches. This led to an excessive nose down pitch attitude with a subsequent impact on the nose landing gear. Neither pilot recalled such inputs subsequently.

Graphic No. 3: DFDR Recording of Second Approach

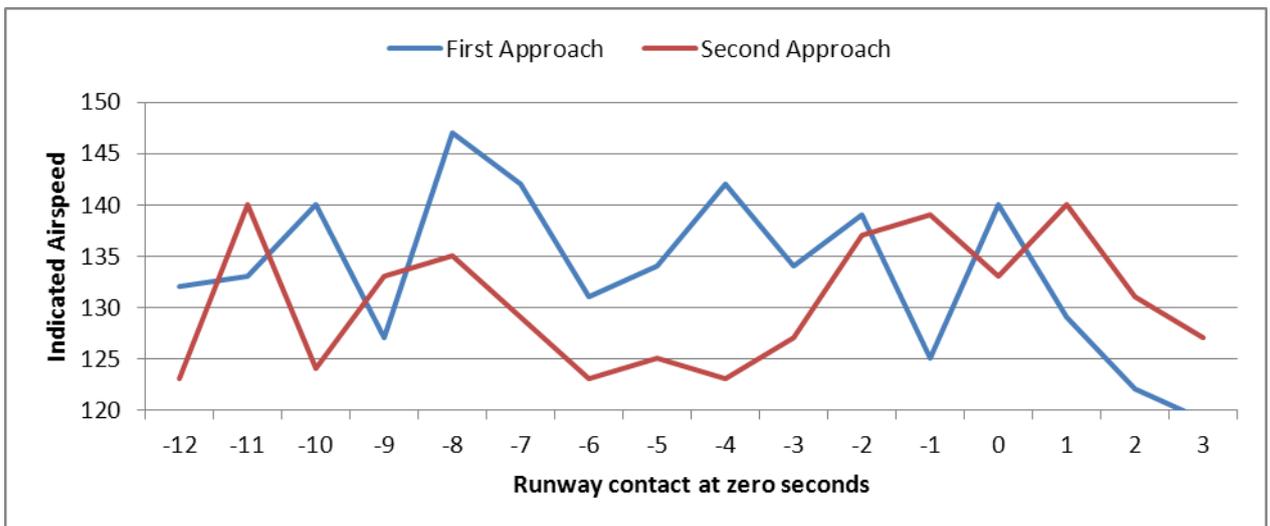
Graphic No. 4 compares the indicated airspeeds during the final seconds of both approaches.

Graphic No. 4: Indicated airspeeds

Nonetheless, the typical IAS flown during both approaches was 20 to 25 kts above that. Although both flares correctly commenced at 20 ft RADALT, the IAS recorded on both occasions were excessive at touchdown, momentarily reaching 139 and 140 kts respectively. This was partly due to the PF increasing torque after flaring and partly due to the prevailing gusty conditions.

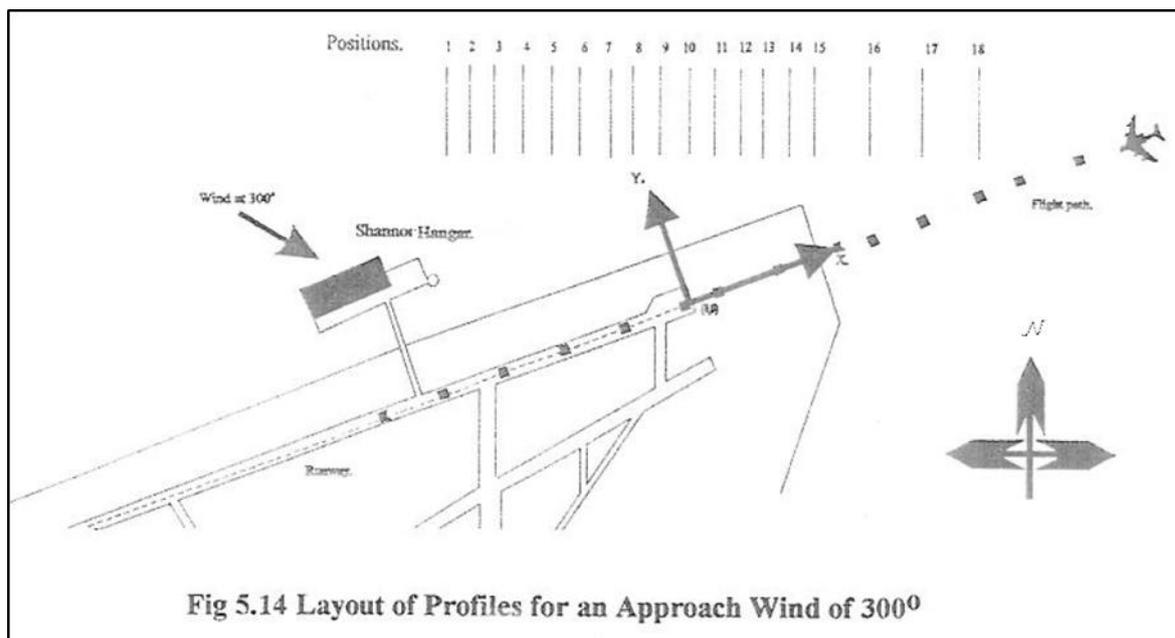
Graphic No. 5: EINN Hanger induced wake turbulence

In each case it was found that the extent of the wake effect of a single building does not extend beyond 15 to 20 building heights downwind from the building. In this case, this is equivalent to between 370 m to 490 m downwind from the hanger. The service hanger is approximately 340 m from the neighbouring runway. Hence, there are slight wind velocity deficits and turbulence intensity changes along the runway close to the hanger when the approach wind is blowing almost normal to the rear face of the hanger".
