Air Accident Investigation Unit Ireland

FACTUAL REPORT

**Piper PA 16 Clipper, EI-EMT
Letterkenny Airfield (EILT), Co Donegal
22 May 2012**

AAIU Report No: 2013-009
State File No: IRL00912056
Report Format: Factual Report
Published: 8 July 2013

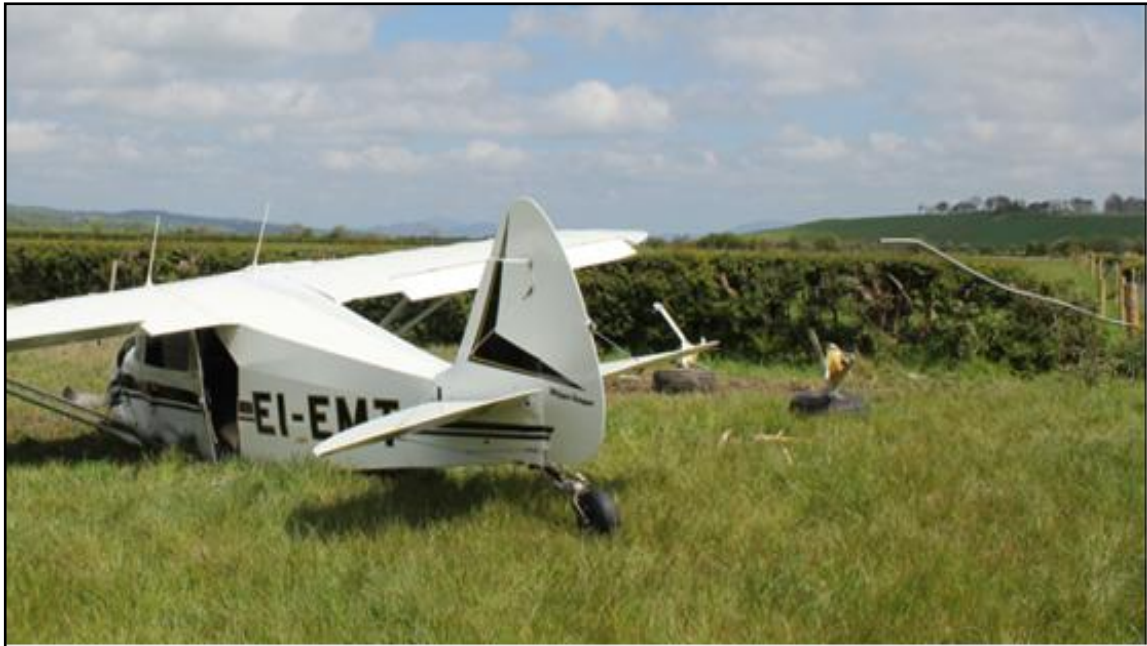
During the final phase of landing, with the throttle closed and the aircraft approximately 25 ft above the runway, a cross wind caught the aircraft and before the Pilot could react the aircraft had tracked to the right of the runway and control was lost. The starboard wing root impacted with a wind sock pole. Both main wheels impacted with the boundary fence and ditch. There was a cast iron vessel, probably an old animal trough, embedded in the soil of the ditch and the wheel impact caused several large fragments of the vessel to break away. Both main wheels separated from the aircraft and the aircraft turned through almost 180 degrees before coming to rest in the adjacent field (**Photo No. 1**). The Pilot smelled fuel and immediately shut off the electrical Master Switch. The door of the aircraft was jammed shut so the Pilot, who was unhurt, made good his escape through a door window and retreated to a safe distance.

Conversations with the Pilot and other pilots familiar with the airfield indicated that with the wind direction on the day, local topography and hangar placement can give rise to sudden, cross wind gust exposure around the point that the Pilot described, as aircraft emerge from the lee of the hangars.

Photo No. 1: Aircraft as it came to rest, note separated wheels and windsock pole

The problem of difficult cross wind conditions when emerging from the lee of the hangars was known at this airfield. On this occasion events unfolded so rapidly that the Pilot was unable to react quickly enough to prevent the accident.
