# **Air Accident Investigation Unit Ireland**

**SYNOPTIC REPORT**

**ACCIDENT  
REIMS CESSNA FRA150M, G-BDOW  
Newcastle Airfield (EINC)  
Co. Wicklow, Ireland  
13 July 2012**

AAIU Report No: 2013-011  
 State File No: IRL00912078  
 Report Format: Synoptic Report  
 Published: 30 August 2013

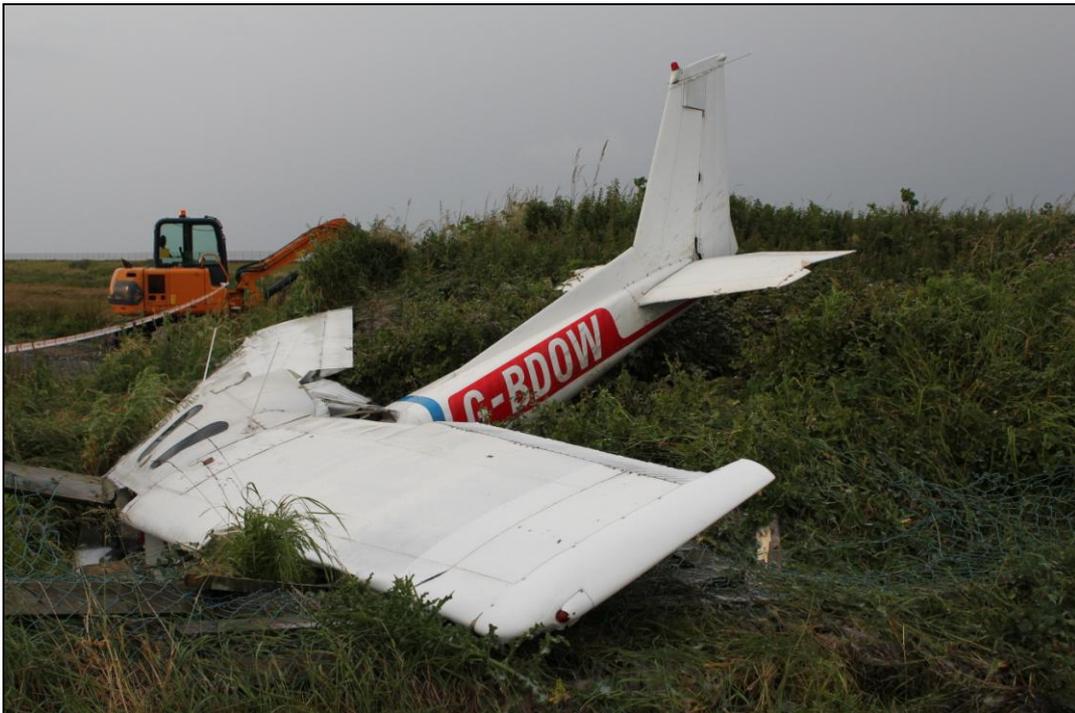
**Photo No. 1:** Final Position of G-BDOW

The Pilot stated that the aircraft was too low and descended too rapidly for him to take any action other than a shallow turn to the left to avoid a mechanical digger which was parked close to the airfield boundary. The aircraft struck a timber fence abutting a road along the southern boundary of the airfield, turned through an angle of approximately 90° on impacting the ground and came to rest in a water-filled ditch at a nose-down angle of approximately 30° (**Photo No. 1**). The two occupants, who were wearing seat belts and shoulder harnesses, were not injured in the accident and they exited unaided through their respective doors into the ditch, where they both sustained scratches from briars. The aircraft was substantially damaged in the accident. There was no fire.

The aircraft sustained substantial damage in the accident and was beyond economic repair. The fact that the forward fuselage ended up in a ditch is likely to have partially cushioned the impact. The nose landing gear leg was pushed rearwards and upwards into an almost horizontal position. The lower arms of the engine bearers, which were attached to this leg, were fractured.

The main landing gear legs were also pushed rearwards and upwards, which resulted in substantial buckling of the fuselage underneath and to the rear of the cabin area. The outer section of the port wing sustained severe deformation of the leading edge while the starboard wing was pushed rearwards from the wing root outwards, which in turn led to the aircraft roof above the cabin area being pushed upwards and deformed.

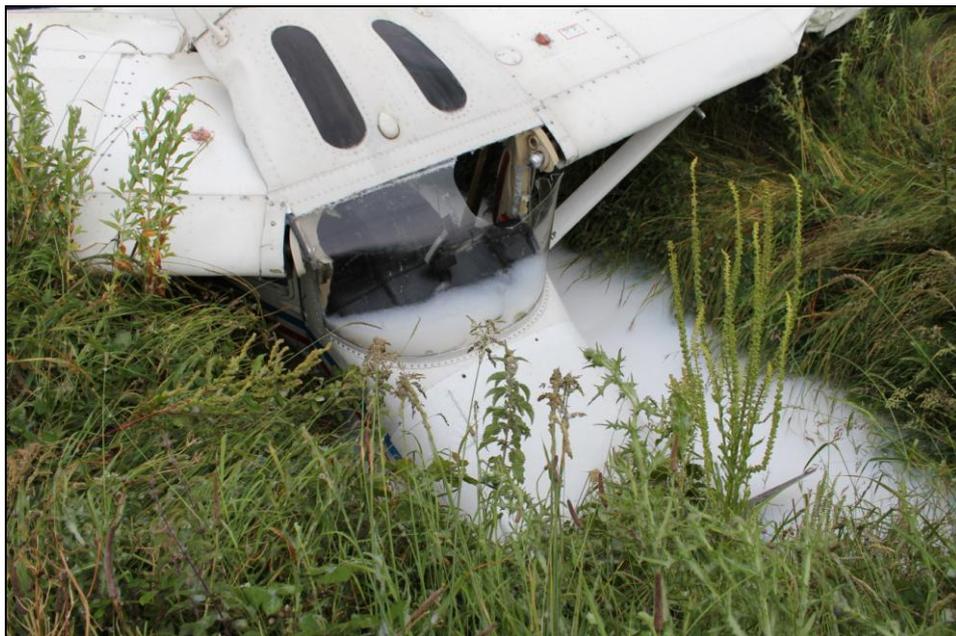
**Photo No. 2:** G-BDOW in Ditch

The AAIU Inspector on Call (IOC) arrived at EINC approximately one hour after the accident had occurred. By that time, there was a smell of fuel from the ditch and the Fire Service had dispensed a considerable quantity of foam onto the forward area of the aircraft and into the ditch (**Photo No. 2**). The IOC supervised the recovery of G-BDOW from the accident site and its transfer to a hangar on the airfield. Subsequently the aircraft was moved to the AAIU wreckage facility in Gormanston for examination.

During the recovery of the wreckage, a quantity of fuel spilled into the ditch from the forward inboard area of the starboard wing where it had separated from the fuselage. This was due to the damage sustained in the impact, as the wing had been pushed back, compromising the fuel system. Because of the nature of the terrain around the accident site, it was not possible to collect the majority of this fuel. However, sufficient was collected to enable analysis at a laboratory.

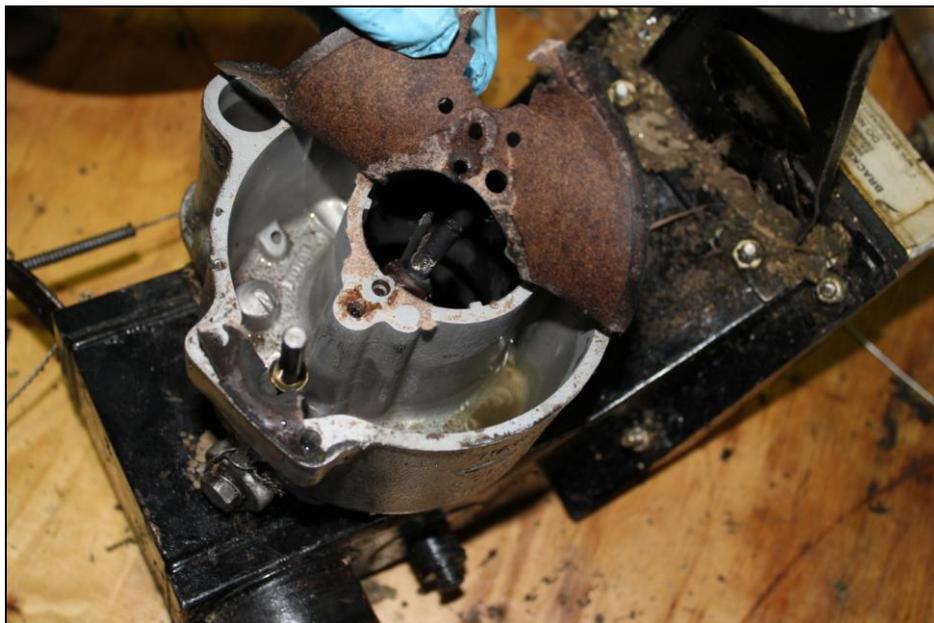
**Photo No. 3:** Carburettor Following Dis-Assembly

The “finger filter” in the fuel inlet to the carburettor was found to be clean and in good condition. The ignition timing was checked and was found to be correct. The muffler was inspected and the gas path was found to be clear.

When the carburettor was disassembled, it was found that only a small quantity of fuel remained inside the bowl. The gascolator, which is at the lowest point of the fuel system, was full of fuel and there was some fuel remaining in the fuel line between the gascolator and the carburettor.
