Air Accident Investigation Unit Ireland

SERIOUS INCIDENT

**Avions de Transport Régional 72-201, EI-REH
Cork Airport
13 May 2012**

AAIU Report No: 2013-016
State File No: IRL00912049
Report Format: Synoptic Report
Published: 3 December 2013

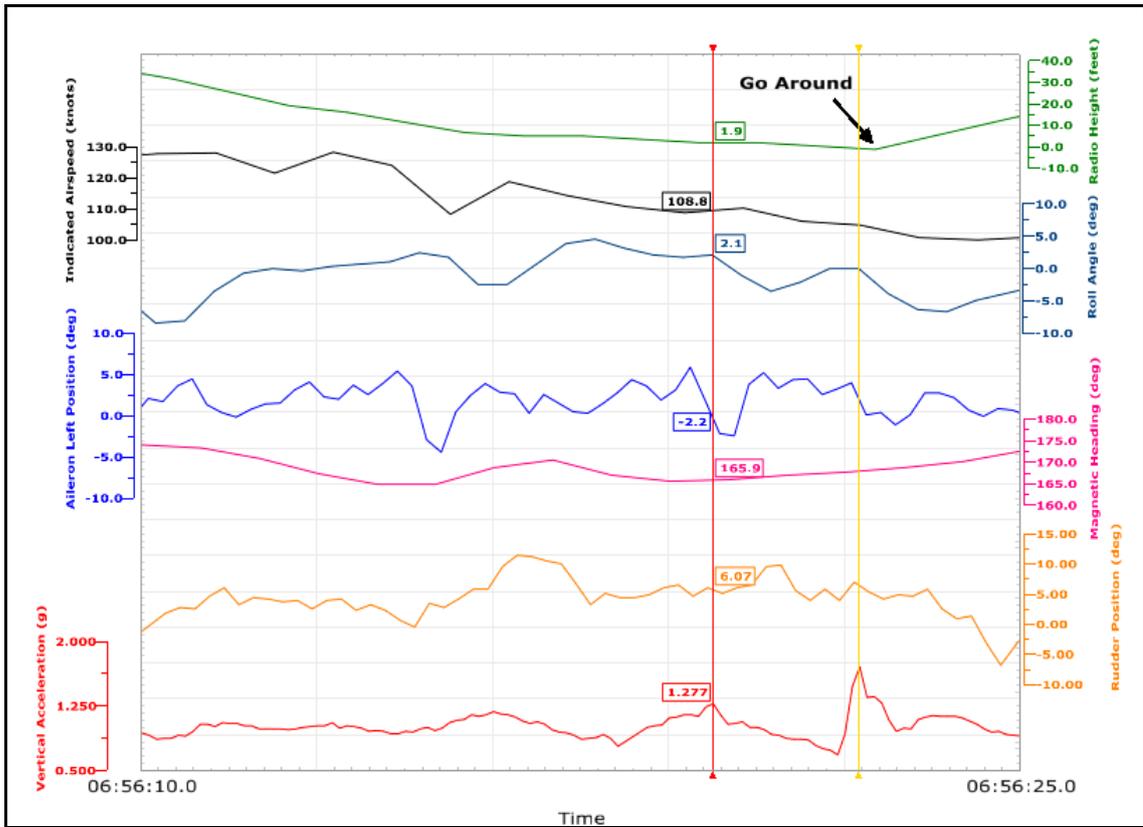
Figure No. 1: DFDR Data During Occurrence

Figures No. 1 and 2 illustrate the most relevant DFDR parameters over a 15 second time interval around the time of the occurrence. The point where the go-around was commenced is marked on the uppermost trace (radio height) in each Figure. The lowest trace in both Figures represents vertical acceleration.

During a period of approximately five seconds preceding the first peak in vertical acceleration of $1.277g$, the recorded rudder position varied from -0.47° to $+11.45^\circ$ (indicating a left pedal input) and then back to approximately $+5^\circ$, while the magnetic heading varied from 164.9° to 170.5° and subsequently decreased, being recorded at approximately 165.9° concurrently with the $1.277g$.

The aircraft initially touched down on its main landing gear at a low vertical velocity in the order of 0.4 m/s and a pitch angle of approximately 3.2° nose up. This vertical velocity at the aircraft centre of gravity was computed by integrating the vertical acceleration values recorded on the DFDR. The maximum vertical acceleration recorded at this time was 1.277g.

The recorded values of elevator position then show it moving rapidly from a negative value to a positive value with a consequent rapid downward change in the aircraft pitch angle from approximately 3.2° (nose up) to a value of -3.2° (nose down). Double integration of the DFDR vertical acceleration values carried out by the Manufacturer and verified by the Investigation show that, simultaneously with the nose pitching down rapidly, there was an upward change of displacement of the aircraft centre of gravity in the order of 0.7 m. This essentially means that the aircraft bounced slightly on its main landing gear and that, at the moment of the second contact with the runway surface, the main wheels were off the ground and the contact was solely on the nose wheels. The maximum vertical acceleration recorded during this part of the manoeuvre was 1.707g, which accounts for the “*noticeable impact*” recalled by the Commander. The fact that the average approach speed exceeded the calculated V_{APP} by approximately 5 kts, when combined with the gusty conditions experienced during the flare, may have contributed to the bounce.

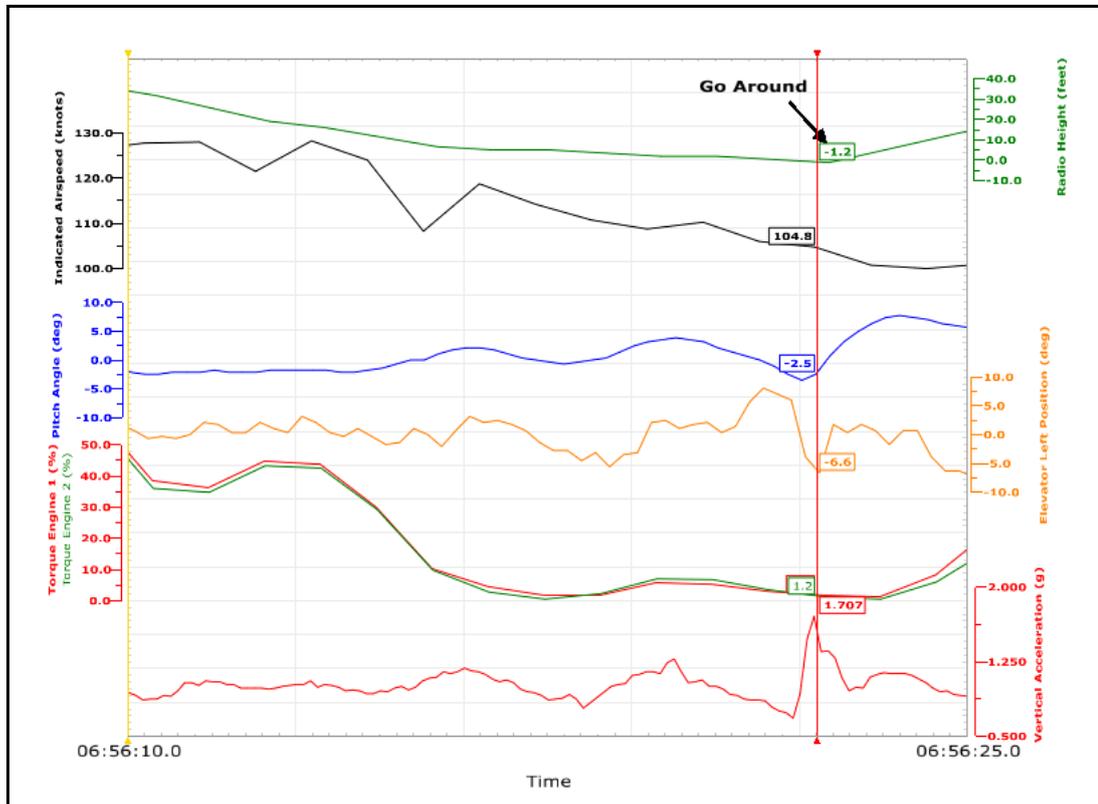
Figure No. 2: Further DFDR Data During Occurrence

During the next 3 seconds, the recorded elevator position moved from -4.02° to $+8.08^\circ$, resulting in the recorded pitch angle changing from $+3.5^\circ$ (nose up) to -3.2° (nose down). In the same time period, the aileron position moved from $+5.5^\circ$ to -2.4° and then back to $+4.1^\circ$.

In the next second the recorded elevator position decreased from $+8.08^\circ$ to -6.19° , a control input to pitch the nose up. The latter figure was approximately co-incident with the maximum vertical acceleration of 1.707g experienced by the aircraft during the occurrence, at which time the pitch angle of the aircraft was approximately -2.5° (nose down). Other recorded parameters at that time were in the order of:-

The data shows that the Commander then reacted very quickly by pulling the control column back to lift the nose again. It is probable that during this sequence the main landing gear wheels made contact with the runway for a second time. Thereafter the Commander made the decision to execute a go-around which was followed by a second approach and successful landing on RWY 17.
