Air Accident Investigation Unit Ireland

SYNOPTIC REPORT

**SERIOUS INCIDENT
BOEING 737-800, EI-DHI
Riga Airport, Latvia
7 January 2012**

AAIU Report No: 2013-017
State File No: IRL00912007
Report Format: Synoptic Report
Published: 19 December 2013

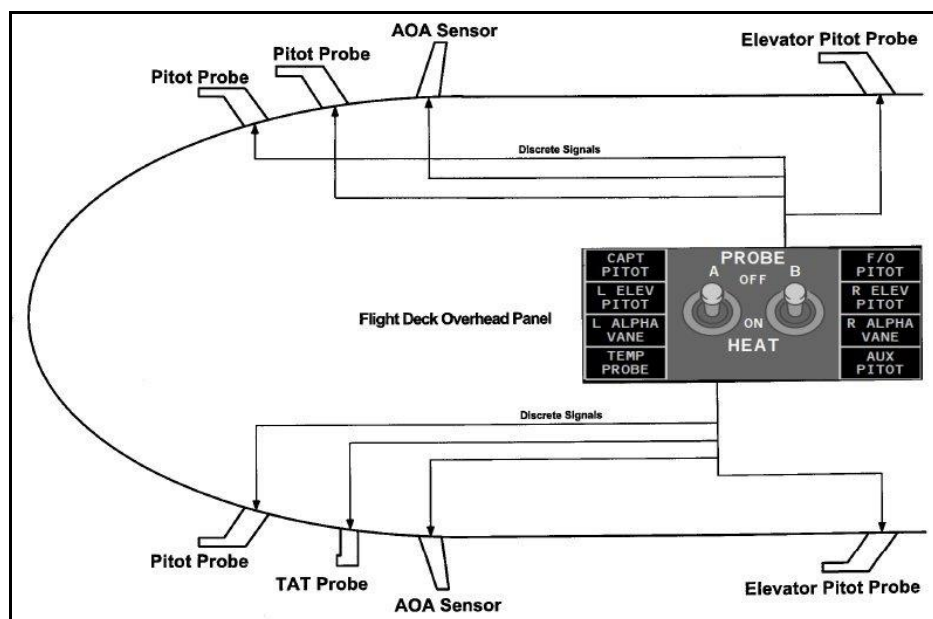
Graphic No. 3: Air Data Sensor Heat System Schematic

There are 5 identical pitot probes on the B737-800 (**Graphic No. 3**), 2 located on the fin and the three on the nose.

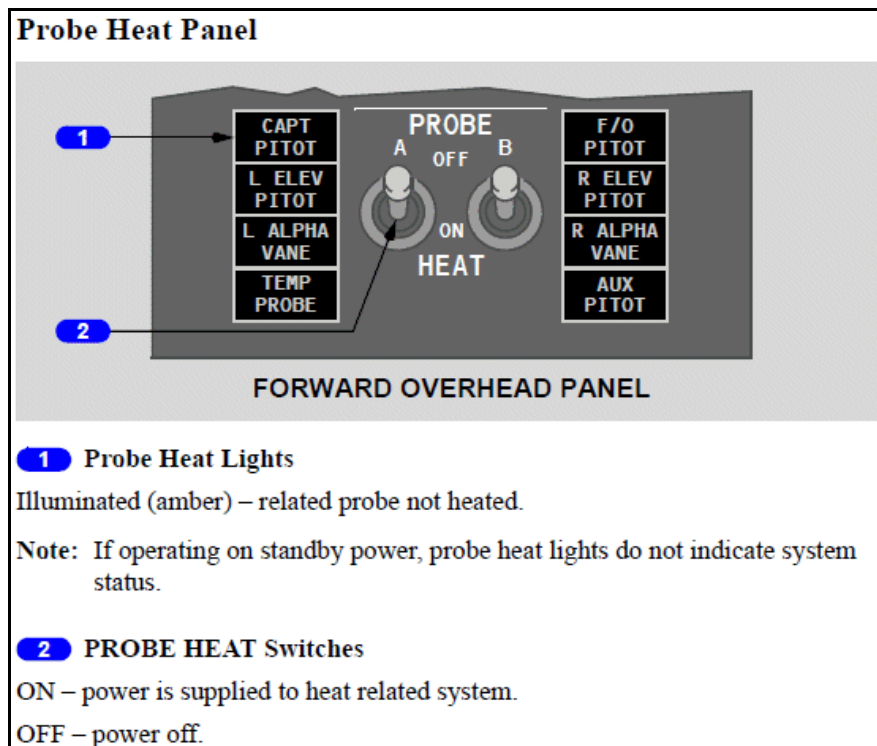
Graphic No. 4: Pitot Probe heater panel

The pitot probe heaters are controlled by two PROBE HEAT toggle switches on the window/pitot heat module (**Graphic No. 4**). This module is located on the forward overhead panel. PROBE HEAT A controls the captain's pitot, the left elevator pitot, the left AOA sensor (alpha vane) and the temperature probe. PROBE HEAT B controls the F/O pitot, the auxiliary pitot, the right alpha vane and the right elevator pitot.

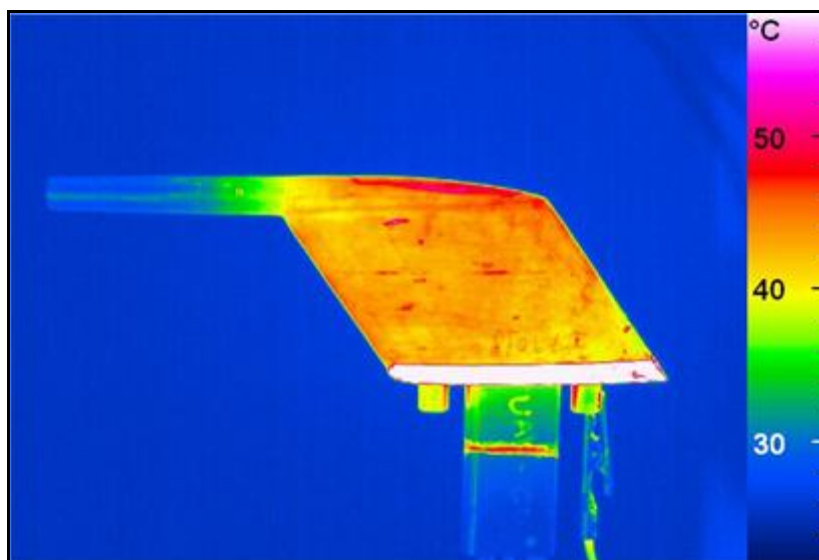
Thermal Image No. 1: Pitot probe heater tip not heated

- Testing demonstrated that when the heater is shorted it can still draw current and not be detected as a failure, yet it will not heat properly which could lead to pitot icing in flight.
- Failure Analysis showed that the cause of the heaters becoming shorted was corrosion through the heater sheath that resulted in electrical arcing and shorting.

However, as evidenced by the failures reported by the Operator to the Manufacturer and confirmed in testing by the pitot heater manufacturer, the failure can be un-announced. In this case the pitot probe can be partially heated, as in **Thermal Image No. 1**, due to:
