Air Accident Investigation Unit Ireland

SYNOPTIC REPORT

**ACCIDENT
Van's RV-7A, EI-FAD
Kilrush Airfield
14 January 2014**

AAIU Report No: 2014-002
State File No: IRL00914003
Report Format: Synoptic Report
Published: 08 May 2014

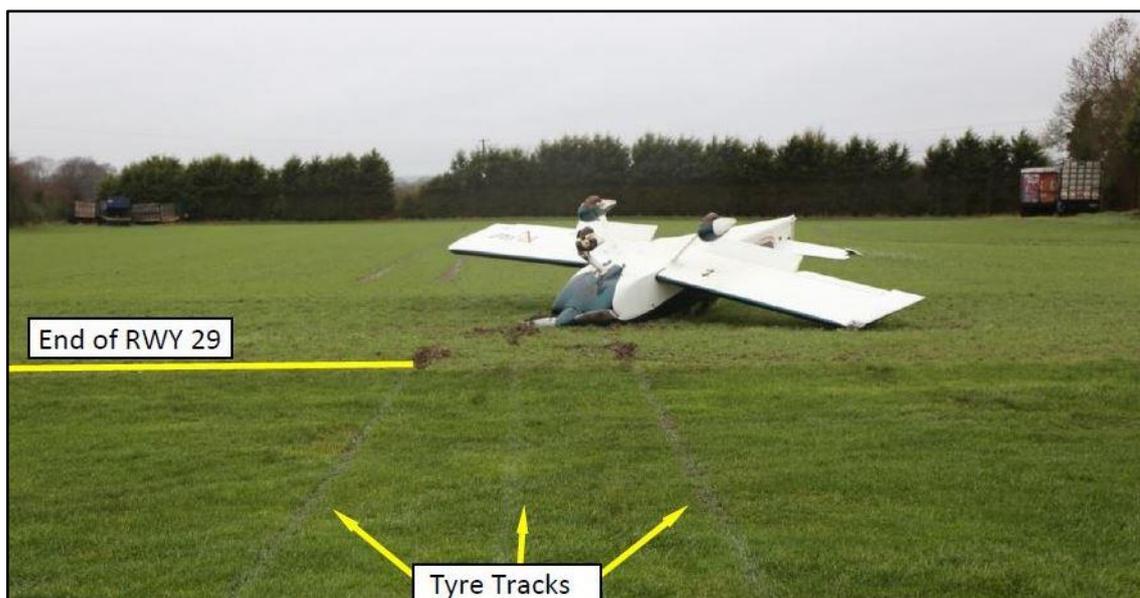
The aircraft left the end of the runway, where there was a vertical drop of approximately 8 cm onto tilled soil, which contained a newly sown cereal crop. The soil was broken, loose and wet. This resulted in the nose landing gear digging in on contact, the aircraft overturning nose first and coming to rest inverted, on a magnetic heading of 148° (**Photo No. 1**).

Photo No. 1: Final resting position of EI-FAD, having overran RWY 29

The nose landing gear was damaged during the accident. The propeller, rudder and tail fin were also damaged when the aircraft inverted. The cockpit canopy and wheel spats were destroyed.

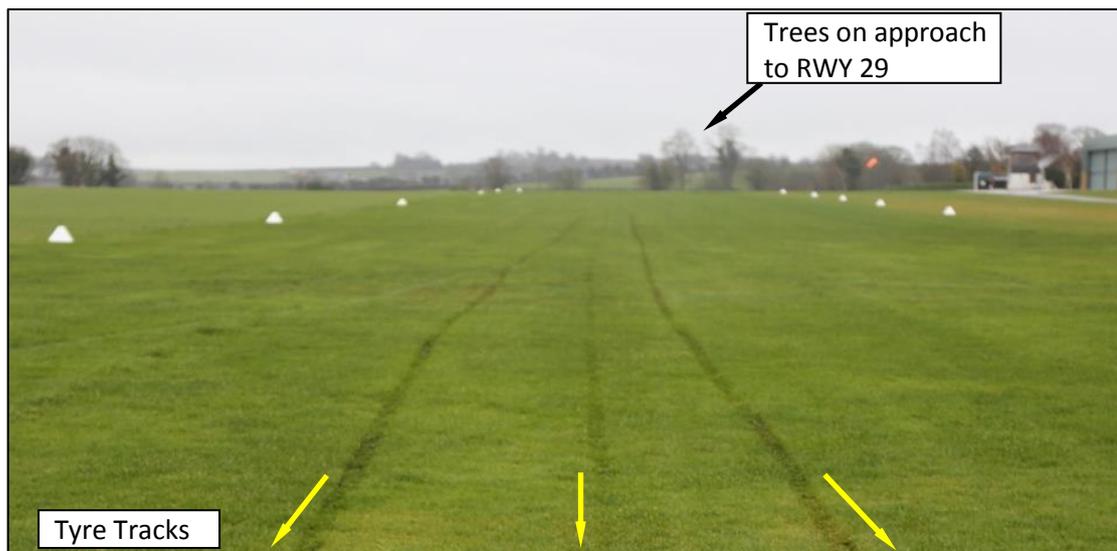
EIKH is listed as a licensed airfield in the IAA’s Aeronautical Information Circular (AIC) 11/13. There are two runways at the airfield; a hard surface runway, RWY 01/19, and a grass runway, RWY 11/29. The lengths of both runways are published in the IAA’s Aeronautical Information Publication (AIP) for EIKH, dated 02 May 2013, as 606 m and 550 m respectively. The AIP also includes the following additional information in Section 2.23: *“Caution: Trees penetrate the 29 approach and the western 01/19 transitional surfaces”*. Additionally, in the privately produced *“VFR Flight Guide, Ireland”*, attention is drawn to *“trees on approach to 29”*. These trees are on the field boundary fence to the left of and a short distance from the beginning of RWY 29 (**Photo No. 2**).

Following the accident, the Investigation examined RWY 29 and identified tyre tracks for the three landing gear wheels which indicated that the aircraft was positively on the ground for the final 210 m of the runway (**Photo No. 2**). In addition, it was noted that the grass was short and wet.

Photo No. 2: Trees on the approach to RWY 29 and tyre tracks on runway
