Air Accident Investigation Unit Ireland

SYNOPTIC REPORT

Piper PA 34-220T Seneca III, G-BMJO

Cork Airport, Ireland

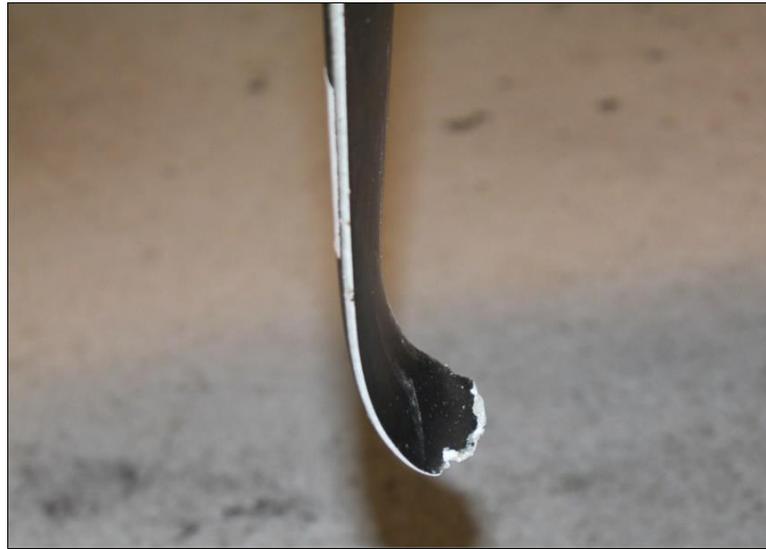
Two Inspectors of Air Accidents travelled to EICK the following day, where the aircraft, which had been secured in a hangar overnight, was inspected. This inspection revealed damage to the tips of the three propeller blades of the left engine (**Photo No. 1**), with consequent shock loading to that engine.

Photo No. 1: Detail of damage to one of the left propeller blades

At some point in the landing sequence, the touchdown attitude was such that the left propeller came into contact with the runway surface. Due to the increasing severity of the oscillations, this was probably late in the sequence. Subsequent hard braking locked the right main wheel as evidenced by the wear spot on the tyre.

A heavy touchdown and bounce led to pilot-induced oscillations which culminated in the left propeller striking the runway.

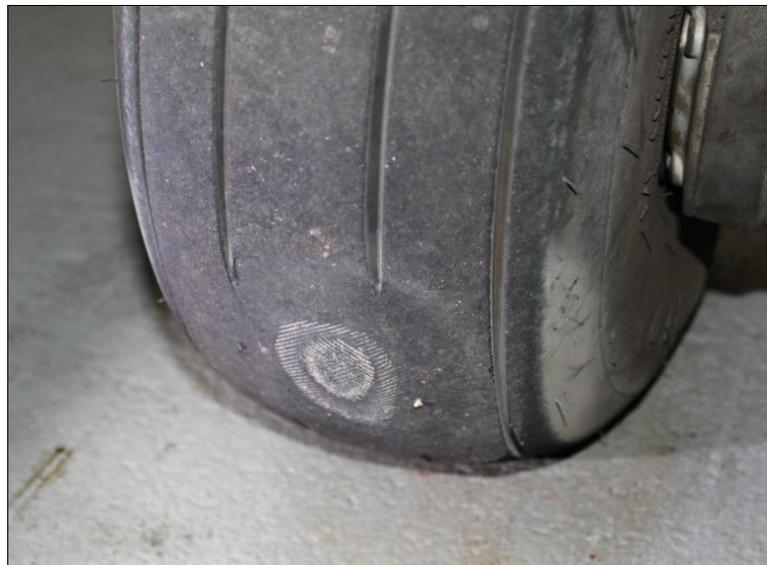
The nose gear and its down lock mechanism were inspected and revealed no damage or obvious distortion. The inspection also noted that the right main tyre exhibited a flat spot (**Photo No. 2**); the left main tyre showed evidence of heavy braking but was still serviceable. A CCTV⁶ recording was obtained from the area of the flying club apron which briefly shows the aircraft airborne late in the landing sequence.

Photo No. 2: Flat spot on right main tyre
