Air Accident Investigation Unit Ireland

SYNOPTIC REPORT

SERIOUS INCIDENT

**ATR 72-201, EI-REH
Approach to Kerry Airport
19 December 2011**

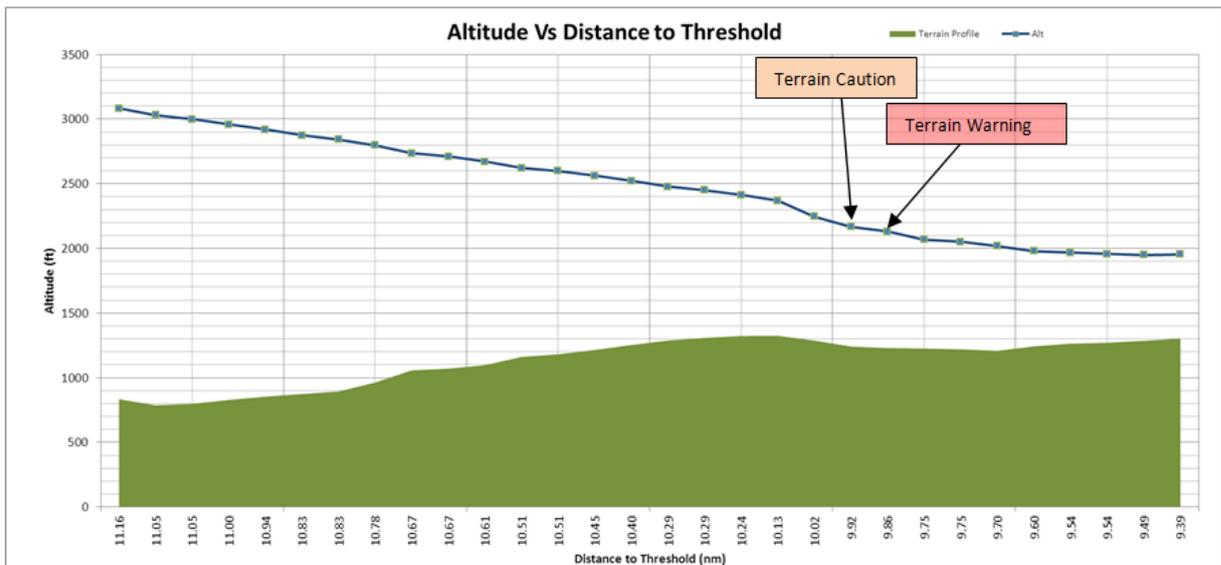
Graphic No. 1: Altitude versus Distance to threshold of RWY 26

The Terrain Caution activated as the aircraft was descending through an altitude of 2,246 ft, at a Radio Altimeter (RADALT) height of 959 ft above the ground and at a distance of 10.02 NM from the threshold of RWY 26. At that time the rate of descent was 2,400 ft/min. The Terrain Warning occurred at an altitude of 2,100 ft when the Glideslope Deviation was showing a valid signal but which incorrectly showed that the aircraft was between 1 and 1.25 dots high.

Graphic No. 1 shows the altitude of the aircraft (dotted line) versus the height of the local terrain for the period the EGPWS recorded.

The minimum RADALT height recorded by the EGPWS was 651 ft shortly after the aircraft became level at 9.39 NM from the threshold of RWY 26.

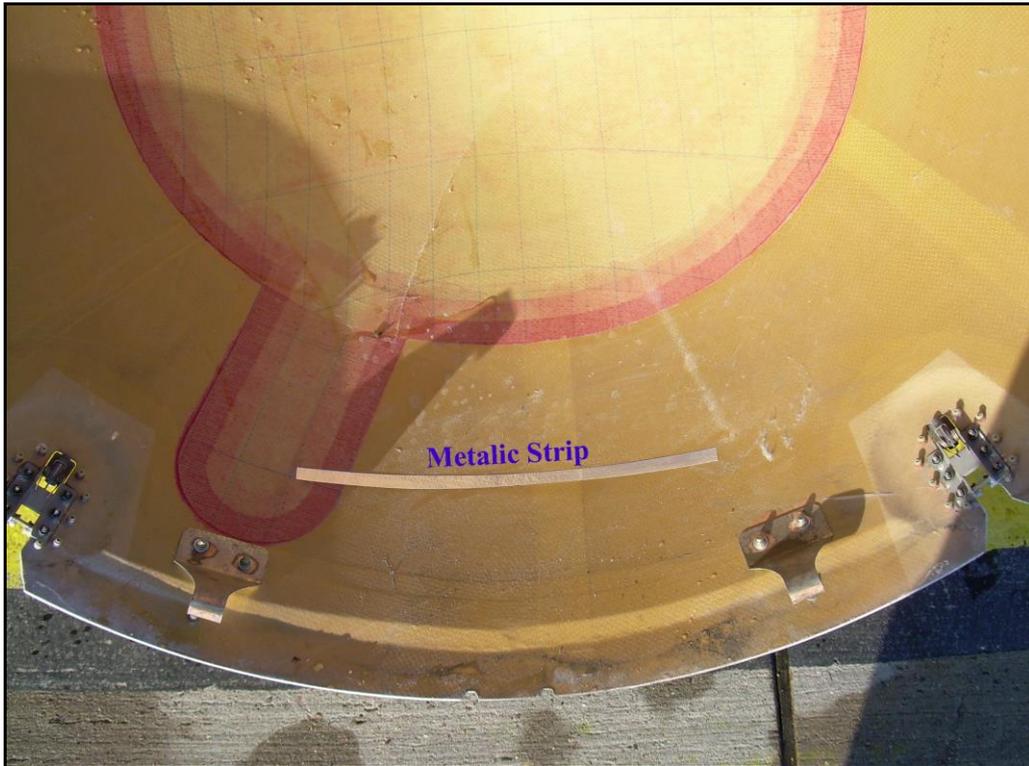
Photo No. 1: Interior of Radome with metallic strip installed.

After a flight later that day the radome was removed. The technical report states ‘*.....the radome currently fitted is found to be without metallic strip for ILS beam concentration, which as per ATR communication email is a likely cause for glideslope problem*’.

The metallic strip, a ‘Glideslope Antenna Deflector’, Part Number (P/N) S53975000-204, is shown installed on a serviceable radome in **Photo No. 1**. It is used to concentrate the glideslope beam towards the glideslope antenna. The strip is 335 mm long by 12.5 mm wide and is attached to the radome by adhesive. The ILS on the aircraft is considered unserviceable if the strip is missing.

It was not possible to determine where or when the metallic strip detached from the radome. However, it appears likely that this may have happened during repair when the radome was stripped, sanded, repainted and refitted to the aircraft without a check for the presence of the Glideslope Antenna Deflector. As there was no evidence of ILS problems on the aircraft prior to maintenance on the radome, the Investigation considers this the most likely scenario.

A different radome was then fitted and the aircraft was returned to service. Following a functional test of the CAT II ILS the following day, the aircraft was cleared for CAT II operations and no further ILS glideslope problems were reported.

The maintenance facility also issued a Quality Alert to ensure that its technicians were aware that it is possible that the Glideslope Antenna Deflector, which has a self-adhesive backing, may become detached during overhaul and that it is the responsibility of the certifying engineer to ensure the serviceability of the component subsequent to maintenance.

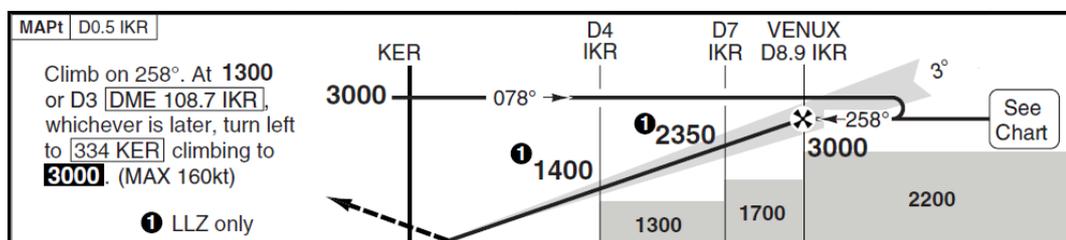
Figure No. 1: Extract from the Approach Chart in Appendix A.

The Flight Crew stated that the briefing for the approach included safety heights as depicted in the chart they used. The chart in **Appendix A** (an extract from which is shown in **Figure No. 1** below) shows grey areas which are the minimum altitudes that should be maintained until the appropriate DME distance is reached.

The ILS approach procedure requires that VENUX, at 8.9 NM from the threshold of the runway, should be crossed at an altitude of 3,000 ft and a descent then commenced. Outside VENUX the safety altitude is 2,200 ft due to a ridge across the approach path.

The data shows that at a position approximately 1.1 NM before VENUX the aircraft descended through 2,246 ft and had reached a descent rate of 2,400 ft/min at which point the EGPWS activated.

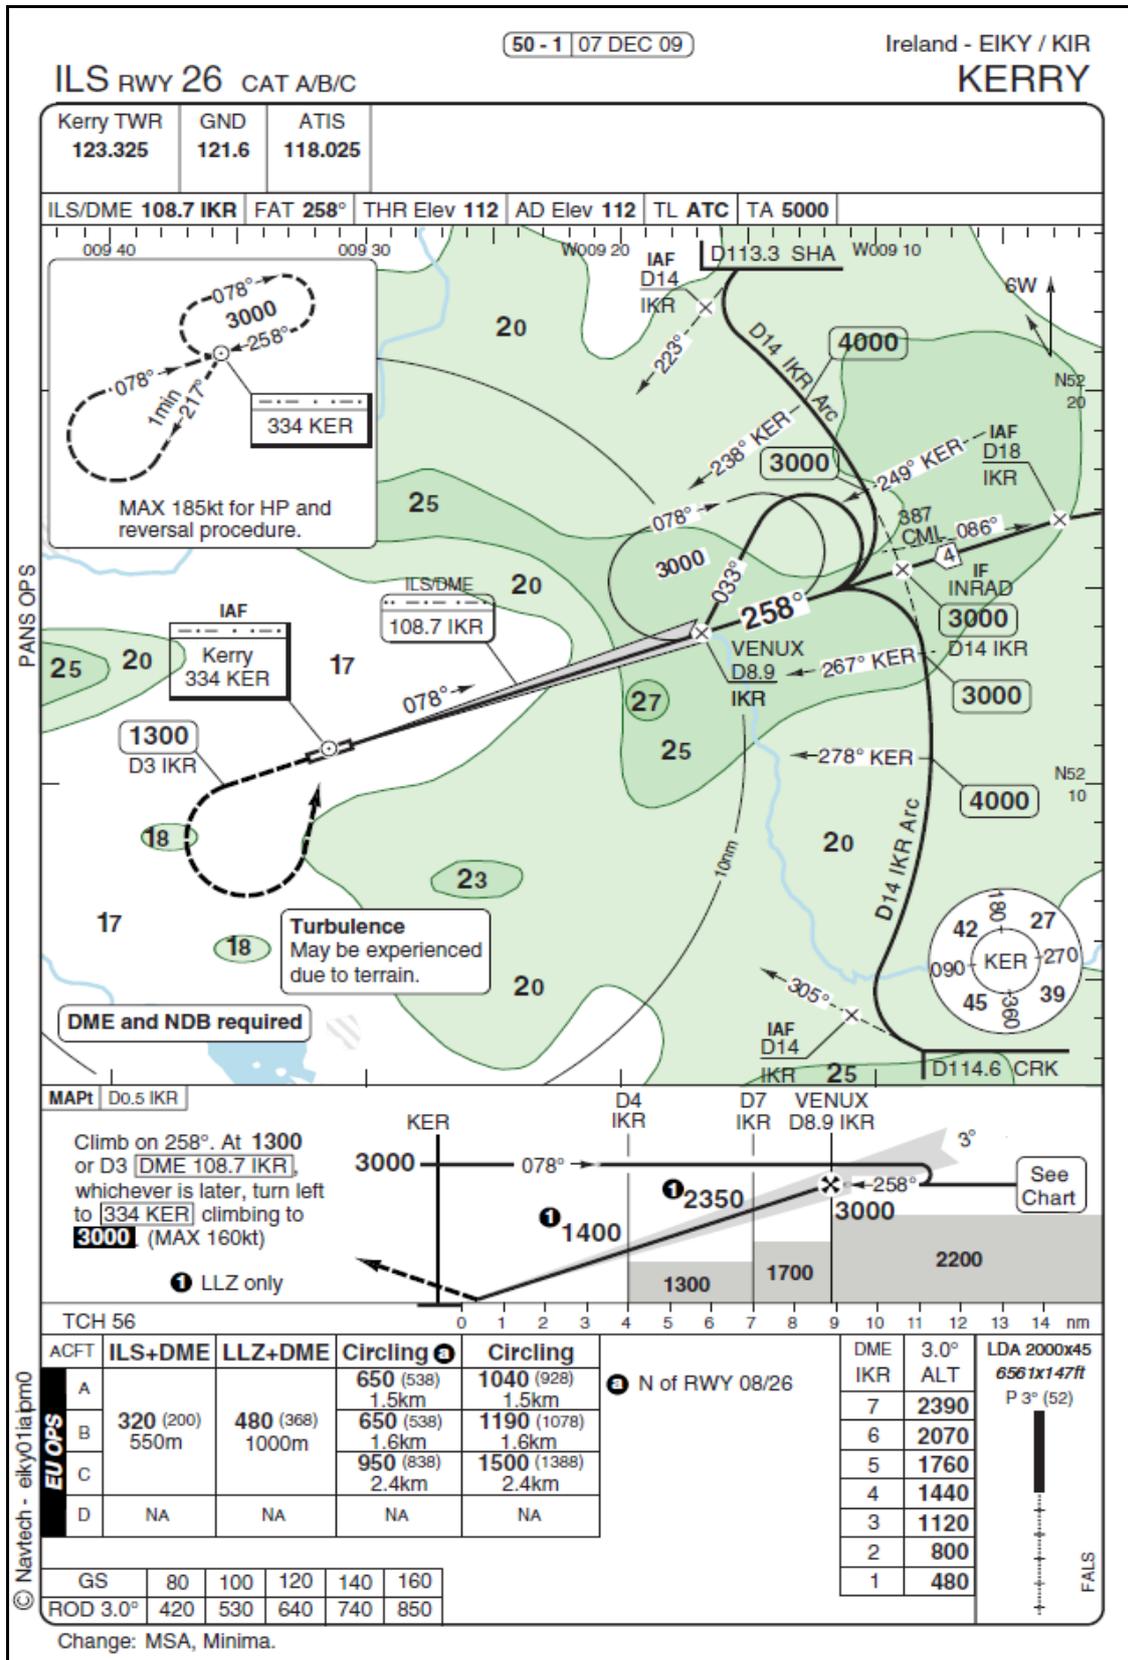
Figure 7: Navtech Approach Chart, EIKY ILS RWY 26.

The Minimum Safe Altitudes (MSAs) for EIKY were briefed in advance of the approach. He said that the charts they used did not show spot heights (**Appendix A**). He had not cross-checked the aircraft's altitude versus DME distances and believed that during the approach he was focussed on the aberrant glideslope and the descent rate and had not noticed the reduced height over the ground.
