# **Air Accident Investigation Unit Ireland**

**SYNOPTIC REPORT**

**Urban Air UFM-10 Samba XLA, EI-XLA  
Birr, Co. Offaly, Ireland  
12 June 2013**

AAIU Report No: 2014 - 008  
State File No: IRL00913054  
Report Format: Synoptic Report  
Published: 25 June 2014

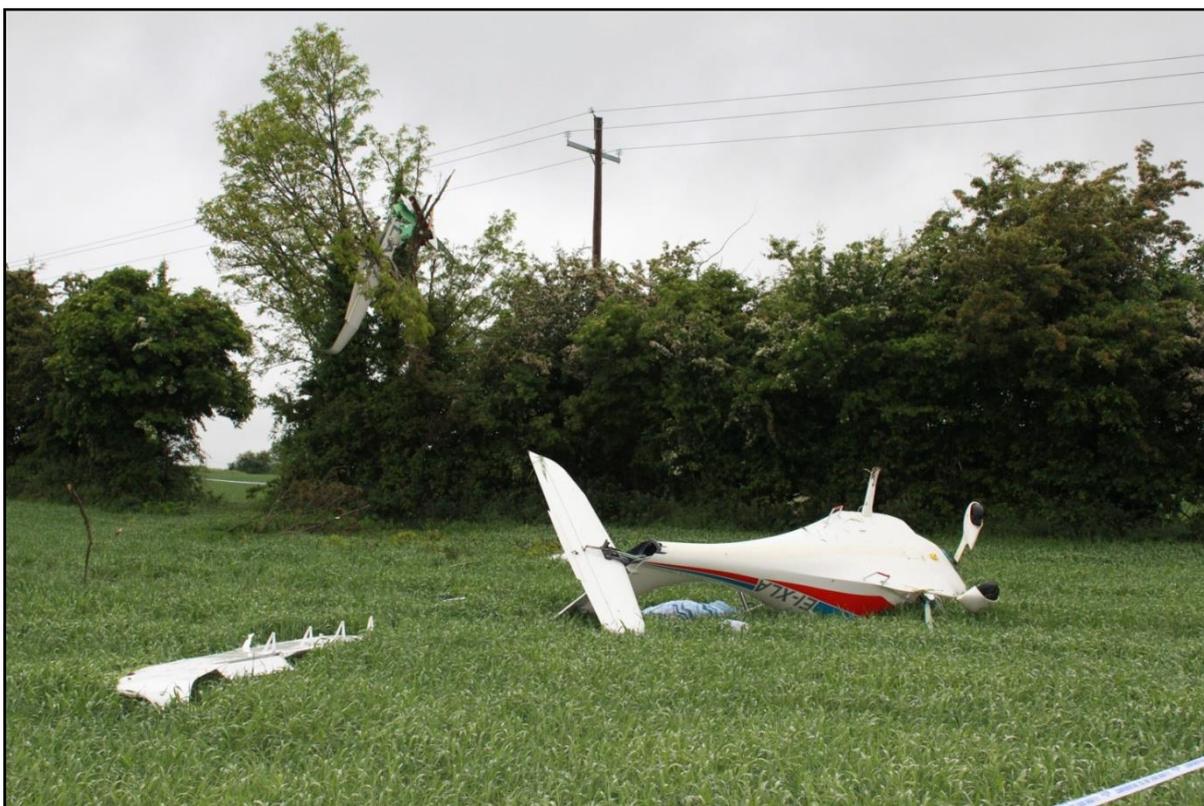
**Photo No. 1:** Final resting position of EI-XLA with bent insulator on top of utility pole and wing embedded in tree.

The adjacent boundary of the field was a tall hedge in which ash trees were located. A second hedge abutted at right angles on the far side of the hedge. A utility pole was located beside the intersection of these two hedges. This pole supported three 20 KVA electric power cables. The top insulator of this pole was bent but had not fractured. Part of the leading edge of the right wing was found 5.4 m to the far side of this pole, embedded in the upper part of the second hedge.

The complete left wing was found lodged in the upper section of an ash tree located in the near hedge, approximately 5 m off the ground where a large branch had been broken. The fuselage was 21 m from the tree. Evidence of an initial ground impact was found 10.5 m from the tree where an indent from the propeller hub and fragmented parts of the disintegrated wooden propeller were also found. These parts and the propeller hub, which remained attached to the engine, displayed damage consistent with the engine being under power at impact.

The inverted right wing, on which the flaps were retracted, lay 5 m from the fuselage or 26 m from the tree. Both elevator and rudder continuity were confirmed. It was not possible to fully check aileron continuity due to impact damage when the wings detached causing splaying of the composite aileron torsion bars and damage to the ailerons during the impact. Nevertheless, the Investigation did not identify any pre-accident defect that would have inhibited aileron operation. Within the cockpit, the fuel valve was found selected to the left tank with the carburettor heater knob in the cold position. Both ignition switches were selected to ON.

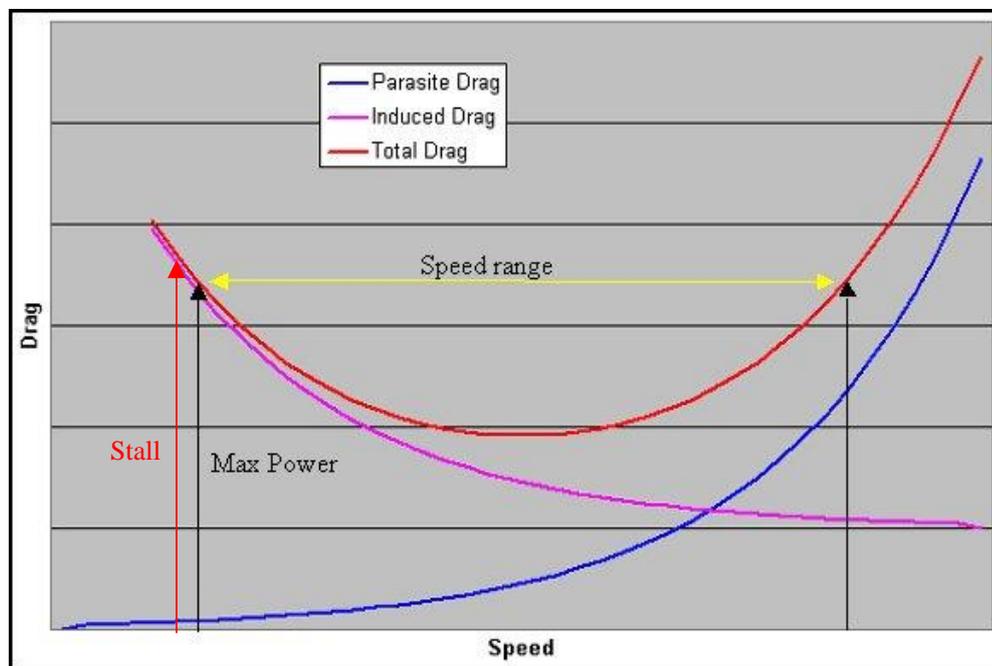
**Graphic No. 1:** Drag-Speed Relationships in stable flight

Between these points the speed range of the aircraft can be controlled, outside these points the aircraft decelerates. Whereas on the right side of the graph (**Graphic No. 1**) the aircraft decelerates into a controllable speed range, on the left hand side it decelerates towards a stall. The aircraft can only be flown out of this latter area by lowering the nose, accelerating and diving the aircraft if necessary. This cannot be done close to the ground.

The left hand side of the Total Drag curve is commonly referred to as the 'back of the drag curve' as the slower the aircraft's speed, counter intuitively, the more power is needed to hold that speed until ultimately power reserve is exhausted and deceleration continues.

As previously noted slow airspeeds (towards the 'back of the drag curve') require additional power and as the airspeed reduces ultimately power reserve is exhausted and deceleration continues. As the aircraft was fitted with an 80 hp engine it did not have a large power reserve should adverse conditions be unexpectedly encountered.

If this outflow had a downdraught component, the 80 hp engine fitted to this aircraft may not have had adequate power to recover from the situation, particularly if the aircraft was slow and 'on the back of the drag curve'.
