# **Air Accident Investigation Unit Ireland**

**SYNOPTIC REPORT**

**SERIOUS INCIDENT**

**Boeing 737-8AS, EI-DLI  
Over the Irish Sea  
20 May 2011**

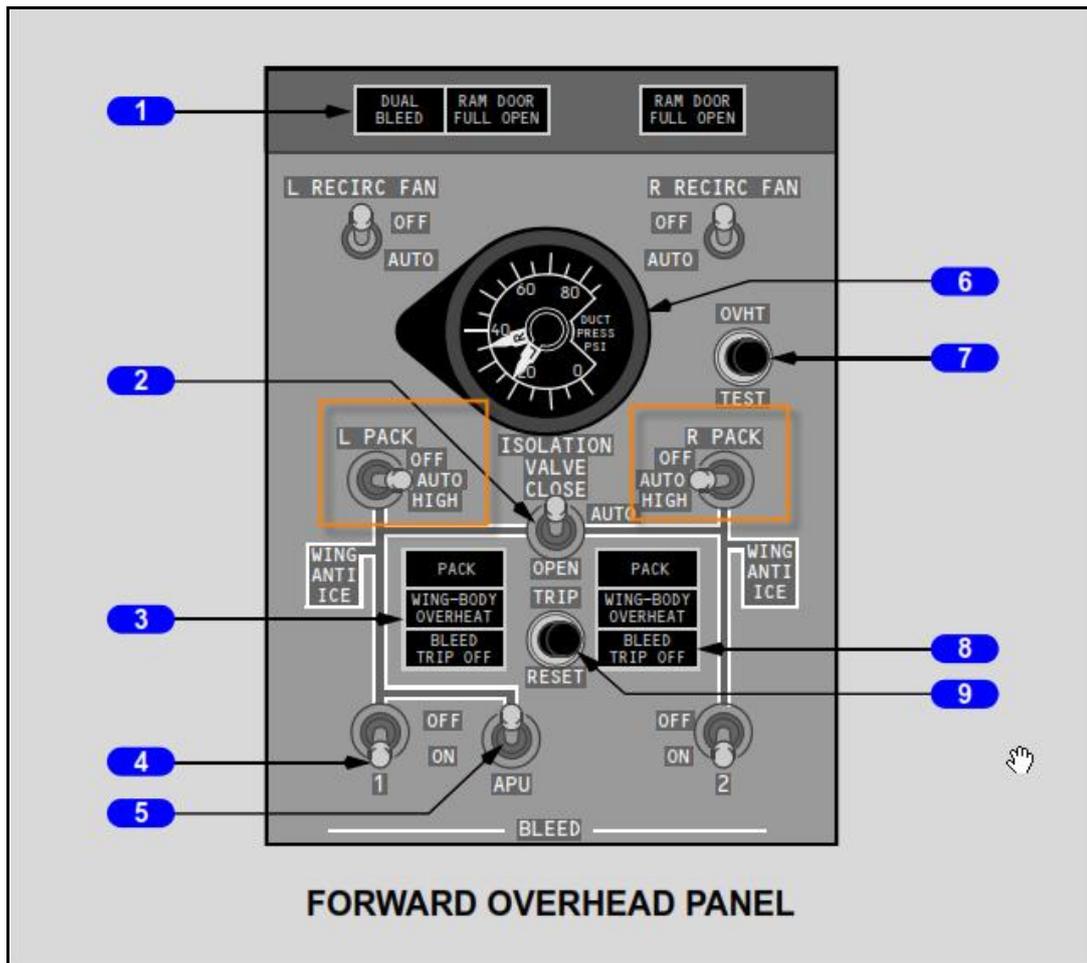
**Figure No. 1:** Bleed Air Controls and Indicators

Bleed air from stages 5 and 9 on each engine compressor is sent through two air conditioning packs and then distributed throughout the cabin. **Figure No. 1** shows the Bleed Air Control and Indicator Panel with the Pack control switches outlined in orange.

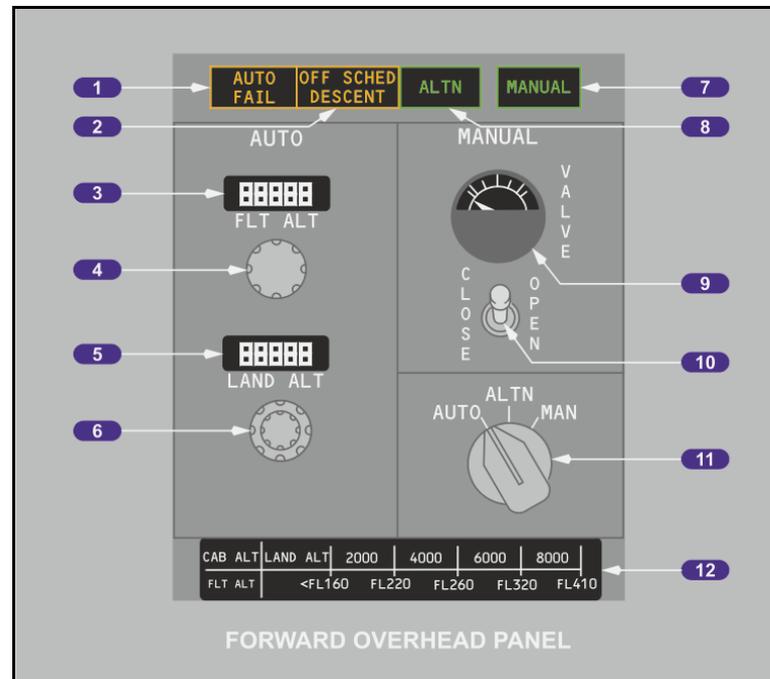
**Figure No. 2:** Pressurization system control panel

Cabin pressure is controlled by a system that includes two Digital Cabin Pressure Controllers (DCPCs). Each DCPC alternates as the main controller on successive flights, with the other DCPC remaining in stand-by in case it is needed. System faults are annunciated by means of a light on the pressurization panel (**Figure 2**, item 1).

Ventilation and pressurization is normally controlled by adjusting the opening of the outflow valve (OFV) either automatically by the active controller when the system is in automatic (AUTO) mode, by the alternate controller if set by the flight crew (ALTN) or manually (MAN) if the flight crew selects manual operation (**Figure No. 2**, item 11)

In flight, the automatic controller adjusts the differential pressure depending on the applicable law for the phase of flight (climb, cruise or descent mode). The pressurization system uses the planned flight level and the elevation of the destination airport (as selected by the flight crew using the pressurization panel FLT ALT and LAND ALT controls, **Figure No. 2** items 3, 4, 5 and 6).

Manual operation activates the associated green indicating light (**Figure No. 2**, item 7). During manual operation, the flight crew directly controls the movement of the OFV (item 10) and monitors its position (item 9).

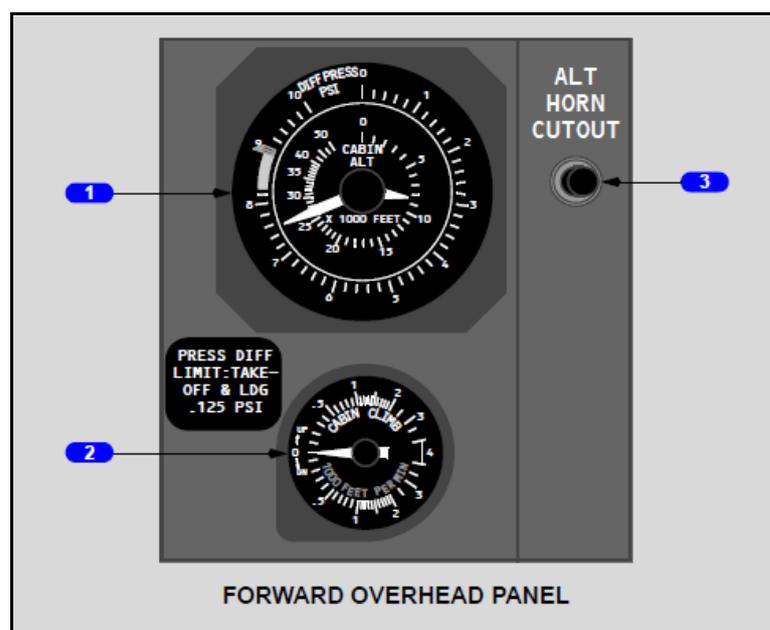
**Figure No. 3:** Cabin altitude panel

Flight crew can monitor the cabin altitude in feet, its climb/descent rate (in ft/min) and the differential pressure in pounds per square inch (psi), all of which are shown on instruments on the cabin altitude panel (**Figure No. 3**). This panel also has a button to silence the cabin altitude alarm (item 3).
