Air Accident Investigation Unit Ireland

SYNOPTIC REPORT

**Cessna F172M, EI-GSE
Cork Airport
19 July 2013**

AAIU Report No: 2014 - 012
 State File No: IRL00913060
 Report Format: Synoptic Report
 Published: 28 October 2014

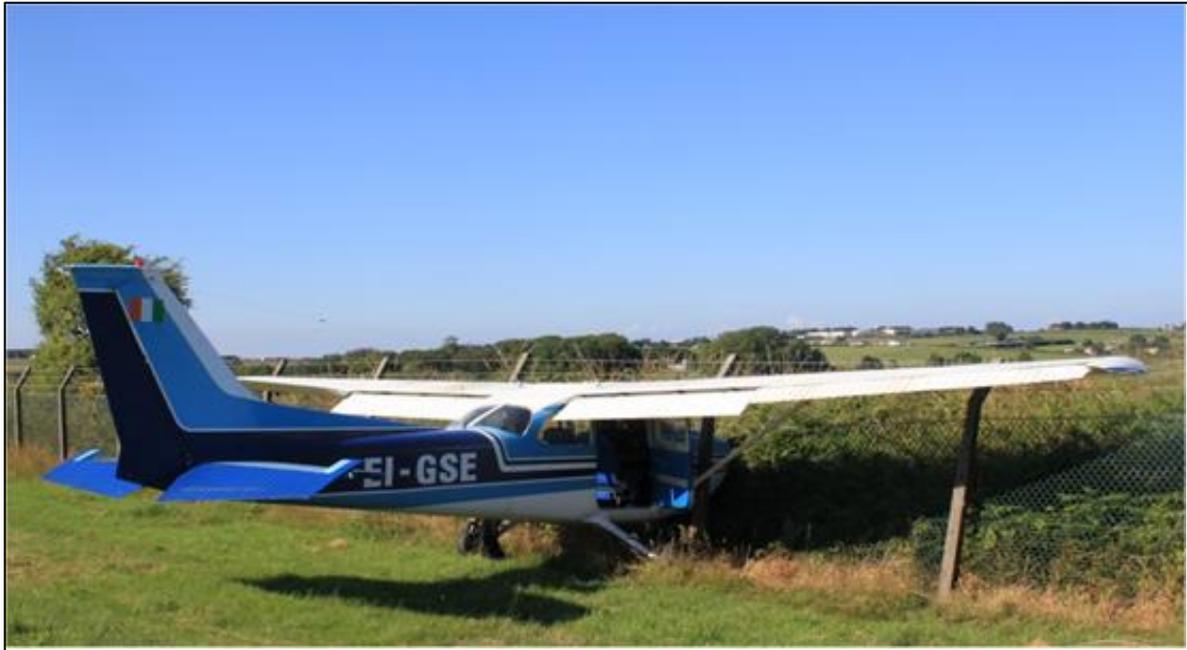
Photo No. 1: Resting position of EI-GSE

The aircraft came to rest embedded in the fence directly abeam the threshold of RWY 35 (Photo No. 1) on a heading of 085°M.

Diagonal scuffing marks on the tyres were consistent with an attempt being made to turn the aircraft left while braking. The right wing sustained damage to the leading edge from a concrete post. The outermost section of the right aileron was damaged by a strand of barbed wire trapped in the gap between the aileron and the wingtip. The flight controls operated normally other than an aileron restriction caused by the trapped barbed wire.

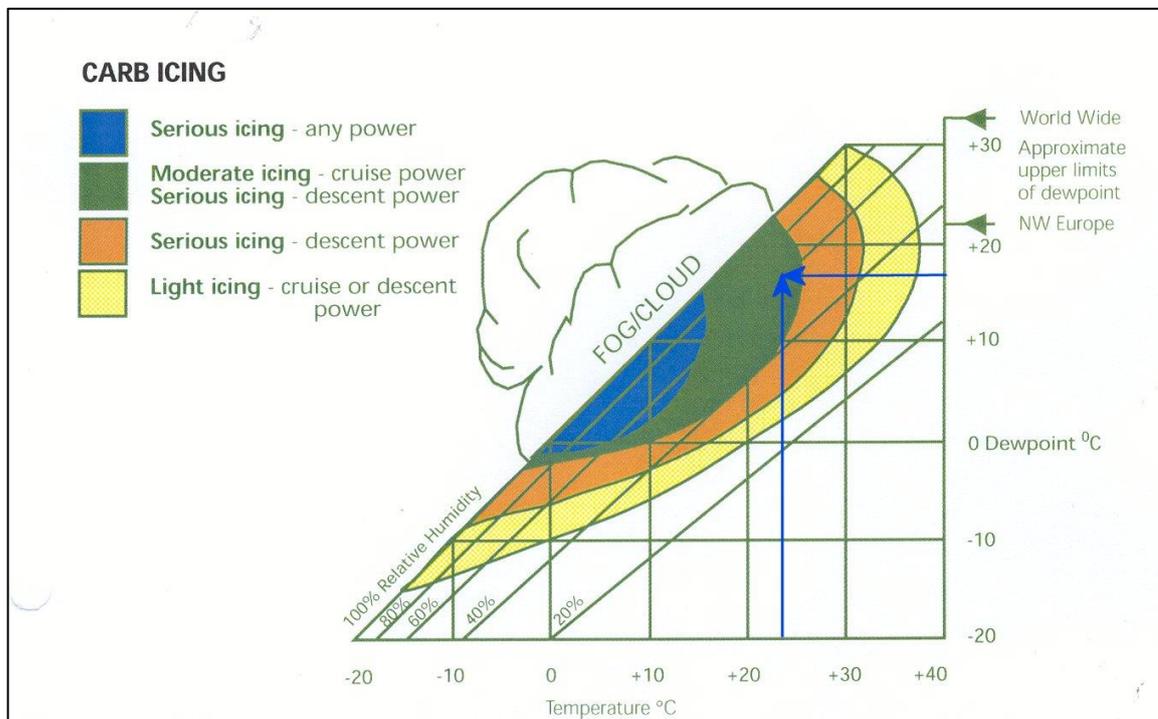
Graphic No. 1: Icing probability at the time of the occurrence

The Investigation notes that the outside air temperature on the day, though warm at 25°C, was in a regime when moderate carburettor ice was possible at cruise power and serious icing at descent power (**Graphic No. 1**). Both pilots reported that carburettor heat had been applied a number of times during the earlier cruise, that no carburettor icing had been observed and the engine operation had been normal. Although a carburettor temperature gauge was fitted it was not trusted and its readings were disregarded; instead the tachometer RPMs were relied on. Had attention been paid to its readings during the final approach it is possible that the gauge may have indicated a requirement for carburettor heat.

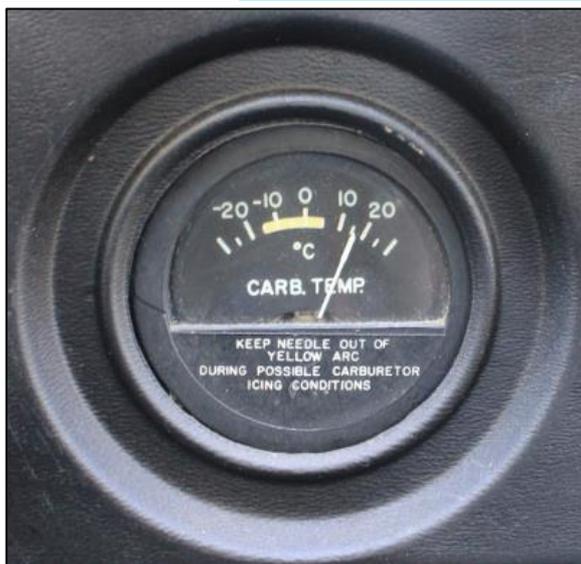
Photo No. 2: EI-GSE carburettor temperature gauge

Although a carburettor temperature gauge was fitted to EI-GSE, he said that he had not noticed its reading. He was unsure about its accuracy and relied more on the 100-150 RPM drop that occurred when the carburettor heat was selected on, since the carburettor heater fitted to EI-GSE was quite effective.

The carburettor heater on the Cessna 172 draws heated air from around the exhaust riser which is ducted through a heater valve into the carburettor. The heater valve is controlled by the pilot and, when operated, results in a drop of approximately 150 RPM at high power settings. The effectiveness of carburettor heat is reduced at low power settings. EI-GSE was fitted with a carburettor temperature gauge (**Photo No. 2**).

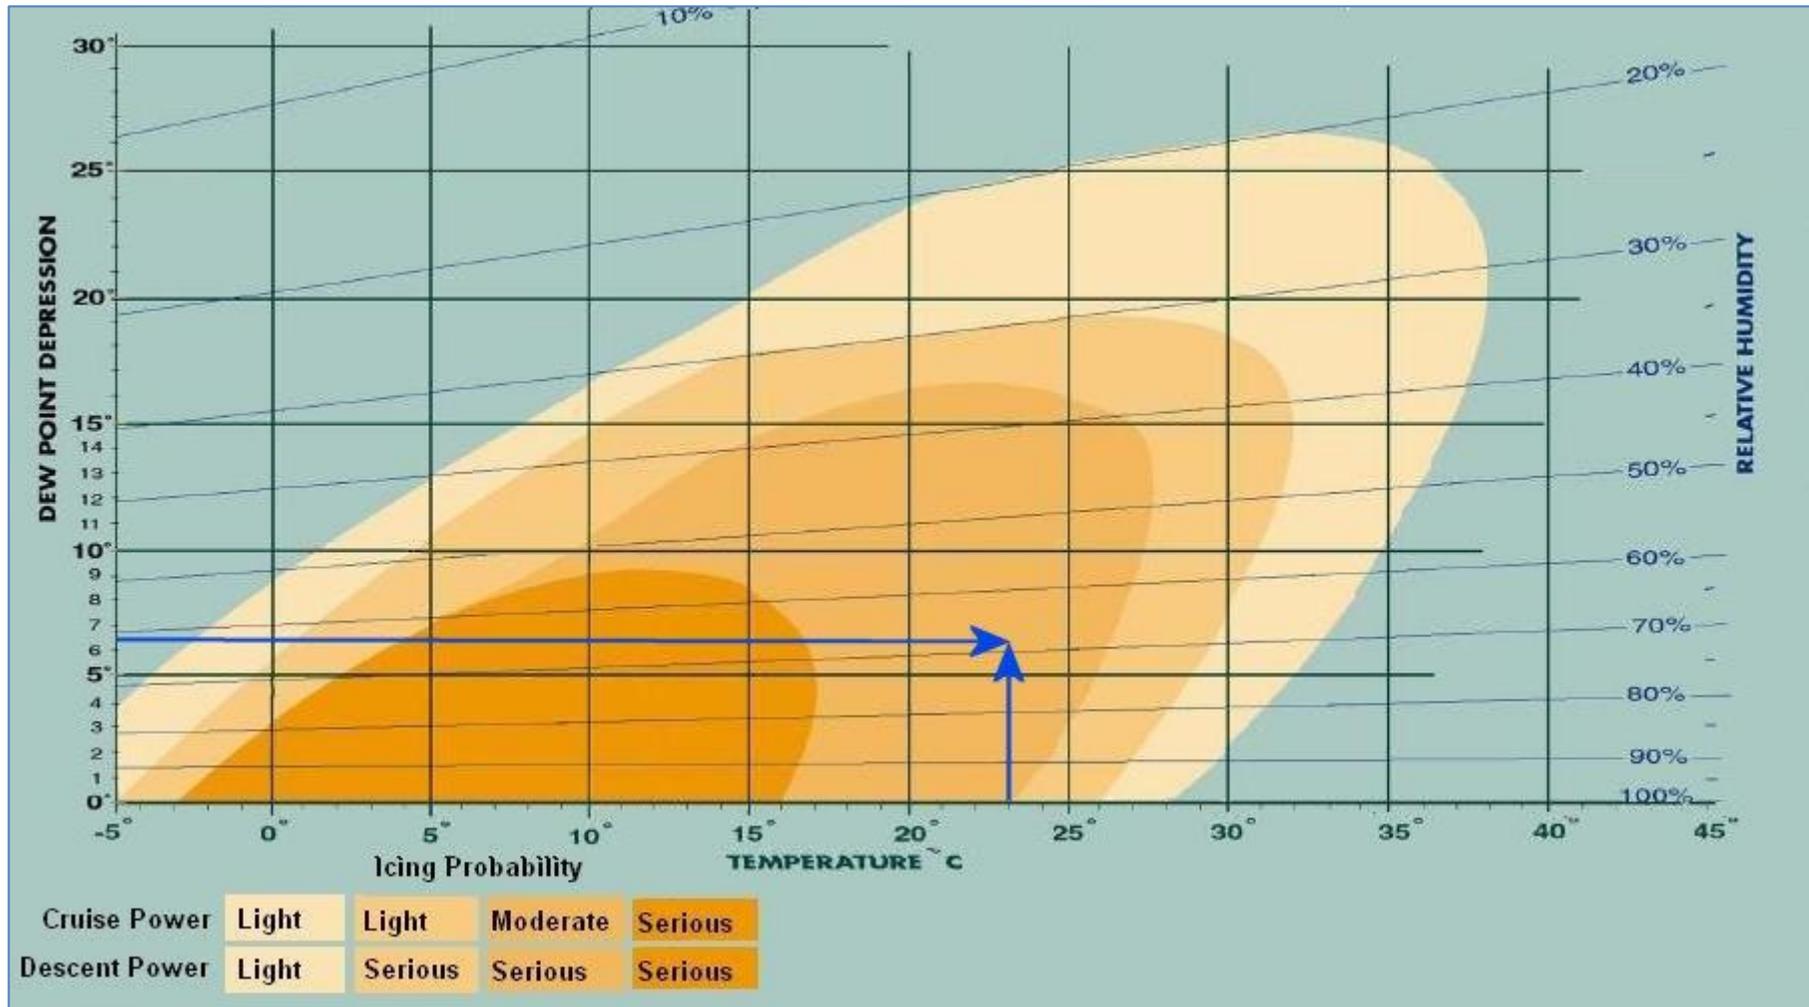
Graphic No. 2: Probability of Carburettor Icing

Further information on carburettor icing is published by the IAA in its Safety Leaflet on [Piston Engine Icing](#), the UK Civil Aviation Authority (CAA) in Safety Sense Leaflet [No. 14 Piston Engine Icing](#) and European General Aviation Safety Team (EGAST) in its Safety Promotion Leaflet [Piston Engine Icing \(GA5\)](#), from which the **Graphic No. 1** is reproduced. A further chart is displayed in **Appendix A, Graphic No. 2**.
