Air Accident Investigation Unit Ireland

FACTUAL REPORT

Robinson R44 Raven I, G-OAJC

Kinnitty, Co. Offaly

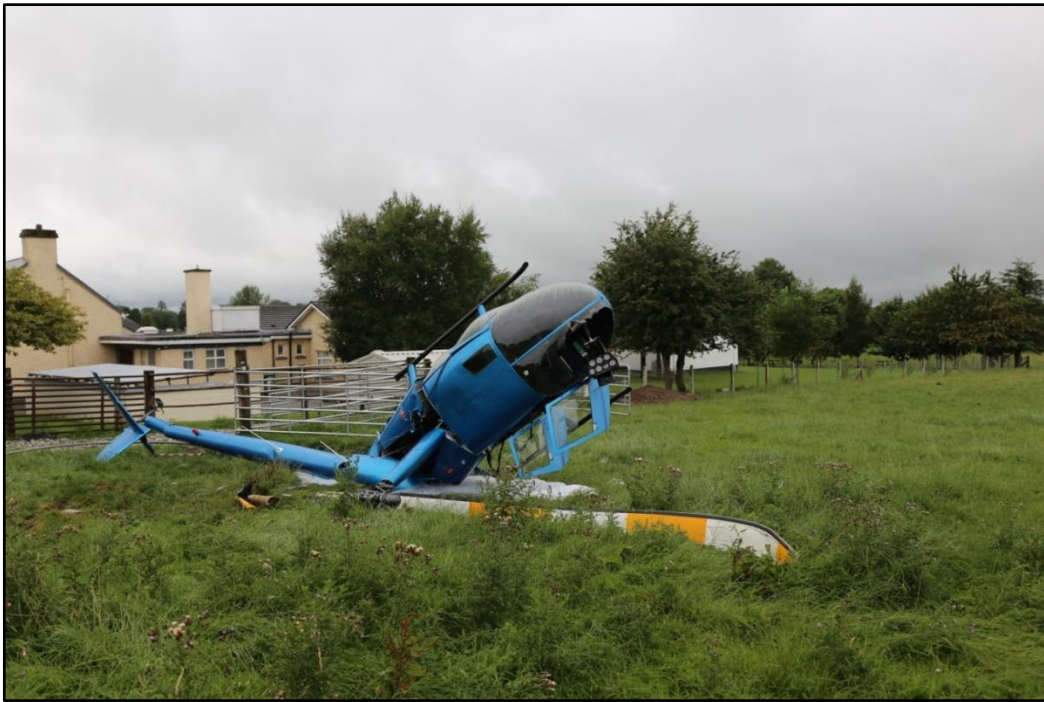
The Pilot said that when the helicopter was at a height of approximately eight feet, his main rotor blades struck telephone wires which were running from a pole in the hedge row boundary (between the field and the road) to the school house which was located adjacent to the landing field. He stated that a Jeep on the road caught his eye and that he did not see the telephone wires. The helicopter immediately spun and tumbled, impacting the ground and coming to rest on a heading of approximately 035° magnetic, **Photo No. 1**

Photo No. 1: The Helicopter as it came to rest.

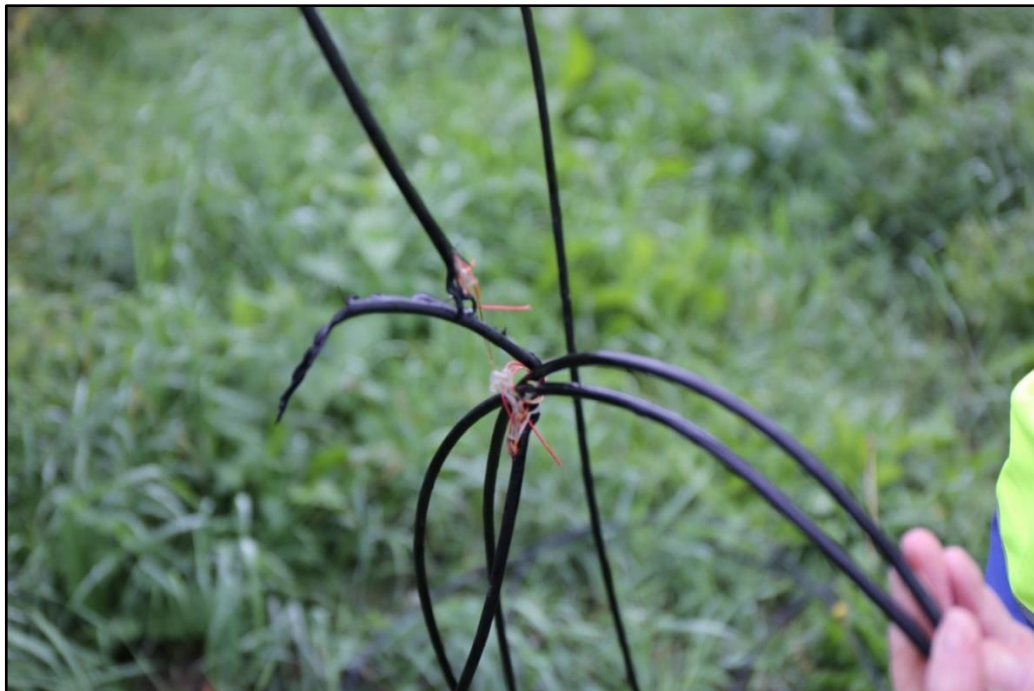
The Pilot informed the Investigation that there were no technical or control difficulties with the helicopter prior to the accident. He was unaware of the presence of the wires (**Photo No. 2**), and informed the Investigation that he did not see the pole in the hedge row boundary or the wires prior to the blades striking them. The Pilot said that weather conditions were not a factor with daylight Visual Meteorological Conditions (VMC) prevailing at all times during the flight.

Photo No. 2: The wire ends as found following the accident.

1. The helicopter's main rotor blades struck telephone wires leading to a loss of control.

These physiological facts have obvious and important implications for pilots. As such, pilots need to use a variety of skills/options to assess the presence of wires. This can be done by viewing local maps, carrying out a local ground inspection, looking for poles or pylons where the likelihood is that wires would be attached. Finally, and prior to commencing descent for an approach/landing, the assessment can be done by carrying out an aerial reconnaissance at an adequate safety height and airspeed above the intended operating or landing site.
