Air Accident Investigation Unit Ireland

SYNOPTIC REPORT

ACCIDENT
Quik GT450 Microlight, G-GTEE
Near Convoy, Co Donegal
30 September 2012

AAIU Report No: 2014 - 014
State File No: IRL00912106
Report Format: Synoptic Report
Published: 1 December 2014

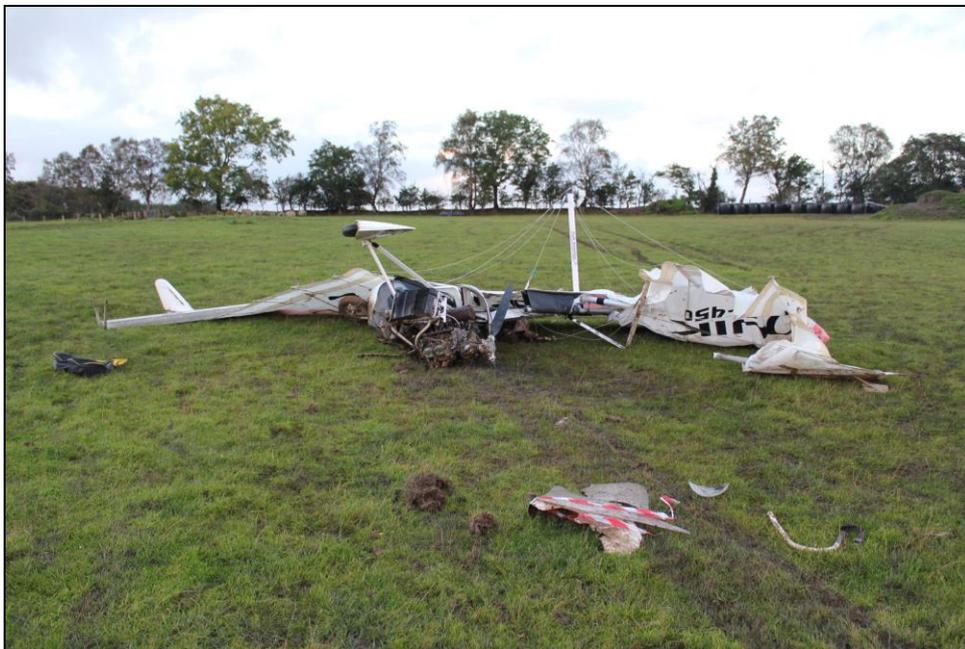
The aircraft impacted heavily in a wet agricultural field (**Photo No. 2**). It continued along a track of approximately 337°M⁸ for a distance of 21.6 m from the initial impact point before coming to rest.

Photo No. 2: General View of Accident Site

The initial impact left deep scars in the soft ground. The starboard undercarriage leg was embedded in the soil close to the first impact mark, with the corresponding wheel hub nearby. One of the propeller blades was also deeply embedded in a slash in the ground adjacent to the initial impact point.

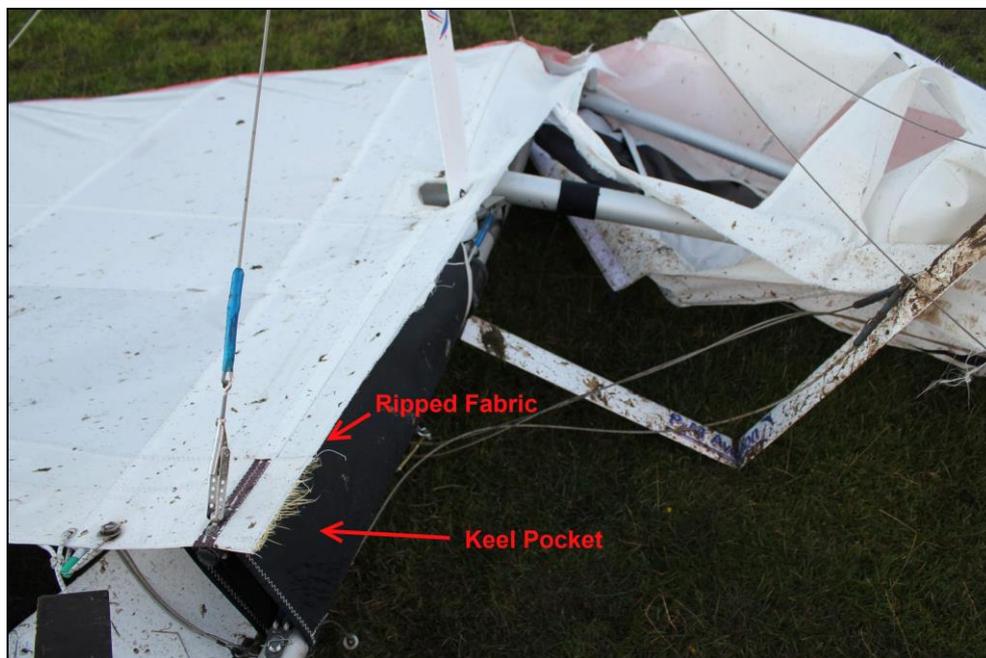
The sail had failed in a longitudinal direction just outboard and to the right of the keel pocket which runs fore and aft along the sail centreline (**Photo No. 3**).

Photo No. 3: Sail failure viewed from above.

The failure extended from the aramid trailing edge forward towards the nose, through a distance well in excess of 50% of the sail's chord. The adjacent trailing edge shift cable grommet had ripped out of the sail, thus allowing the split to open completely. The sail fabric was muddy on the starboard side of the split but relatively clean on the keel pocket side.

From examination of the wreckage it was evident that the sail had split from the starboard trailing edge running forward towards the nose, just to the right of the central keel pocket. The starboard trailing edge shift cable grommet had failed which, had it remained intact, might have served to restrict how far the split travelled. However, due to the failure of this grommet, the shift cable was ineffective and the sail ripped along more than 50% of its fore and aft axis. A clean panel of fabric, which was identified as coming from the right hand side of the sail, was found a considerable distance away from the final resting position of the remainder of the sail. The area of the sail from which this had come was muddy in stark contrast to the clean panel.

The nature of the sail failure would have caused a major loss of lift on the starboard wing and in the wing root area which in turn would have caused the starboard wing and the nose to drop. The evidence available from the wreckage, in which the starboard side of the aircraft and the starboard wing structure were severely damaged, was that G-GTEE had impacted the ground with its starboard wing down. The impact marks in the field also supported this scenario.

Post-accident testing of the sail material showed that the both the polyester sailcloth and the aramid reinforcement band possessed insufficient residual strength to pass the annual pull tests required for Permit to Fly renewal and thus the sail would have been scrapped if being tested for a Permit renewal at that time. However, the same sail tests had been successfully accomplished on 1 June 2012, although no specific values had been recorded at that time nor were they required to be. Therefore, the Investigation believes that the sail had been subject to further degradation and loss of strength due to exposure to UV radiation during the period following its Permit renewal, during which time it remained fully rigged at all times.

It is recommended that the General Aviation Safety Council of Ireland should conduct an awareness programme for their applicable membership, on the hazards associated with ultraviolet degradation of microlight sails and covers and on measures which may be taken to mitigate such hazards. (IRLD2014026)
