Air Accident Investigation Unit Ireland

SYNOPTIC REPORT

**INCIDENT
Avions de Transport Régional
ATR 72-201, EI-REI
Dublin Airport
30 March 2013**

AAIU Report No: 2014-015

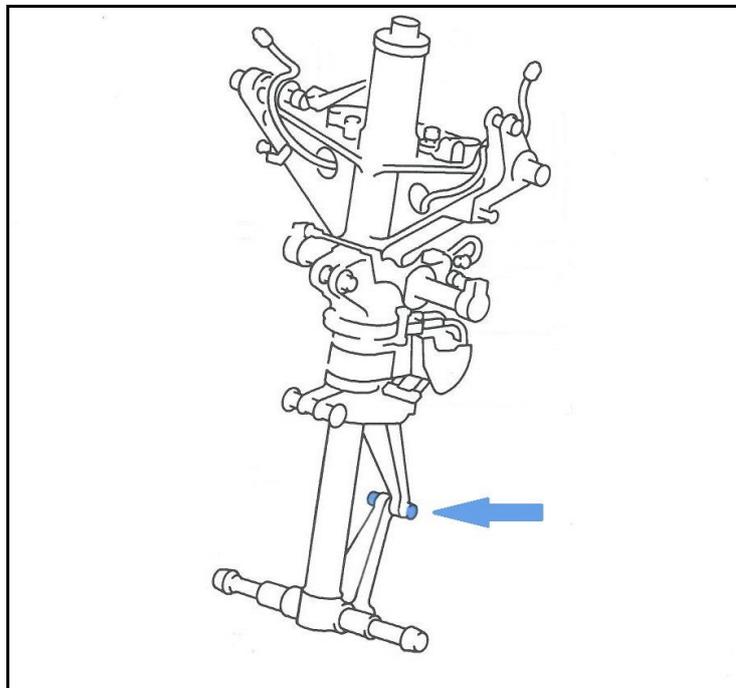
Figure No. 1: Location of torque link apex pin on nose leg assembly

An inspection on the taxiway revealed the NLG torque link apex pin to be missing (**Figure No. 1**).

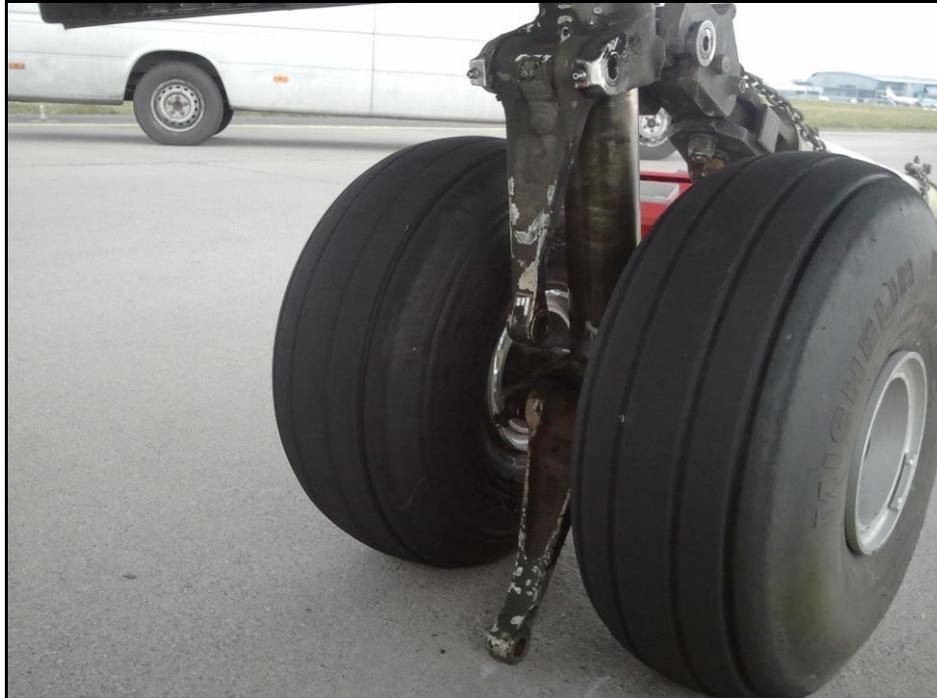
Photo No. 1: Separated Torque Links

The nose landing gear was photographed (**Photo No. 1**) and the aircraft was then towed to a hangar for further inspection.

The AAIU inspected the aircraft later that day. The NLG torque link apex pin, washers, retaining nut and lock washer were missing which allowed the torque links to separate. When the upper link separated, it caused damage to the weight-on-wheel switch assembly and the loss of the switch targets and bracket. Following separation, the lower link caused damage to the inside of both nose landing gear wheels. The bushings installed at the end of each torque link, through which the pin is located, both remained in place.

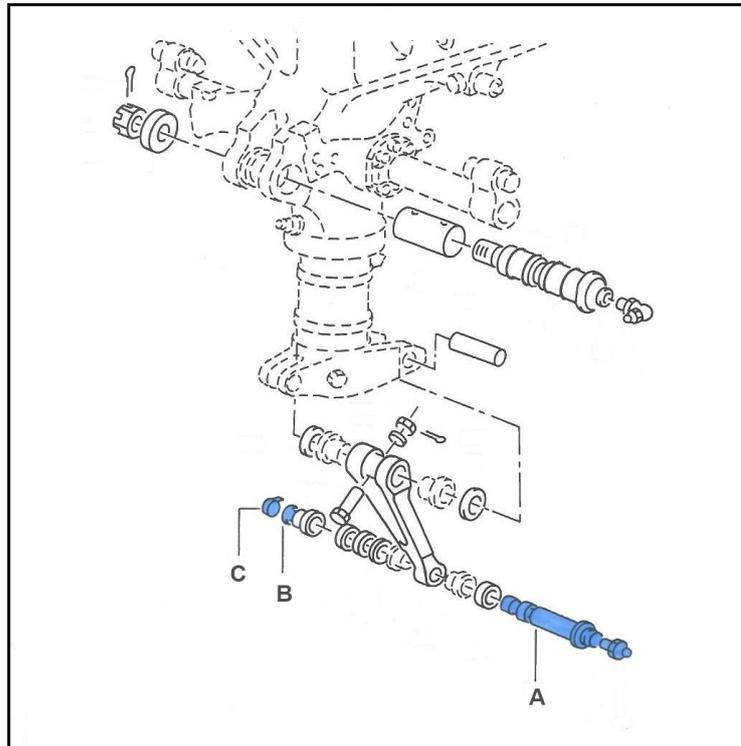
Figure No. 2: Detail showing torque link apex pin (A), retaining nut (B) and serrated (locking) washer (C).

The nose landing gear comprises, *inter alia*, the oleo leg strut and two torque link arms, which allow vertical movement of the axle whilst preventing sideways rotation. The torque link arms are joined together by means of a pin, which is located in bushings in each of the torque links. The pin assembly contains a number of shaped washers and a retaining nut, which is secured by means of a serrated (locking) washer (**Figure No. 2**).

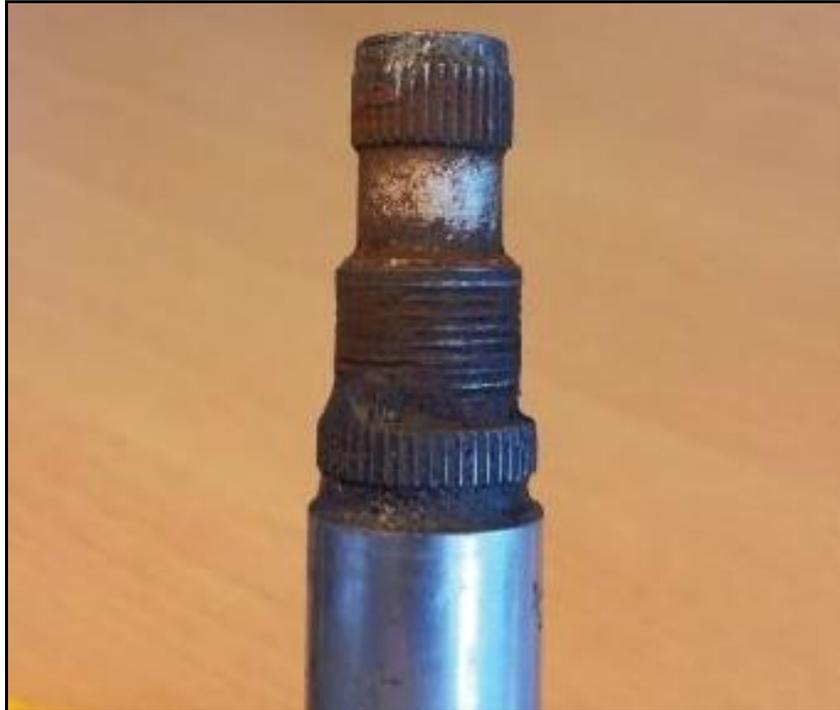
Photo No. 2: Example of corrosion found on NLG torque link apex pin following fleet inspection

This inspection revealed a number of apex pins with various levels of corrosion; degradation of the cadmium protection was noted (**Photo No. 2**). In response to this, the Operator added a supplementary maintenance program task with a 4-year interval to remove and inspect apex pins for corrosion (Engineering Order TS-32-0183) to be incorporated in the next revision of the ATR 72 and ATR 42 maintenance programmes.

The Manufacturer advised the Investigation that inspection of ATR aircraft revealed, in some instances, significant corrosion of the threaded portion of the apex pin. It is probable that such corrosion had some bearing on the loss of the serrated washer and nut thereby allowing the pin to migrate free. The root cause of the corrosion has not yet been determined; however, degradation of the cadmium protection was noted.

1. It is likely that corrosion of the threaded portion of the apex pin had occurred such that the serrated washer and retaining nut separated from the link pin allowing the link pin to migrate free.

1. The susceptibility of the link pin material to corrosion at the threaded portion following degradation of the cadmium protection.
