Air Accident Investigation Unit Ireland

FACTUAL REPORT

RANS S6-ES, G-BZRA

14 April 2014

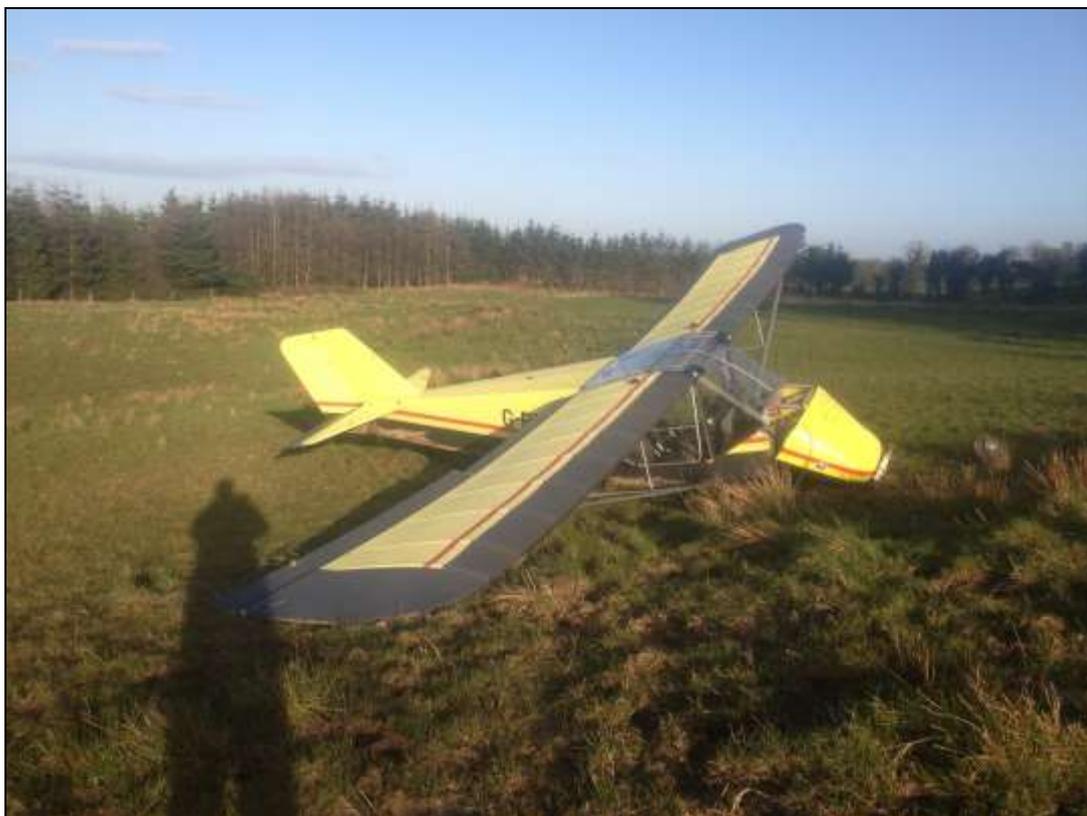
Photo No. 1: G-BZRA after the Occurrence

The cockpit cage was distorted and the windscreen was damaged. The nose wheel leg and the starboard main landing gear leg were both sheared off. The port main landing gear leg was bent. The engine bearer arms failed and the engine was detached from the airframe. The propeller was destroyed with only the two blade stubs remaining attached to the propeller hub. Only one of the two propeller blades was recovered. This blade was fractured near the root and also sustained damage at the tip. The nature of the fractures of the composite blades and of the damaged blade tip showed evidence of rotation at impact. Some of the fabric coverings were torn and the engine cowling was damaged.
