Air Accident Investigation Unit Ireland

FACTUAL REPORT

Aero AT-3 R100, G-DPEP

Birr Airfield, Co. Offaly

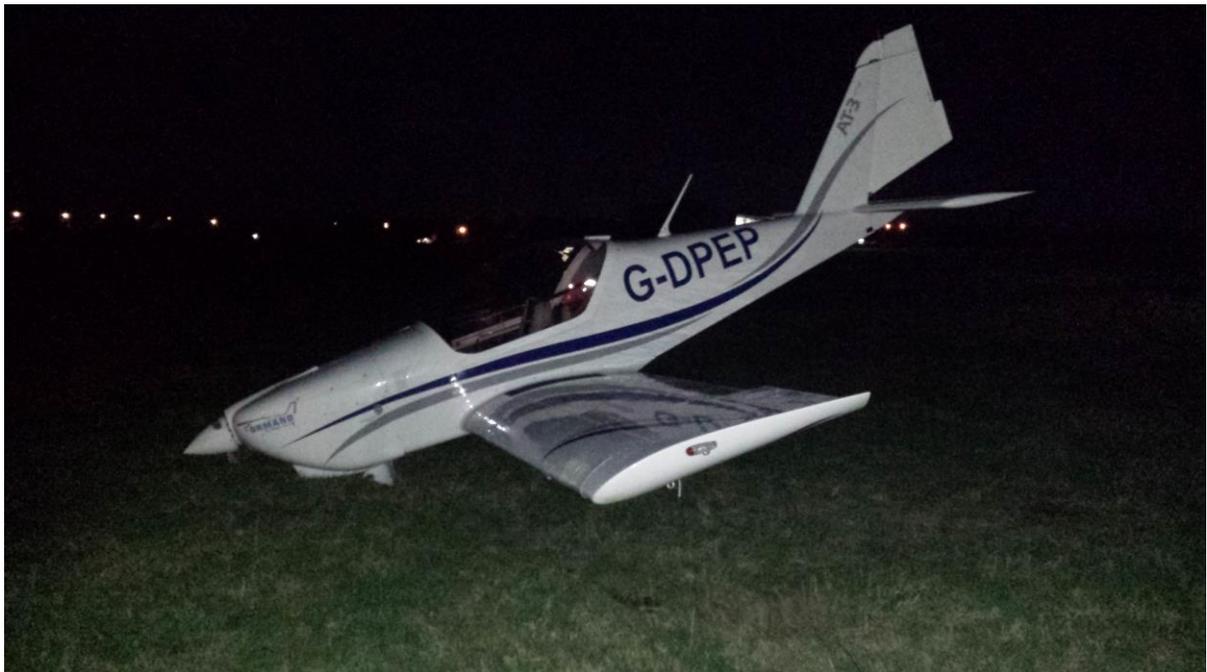
The Pilot was on a routine local flight from EIBR. The weather at the time was good with a light breeze from the northwest. The Pilot reported to the Investigation that he was making a normal approach to Runway (RWY) 36. Just before landing on the grass runway, the aircraft "*ballooned*", then bounced and became airborne again. The Pilot applied power to arrest the descent, whereupon the aircraft yawed sharply to the left. The aircraft touched down again in a nose-down attitude in the grass to the left of the runway. The nose landing gear collapsed and the propeller struck the ground, **Photo No. 1**. The Pilot was not injured and he exited the aircraft in the normal manner.

Photo No. 1: Final Position of G-DPEP.

The Pilot informed the Investigation that he considered that the cause of the accident was that he did not apply enough right rudder to overcome the yaw to the left which he felt was caused by the application of power when the aircraft became airborne again after the bounce.

The aircraft sustained substantial damage to its nose landing gear, propeller and engine firewall.

The slipstream from a nose-mounted propeller flows back around an aircraft and meets the vertical stabiliser at an angle of attack which generates a sideways aerodynamic force on the stabiliser and this tends to yaw the aircraft's nose. The direction of the yaw depends on the direction of propeller rotation. The propeller on G-DPEP rotated clockwise (as viewed from the cockpit) and therefore the tendency was for the nose to yaw to the left.

An application of power increases the slipstream effect on the vertical stabiliser and this will be particularly noticeable at low airspeed. The Pilot's own analysis of the event was that he did not apply enough right rudder to counteract the left yaw generated by his application of power when the aircraft became airborne after the bounced landing.
