Air Accident Investigation Unit Ireland

FACTUAL REPORT

**Dominator Ultrawhite Gyroplane, EI-EZY
Near Athenry, Co. Galway
23 August 2014**

AAIU Report No: 2015 - 011
State File No: IRL00914069
Report Format: Factual Report
Published: 28 May 2015

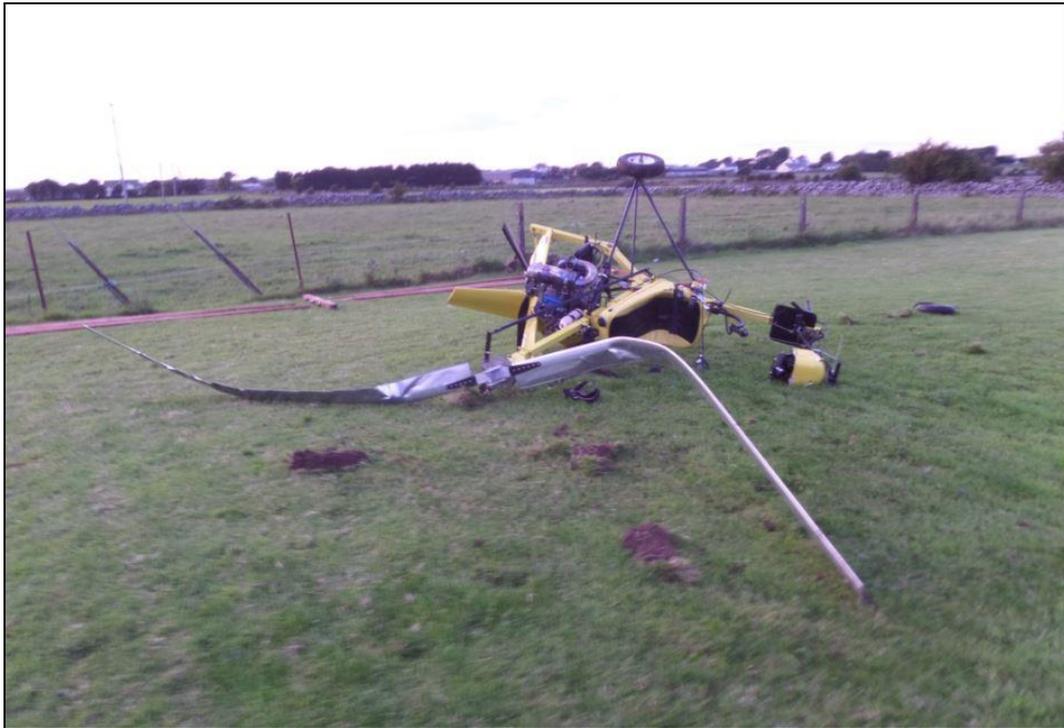
Photo No. 1 shows the final position of EI-EZY, with the side fence of the garden in the background.

Photo No. 1: Final Position of EI-EZY.

The gyroplane sustained substantial damage during the accident. The two rotor blades were destroyed by ground contact. One of the three composite propeller blades sheared off while a second blade exhibited impact witness marks. The tail assembly and the pre-rotator cable were also damaged. The nosewheel leg fractured and the nosewheel assembly separated from the airframe.

The Pilot reported that he had experienced some sink just prior to landing and that the gyroplane had landed somewhat heavily. It is possible that during the landing, the nosewheel made contact with the ground with sufficient force to fracture the leg and cause the nosewheel itself to separate from the airframe. Once the nosewheel had departed, the gyroplane was unstable and toppled over causing substantial damage.

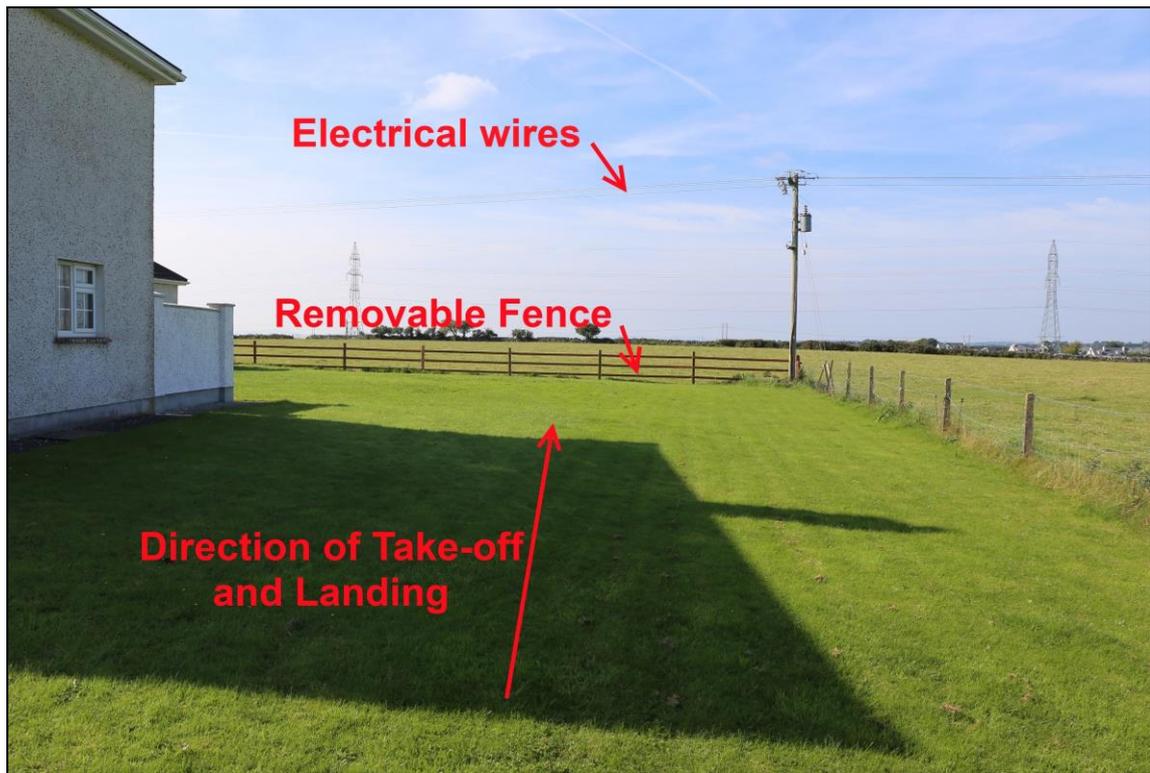
The Pilot had been using a grass area of the garden alongside his house as a take-off and landing site, which was aligned along a magnetic bearing of 055°/235°. Given the prevailing westerly winds, a take-off and landing direction of 235° was normally used and this was the case on the day of the occurrence. The overall length of the site was 53.2 m and the available width between the house and a fixed side fence was 12.5 m. The easterly end of the site was bounded by a 1.5 m high garden wall running alongside a public road. The westerly end was bounded by a timber fence which was removed whenever the gyroplane was operating from the site. This fence was between the garden and an agricultural field.

Overhead electrical supply cables at a height of approximately 10 m also ran adjacent to this fence-line, perpendicular to the take-off/landing site orientation. The Pilot’s standard operating procedure was to take off in the direction of the agricultural field, pass underneath the electrical cables and then climb away. A divot in the grass associated with the accident was measured at 8.5 m from the westerly end of the garden and 7.2 m from the side fence. A general view of the take-off/landing site is shown in **Photo No. 2**.

Photo No. 2: Take-off and Landing Site.

Following the AAIU visit to view the gyroplane and the take-off/landing site at the Pilot's residence, the Investigation's opinion was that the site was unsuitable and inappropriate for gyroplane operations. Accordingly, the Investigation wrote to the Pilot concluding the letter with the following recommendation: *"Therefore, the AAIU would strongly recommend that you should not operate gyroplane aircraft from your garden and that you should re-locate the operation to a safer and more appropriate base."* The Pilot responded that he appreciated the advice and recommendations and planned to act on them immediately.
