Air Accident Investigation Unit Ireland

SYNOPTIC REPORT

Roko Aero NG4 UL, OK-TUR 22
Near Wicklow town, Ireland
30 December 2014

AAIU Report No: 2015 - 013
State File No: IRL00914111
Report Format: Synoptic Report
Published: 6 July 2015

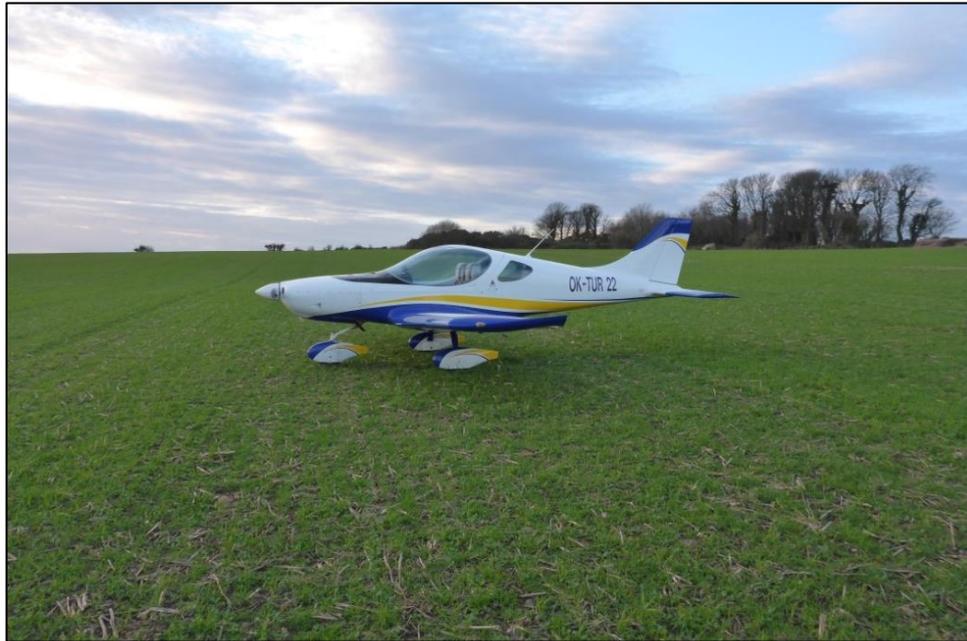
The aircraft landed on a southerly heading in a large field to the south of Wicklow town. The surface of the field was covered in short grass and sloped gently away from the direction of landing. It was smooth, firm and obstruction-free (**Photo No. 1**).

Photo No. 1: Aircraft at site of forced landing.

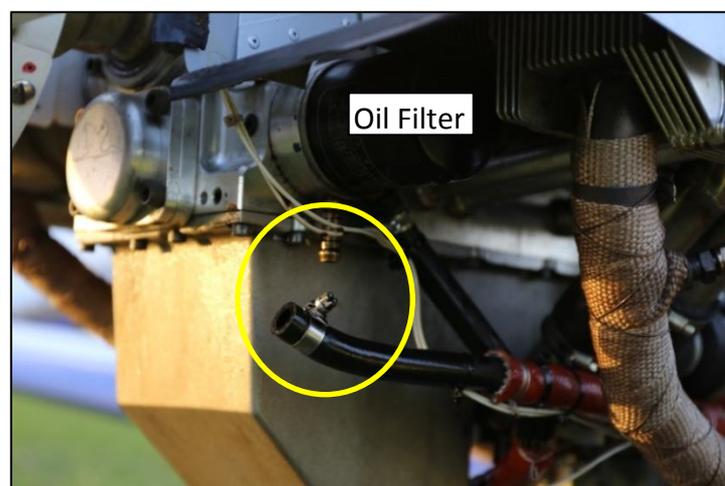
When the aircraft was examined by the Investigation following the event, evidence of engine oil was apparent on the nose landing gear. The engine cowlings were removed and the source of the oil leak was traced to a flexible hose which had disconnected from a fitting installed in the engine oil filter adapter (**Photo No. 2**). The dipstick was examined and it indicated that the engine oil sump was empty.

Photo No. 2: Supply hose to oil cooler found disconnected at engine oil filter adapter (circled).

Loss of engine oil in flight, due to the detachment of a hose supplying oil to the engine oil cooler.

Jabiru Aircraft Pty Ltd should include a warning in the Instruction and Maintenance Manuals for the Jabiru 2200 engine and similar Jabiru engine types, highlighting that if oil cooler hoses are installed with oil on the hose fittings or, with oil on the inside of the hose in the vicinity of the fittings, hose security may be adversely affected. (IRLD2015008).

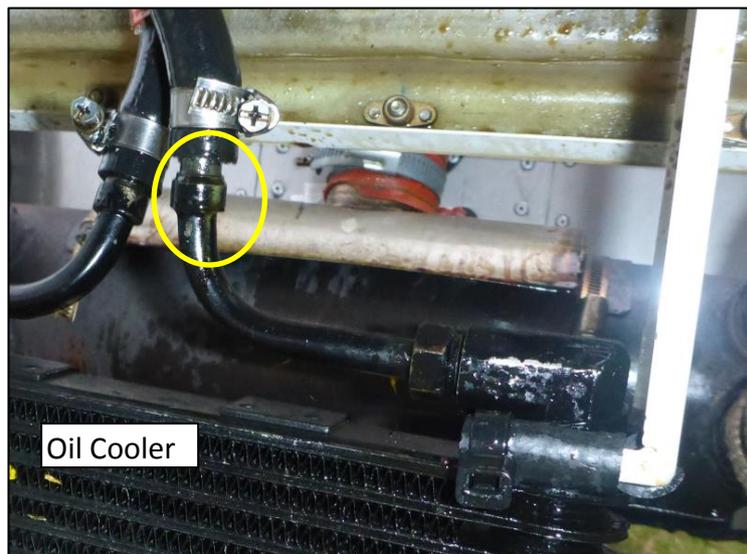
Two flexible hoses, a supply and a return, route engine oil between the engine and an external oil cooler. The hoses are connected to the engine oil system through fittings installed in the oil filter adapter and are normally secured to the fittings by means of worm drive hose clamps/clips⁷. The disconnected hose was the hose that supplies oil to the cooler. The other end of the hose, where it was connected to the oil cooler, was noted to be not fully 'home' on its fitting (**Photo No. 3**).

Photo No. 3: Supply hose to oil cooler not fully 'home' on its fitting (circled).

The Engine Manufacturer's *'Instruction & Maintenance Manual'* warns against disconnecting the hoses at the oil cooler during oil changes as this can lead to premature ageing of the hose and cause it to slip off the cooler. It was noted by the Investigation that the end of the disconnected hose, where it connects to the oil cooler, was not fully in position on the oil cooler fitting. This may have been due to the hose not being pushed fully 'home' during installation or as a result of hose deterioration caused by disconnecting and reconnecting the hose during oil changes, as warned against by the Engine Manufacturer. When the hose clamp was removed at the oil cooler, it was difficult to remove the hose, indicating that the hose was not loose and was therefore most likely not pushed fully 'home' during installation.

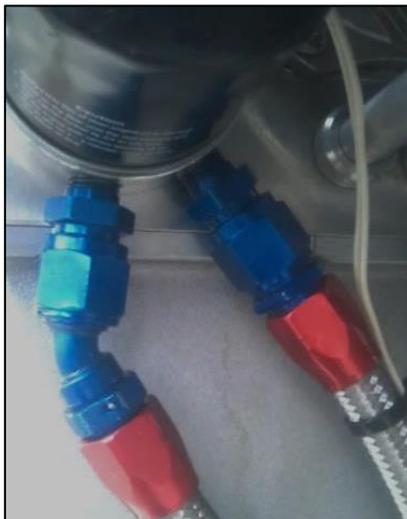
The aircraft Owner informed the Investigation that the oil cooler hoses and fittings have since been replaced with a 'screw-on' type (**Photo No. 4**). The Engine Manufacturer advised the Investigation that the use of hoses with 'screw-on' fittings was considered, but that there were *"no problems with the current system"* and that there *"is less cost involved when the hoses need to be changed"*.

Photo No. 4: New hoses with screw-on fittings.

It should be noted that the Investigation was informed that following the event, the aircraft Owner replaced the hoses on OK-TUR-22 with a screw-on type, which the Investigation considers to be a more secure arrangement for pressurised hoses.

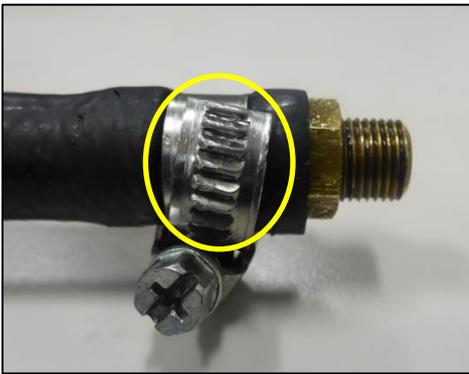
The fittings were removed from the oil filter adapter and the hose that had detached was reinstalled on its fitting. The hose clamp was tightened and the clamp, in its tightened state, was examined. It was noted that a large portion of the threaded band of the clamp was protruding at the screw head end (**Photo No. 5**), and that the clamp had almost reached its minimum diameter (**Photo No. 6**).

Photo No. 5: Hose clamp/clip in its tightened state, with large portion of threaded band protruding at screw head.

The Investigation could not refit the hose that had detached from the fitting in the oil filter housing without first loosening the clamp. When the hose was refitted and the clamp tightened, the clamp was found to be almost at the limit of its travel. It was possible to rotate the hose with some effort but it was not possible to remove it without first loosening the clamp. These observations indicate that the clamp was performing a clamping function. However, the Investigation considers that the use of a clamp rated from 16-27 mm on a hose with an external diameter of 16.2 mm is less than ideal and may result in ineffective clamp pressure.

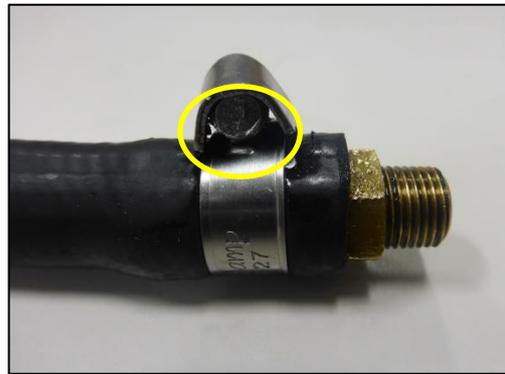
Photo No. 6: Other side of hose clamp/clip showing it to be almost at its minimum diameter.
