Air Accident Investigation Unit Ireland

SYNOPTIC REPORT

Roko Aero NG4 UL, OK-TUR 22
Near Wicklow town, Ireland
30 December 2014

AAIU Report No: 2015 - 013
State File No: IRL00914111
Report Format: Synoptic Report
Published: 6 July 2015

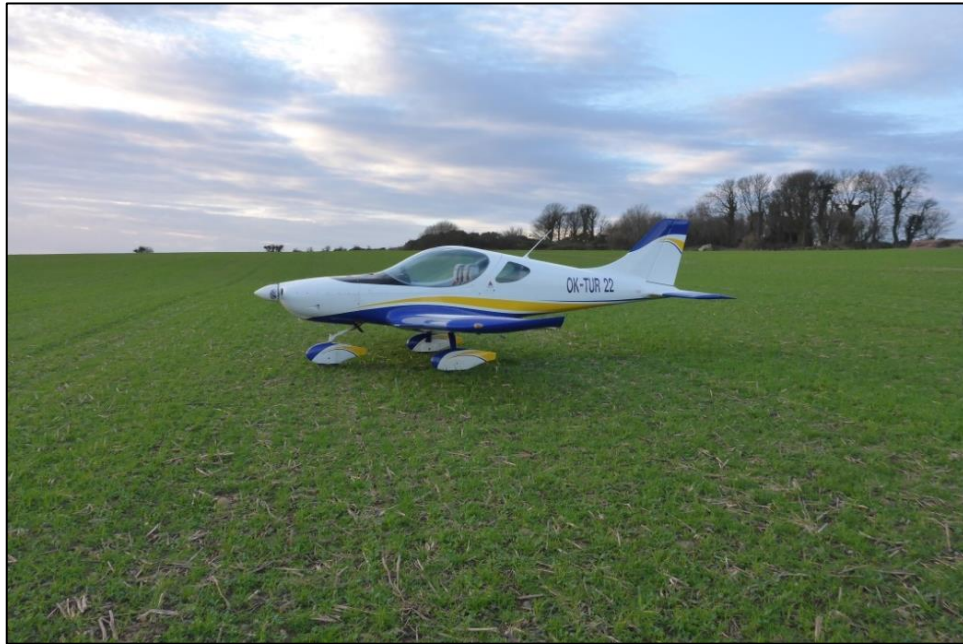
The aircraft landed on a southerly heading in a large field to the south of Wicklow town. The surface of the field was covered in short grass and sloped gently away from the direction of landing. It was smooth, firm and obstruction-free (**Photo No. 1**).

Photo No. 1: Aircraft at site of forced landing.

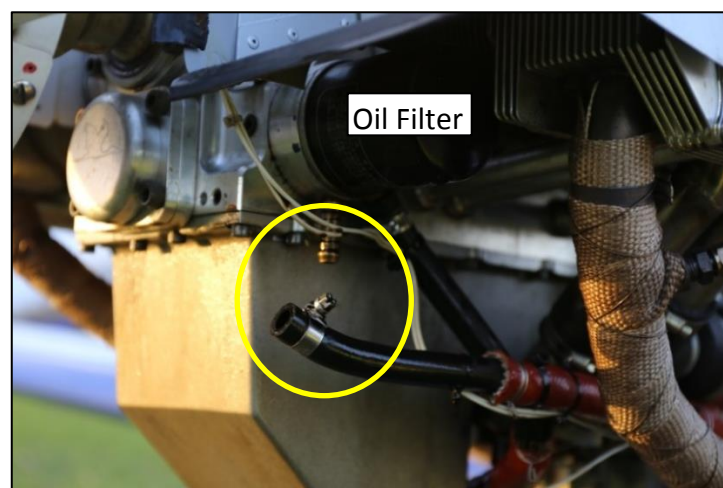
When the aircraft was examined by the Investigation following the event, evidence of engine oil was apparent on the nose landing gear. The engine cowlings were removed and the source of the oil leak was traced to a flexible hose which had disconnected from a fitting installed in the engine oil filter adapter (**Photo No. 2**). The dipstick was examined and it indicated that the engine oil sump was empty.

Photo No. 2: Supply hose to oil cooler found disconnected at engine oil filter adapter (circled).

The Investigation could not refit the hose that had detached from the fitting in the oil filter housing without first loosening the clamp. When the hose was refitted and the clamp tightened, the clamp was found to be almost at the limit of its travel. It was possible to rotate the hose with some effort but it was not possible to remove it without first loosening the clamp. These observations indicate that the clamp was performing a clamping function. However, the Investigation considers that the use of a clamp rated from 16-27 mm on a hose with an external diameter of 16.2 mm is less than ideal and may result in ineffective clamp pressure.

Information obtained by the Investigation suggests that installing an oil-moistened hose can lead to subsequent detachment. Furthermore, it was identified during testing conducted by the Investigation that the presence of oil on the exterior of the hose fitting/interior of the hose in the vicinity of the fitting had a significant adverse effect on the security of the hose.

The cause of the hose detachment in this particular case could not be positively established. The hoses were considered by the Investigation to be of sufficient length and therefore this was not a factor. The detachment may have been caused by ineffective clamp pressure, assembly when wet, age-related deterioration or a combination of these factors. Nevertheless, the event highlights the importance of following the Engine Manufacturer's guidelines in relation to the use of the correct parts, the replacement of hoses every two years and not disconnecting the hoses when changing the engine oil. To highlight this event to users of Jabiru engines, the following Safety Recommendation is issued to the Engine Manufacturer:

Jabiru Aircraft Pty Ltd should include a warning in the Instruction and Maintenance Manuals for the Jabiru 2200 engine and similar Jabiru engine types, highlighting that if oil cooler hoses are installed with oil on the hose fittings or, with oil on the inside of the hose in the vicinity of the fittings, hose security may be adversely affected. (IRLD2015008).

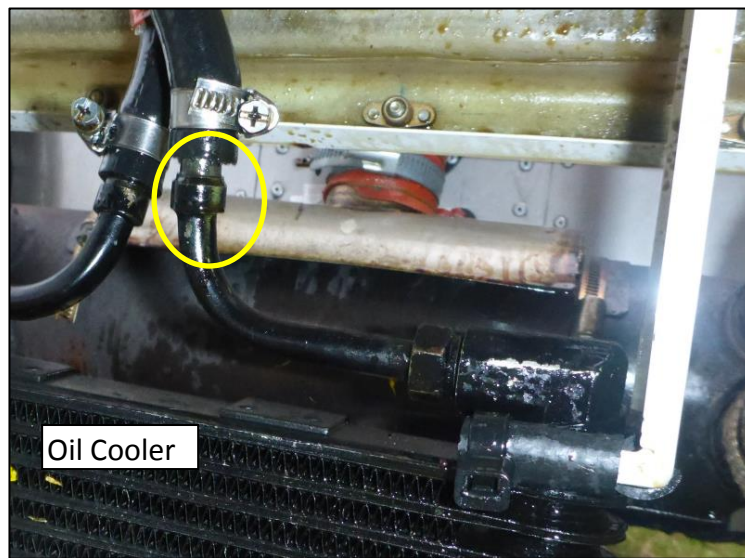
Two flexible hoses, a supply and a return, route engine oil between the engine and an external oil cooler. The hoses are connected to the engine oil system through fittings installed in the oil filter adapter and are normally secured to the fittings by means of worm drive hose clamps/clips⁷. The disconnected hose was the hose that supplies oil to the cooler. The other end of the hose, where it was connected to the oil cooler, was noted to be not fully 'home' on its fitting (**Photo No. 3**).

Photo No. 3: Supply hose to oil cooler not fully 'home' on its fitting (circled).

The Engine Manufacturer's *'Instruction & Maintenance Manual'* warns against disconnecting the hoses at the oil cooler during oil changes as this can lead to premature ageing of the hose and cause it to slip off the cooler. It was noted by the Investigation that the end of the disconnected hose, where it connects to the oil cooler, was not fully in position on the oil cooler fitting. This may have been due to the hose not being pushed fully 'home' during installation or as a result of hose deterioration caused by disconnecting and reconnecting the hose during oil changes, as warned against by the Engine Manufacturer. When the hose clamp was removed at the oil cooler, it was difficult to remove the hose, indicating that the hose was not loose and was therefore most likely not pushed fully 'home' during installation.

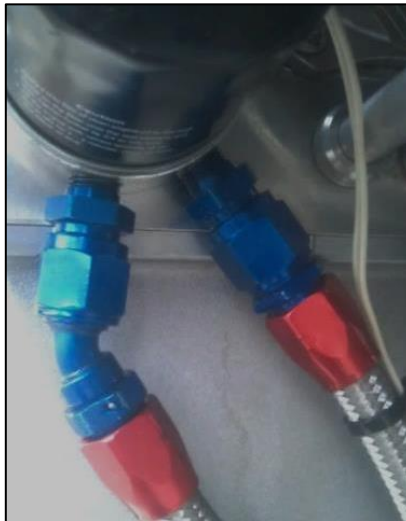
Photo No. 4: New hoses with screw-on fittings.

The aircraft Owner informed the Investigation that the oil cooler hoses and fittings have since been replaced with a 'screw-on' type (**Photo No. 4**). The Engine Manufacturer advised the Investigation that the use of hoses with 'screw-on' fittings was considered, but that there were *"no problems with the current system"* and that there *"is less cost involved when the hoses need to be changed"*.

It should be noted that the Investigation was informed that following the event, the aircraft Owner replaced the hoses on OK-TUR-22 with a screw-on type, which the Investigation considers to be a more secure arrangement for pressurised hoses.

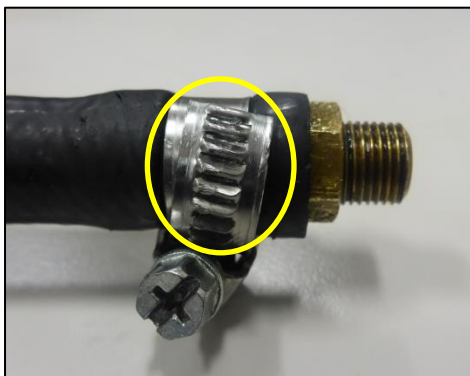
The fittings were removed from the oil filter adapter and the hose that had detached was reinstalled on its fitting. The hose clamp was tightened and the clamp, in its tightened state, was examined. It was noted that a large portion of the threaded band of the clamp was protruding at the screw head end (**Photo No. 5**), and that the clamp had almost reached its minimum diameter (**Photo No. 6**).

Photo No. 5: Hose clamp/clip in its tightened state, with large portion of threaded band protruding at screw head.

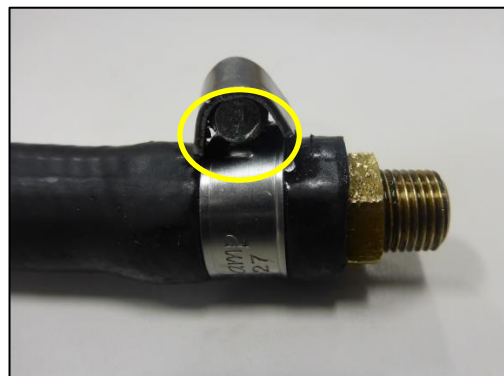
Photo No. 6: Other side of hose clamp/clip showing it to be almost at its minimum diameter.
