# **Air Accident Investigation Unit Ireland**

**SYNOPTIC REPORT**

**Piper PA-34 Seneca, EI-CMT**

**Cork Airport, Co. Cork**

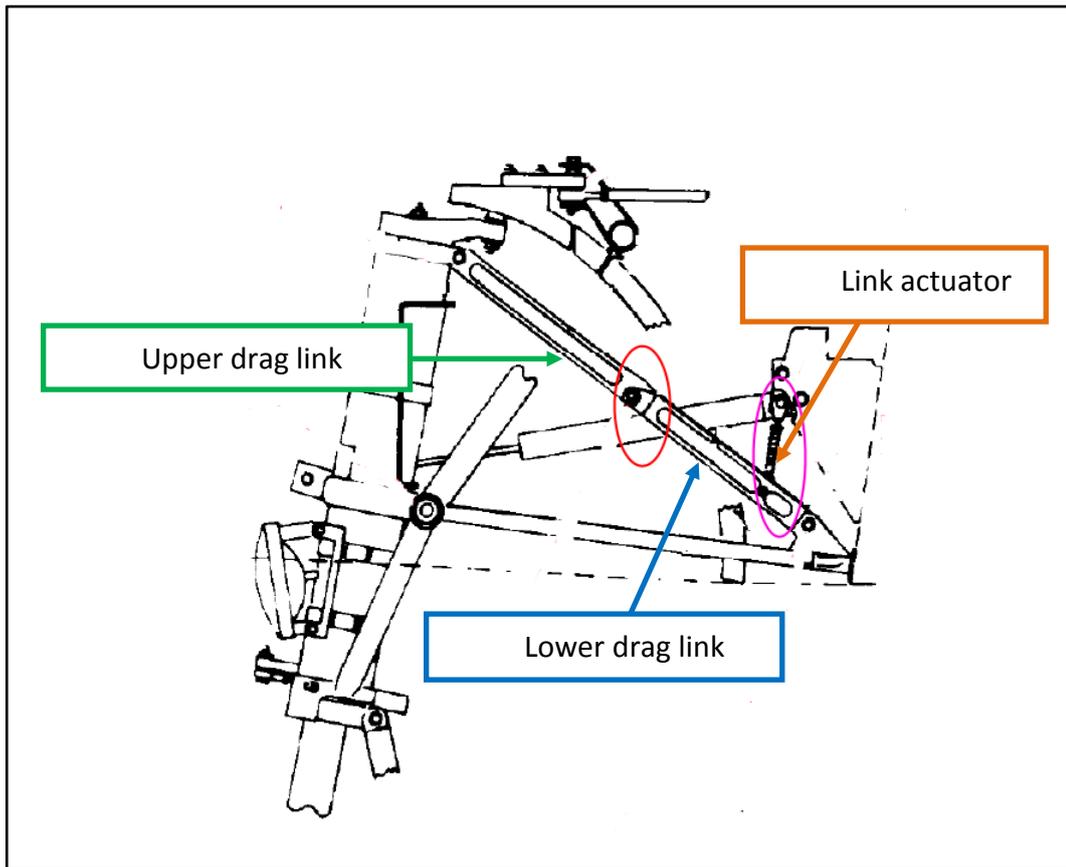
**Figure No. 1** shows a schematic diagram of the NLG actuating linkages with the over-centre, geometric lock indicated in red and the down lock link indicated in purple.

**Figure No. 1:** NLG actuation schematic showing the geometric lock (red) and down lock link (purple)

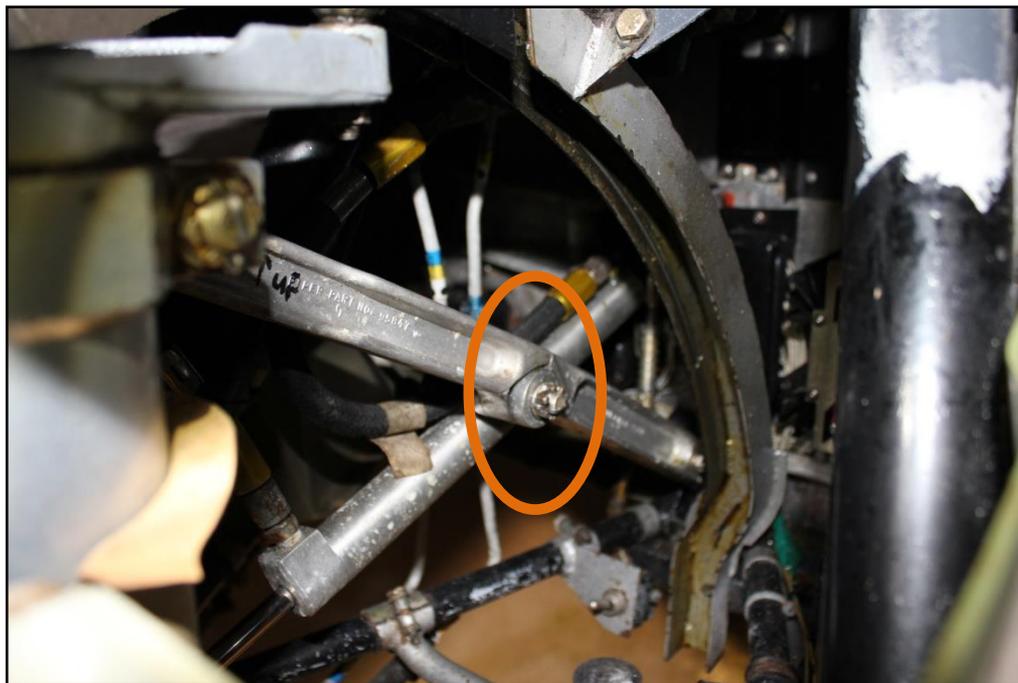
The actuating linkages for the NLG on the subject aircraft were examined. Locking of the NLG in the down position relies on an over-centre, geometric lock being formed and maintained between the upper and lower drag links. In normal operation, the aircraft's weight on the nosewheel applies a load to the NLG's drag link assembly which will maintain the over-centre geometric lock condition. However, if for any reason the geometric lock over-centre condition has not been achieved when weight is put on the nosewheel, then the load will actually cause the NLG drag linkage to fold and the gear will retract into the wheel well. The Investigation noted that, with the gear in the down position, the geometric lock over-centre condition was not in evidence on the subject aircraft (**Photo No. 1**). The link actuator was examined and found to be damaged in such a way that the over-centre geometric lock could not be achieved.

**Photo No. 1:** Linkages as found with no geometric lock in evidence.

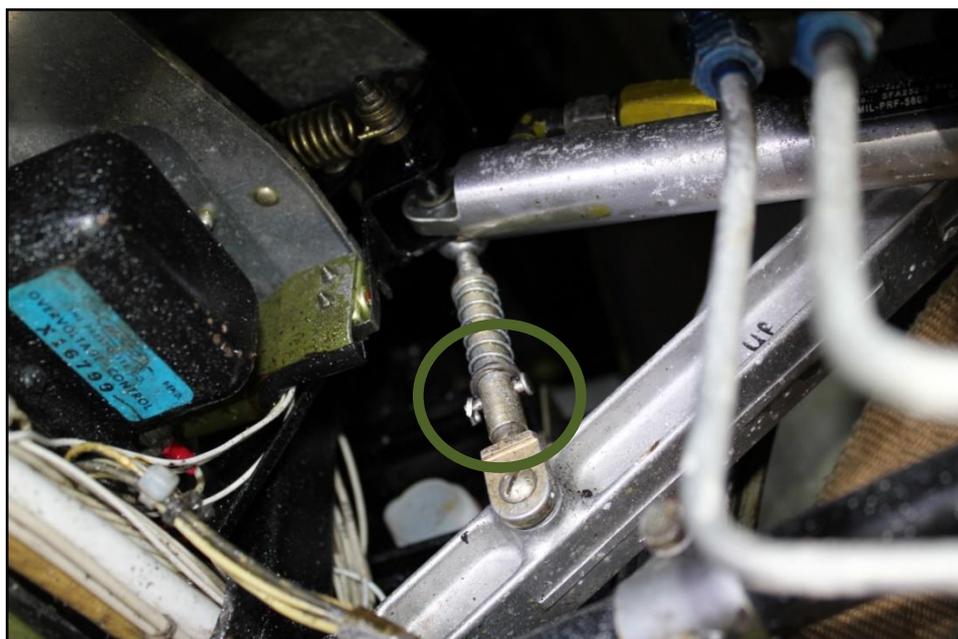
5  
The down lock link was closely examined. This link is a spring-loaded device which is set to a specific length so as to ensure that during extension it applies a load to the lower drag link, thereby forcing it into an over-centre, geometric lock with the upper drag link. Effective spring action is critical to maintaining the correct length of the down lock link. It was noted that this link had suffered crush damage and permanent distortion of the pin holes (**Photo No. 2**) and as a consequence the down lock link was not properly spring loaded to the correct length.

**Photo No. 2:** Down lock link crush damage at the pinholes.

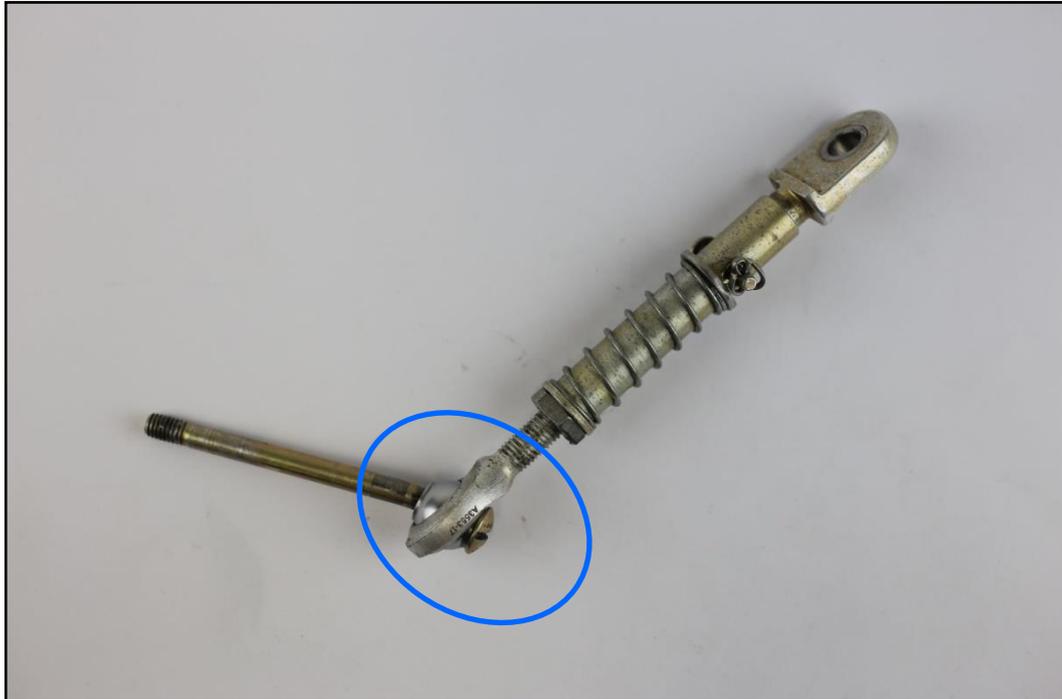
On removal of the down lock link it was further noted that the centre pivot bolt which passes through the upper eye-end of the down lock link, securing it to the aircraft structure, had failed in bending (**Photo No. 3**).

**Photo No. 3:** Failure in bending of the down lock link bolt.

It is probable that the bending failure of the down lock link bolt and/or the elongation of the down lock link pin holes (and associated loss of effective spring loading) resulted in a situation where the length of the down lock link was insufficient to maintain the over-centre geometric locking between the upper and lower drag links. It was not possible to determine when, why or in what sequence the bending failure and hole elongation occurred. Once geometric locking between the upper and lower drag links was lost, the NLG retracted under the applied loads during the landing roll.

The bending failure of the down lock link bolt and/or the elongation of the down lock link pin holes (and associated loss of effective spring loading) resulted in a situation where the length of the down lock link was insufficient to maintain the over-centre geometric lock between the upper and lower drag links.

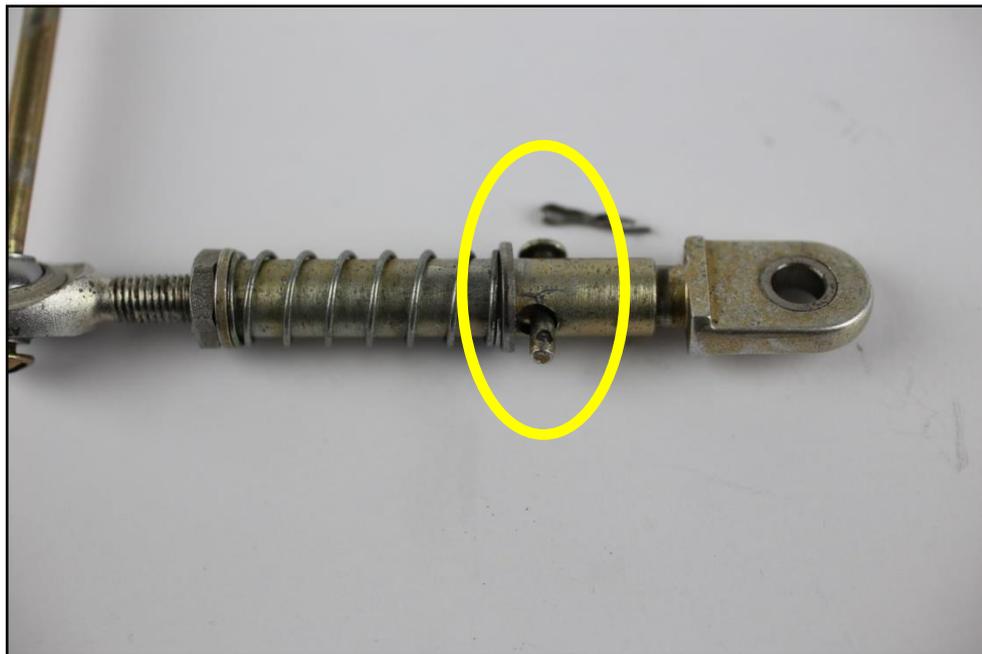
Closer examination revealed the extent of the pin hole elongation and confirmed the failure of the spring loading which is necessary to ensure correct link length (**Photo No. 4**).

**Photo No. 4:** Down lock link elongated pin holes and improper spring loading.

In the case of this particular aircraft, examination of the aircraft maintenance and operational records did not reveal any issues relating to maintenance or operational history which could explain why the NLG collapsed. There was a failure in bending of the down lock link bolt. There was also an elongation of the pin holes in the down lock link barrel which resulted in a loss of effective spring loading and hence loss of length in the down lock link.
