Air Accident Investigation Unit Ireland

SYNOPTIC REPORT

Piper, PA-32R-301, N808CA

Ballyboe, Co. Tipperary

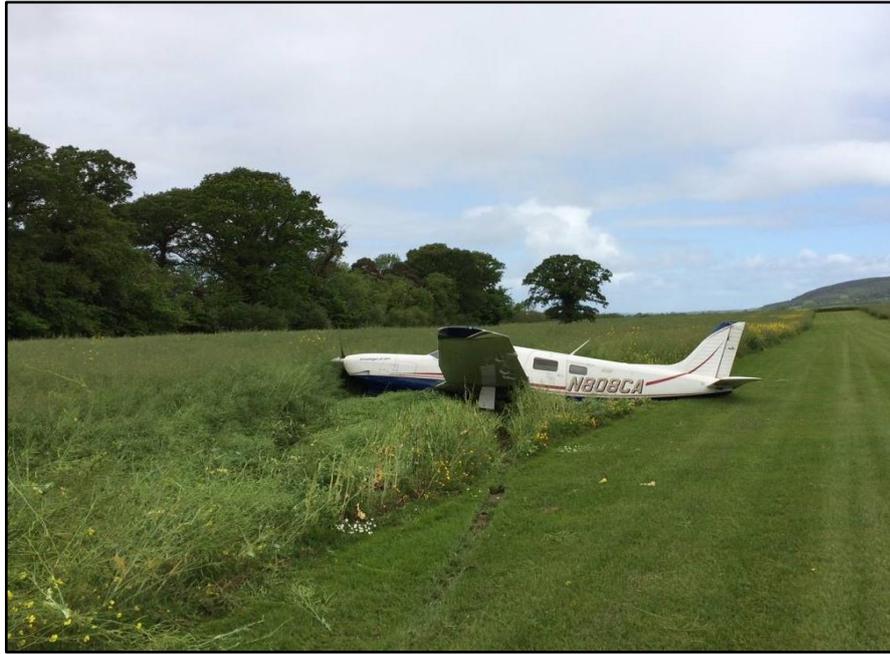
The Pilot estimated that the aircraft touched down on RWY 33, 70 metres (m) from the threshold. He raised the flaps and started to apply the wheel brakes to stop the aircraft. Shortly after touchdown, the Pilot heard a noise from the left side of the aircraft which he identified as the wingtip contacting the adjacent agricultural crop. This caused the aircraft to begin turning to the left. The application of right rudder did not counteract this turn and the aircraft departed the runway at a speed estimated by the pilot to be 40 to 50 kts. The right-hand undercarriage leg collapsed during this excursion resulting in damage to the underside of the aircraft fuselage, the starboard wing and the horizontal stabiliser. The aircraft came to rest straddling the edge of the runway and the adjacent field (**Photo No. 1**).

Photo No. 1: Final resting position of N808CA

When the aircraft wingtip contacted the Rapeseed crop the resultant asymmetric deceleration caused a rapid turning moment to the left that was not counteracted by the rudder inputs of the Pilot, probably due to reduced rudder authority as the aircraft decelerated. As the aircraft departed the prepared surface the right undercarriage leg collapsed due to a combination of lateral forces applied to the undercarriage leg and contact with the unprepared surface of the field. The final position of the aircraft indicates that it had turned left through approximately 110° from the runway centreline axis.

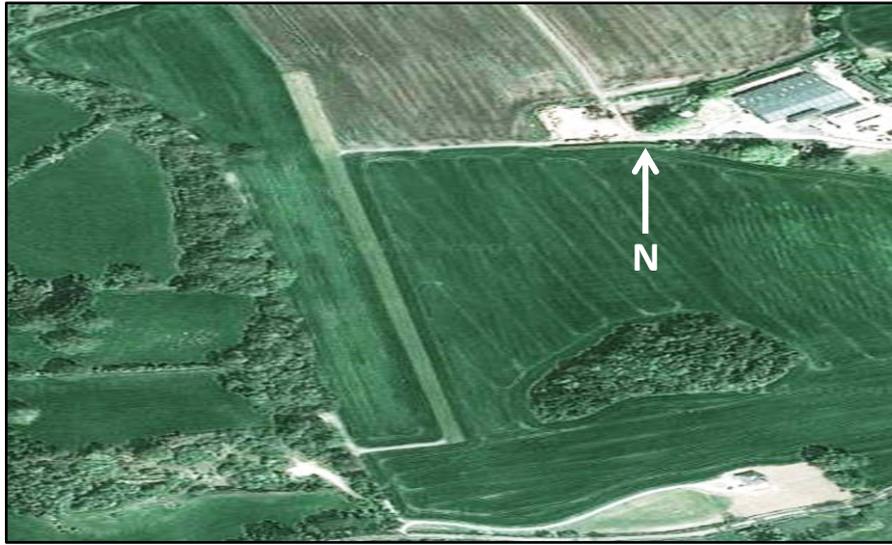
The runway has an initial downhill slope when viewed from the threshold of RWY 33 followed by an uphill segment for the remainder of the runway length. There is also a minor slope from right to left along the length of RWY 33 to the final location of the aircraft. A line of trees is located 50 m west of the airfield, commencing 50 m before the threshold of RWY 33 and running parallel to the full length of the airfield (**Photo No. 2**). There are wires and trees on the approach to RWY 33.

Photo No. 2: Ballyboe Airfield

RWY 33 is flanked by a crop of Field Beans to the right and a crop of Rapeseed to the left. The Field Beans had reached a height of 0.7 m (1-2 ft) at the time of the accident. The Rapeseed had grown to a height of approximately 1.5 m (4-5 ft). Rapeseed is an agricultural crop that consists of long stems and distinctive yellow flowers (**Photo No. 3**). The Rapeseed plant can grow to a height of up to 2.5 m (8 feet). This was the first time that the airfield owner had planted Rapeseed as a crop.

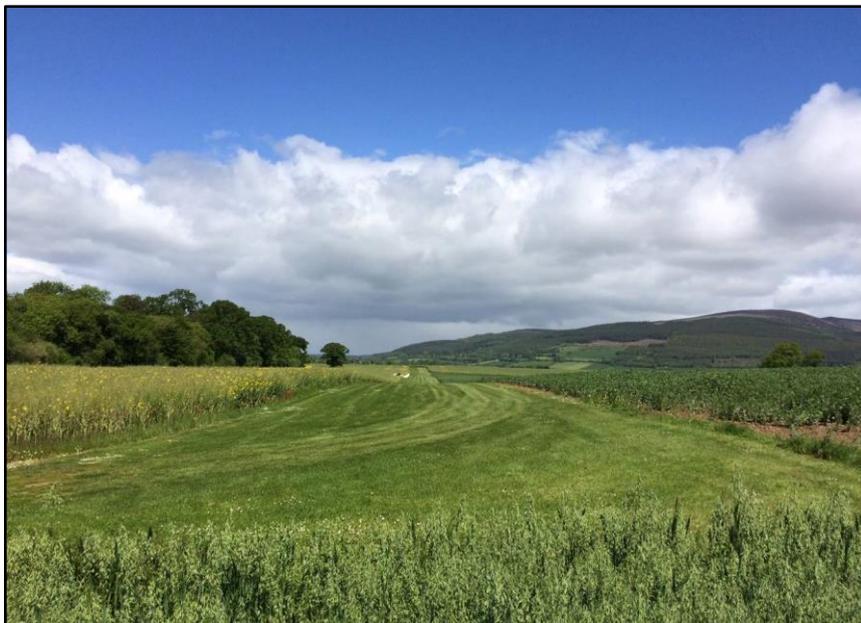
Photo No. 3: View north-westerly from the threshold of RWY 33
