# Air Accident Investigation Unit Ireland

FACTUAL REPORT  
SERIOUS INCIDENT

Boeing 737-8AS, EI-EFF  
Boeing 737-8AS, EI-DHA

Dublin Airport  
8 March 2015

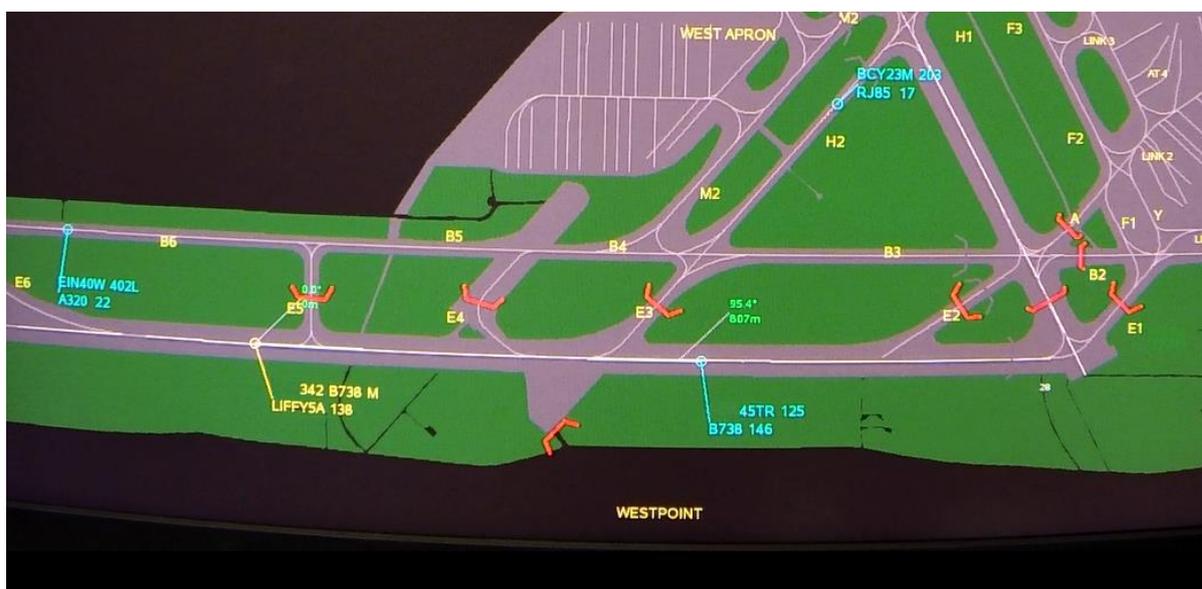
The landing aircraft (EI-DHA) was advised of the departing traffic and to expect a late landing clearance. The A-SMGCS RIMCAS<sup>5</sup> activated at 21.56:21 hrs with aural and visual alerts to the AMC. Data provided by the Operator's FDM<sup>6</sup> shows that the departing aircraft became airborne prior to the landing aircraft touching down. At their closest point the aircraft were 807 metres apart; however the rate of closure was low. At this point, EI-EFF was past the intersection at TWY E5 accelerating past a speed of 138 kts, EI-DHA was approaching TWY E3 at 146 kts and decelerating (**Graphic No. 1**).

**Graphic No. 1:** Captured A-SMGCS image showing EI-EFF (Callsign 342) and EI-DHA (Callsign 45TR) at their closest point (807 m).
