Air Accident Investigation Unit Ireland

FACTUAL REPORT

**Boeing, 737-8AS, EI-DWE & EI-DYA
Taxiway LINK 2/F1, Dublin Airport, Ireland**

1 April 2015

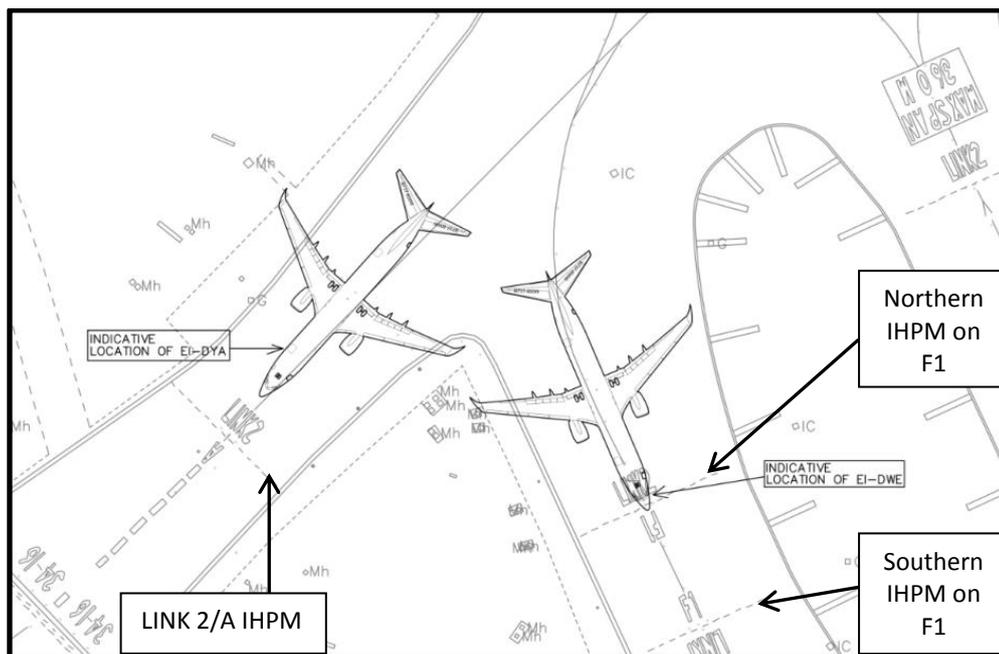
Figure No. 2: Final position of both aircraft, post impact

The first aircraft, EI-DWE, was found in its original parked position on LINK 2 with the nose wheels approximately 3.3 metres (m) short of the northern Intermediate Holding Position Marker (IHPM), delineating the start of TWY F1, with its nose tip protruding slightly into TWY F1 (**Figure No. 2**). The nose wheels were approximately 0.2 m left of the taxiway centreline.

The second aircraft, EI-DYA, was found a short distance (approximately 5 m) from its first point of contact with EI-DWE. The aircraft was positioned over the inbound STOPBAR lights for TWY Alpha/LINK 2 and was approximately 12.2 m short of the IHPM between LINK 2 and TWY Alpha. The nose wheels were approximately 0.7 m to the right of the taxiway centreline (**Figure No. 2**).

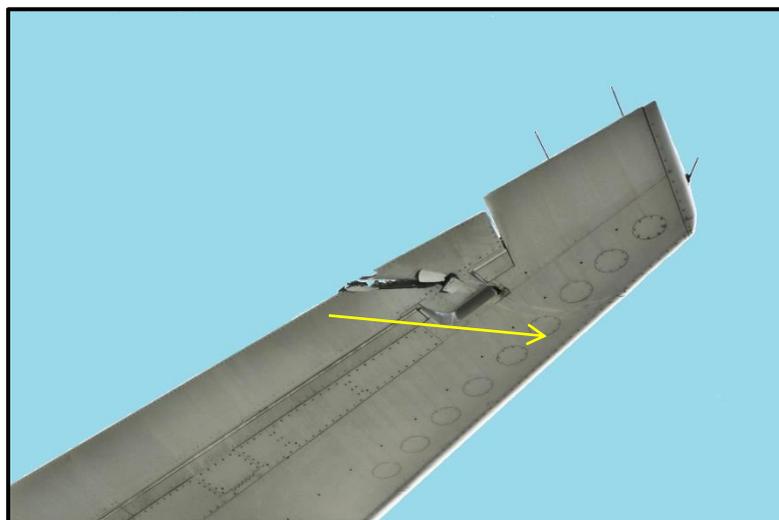
The tip section of the port side winglet of EI-DYA struck the outer portion of the starboard elevator of EI-DWE, causing substantial damage to the elevator. As EI-DYA continued forward, the tip then sheared from the main part of the winglet once it had reached the hinge point of the elevator of EI-DWE. The underside of the horizontal stabilizer of EI-DWE suffered scuff and scrape marks on its lower surface, as a result of the stub of the winglet remaining in contact with the aircraft structure as EI-DYA continued forward. Both the winglet of EI-DYA and elevator of EI-DWE were subsequently replaced.

Photo No. 1: Underside of right elevator of EI-DWE showing damage and scuff marks. Arrow indicates direction of travel of EI-DYA's Winglet.

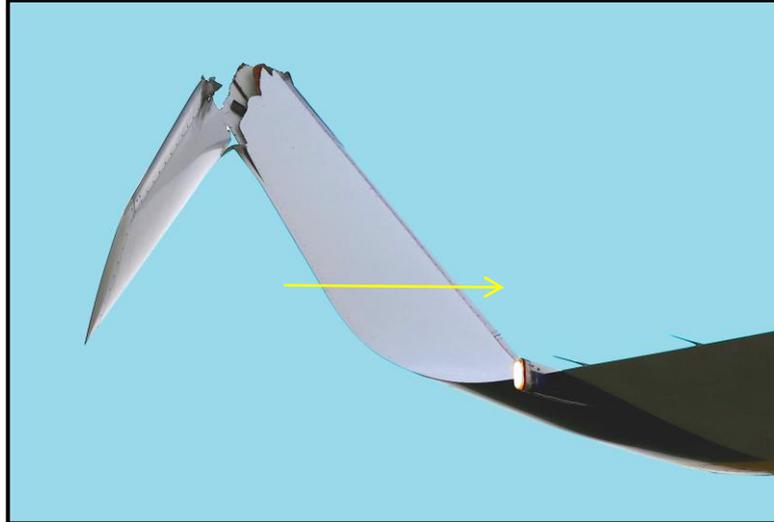
Photo No. 2: Left Winglet of EI-DYA showing damage to top section. Arrow indicates direction of travel.
