# **Air Accident Investigation Unit Ireland**

**FACTUAL REPORT**

**Boeing 737-8AS, EI-EKB**

**En route Krakow - Edinburgh**

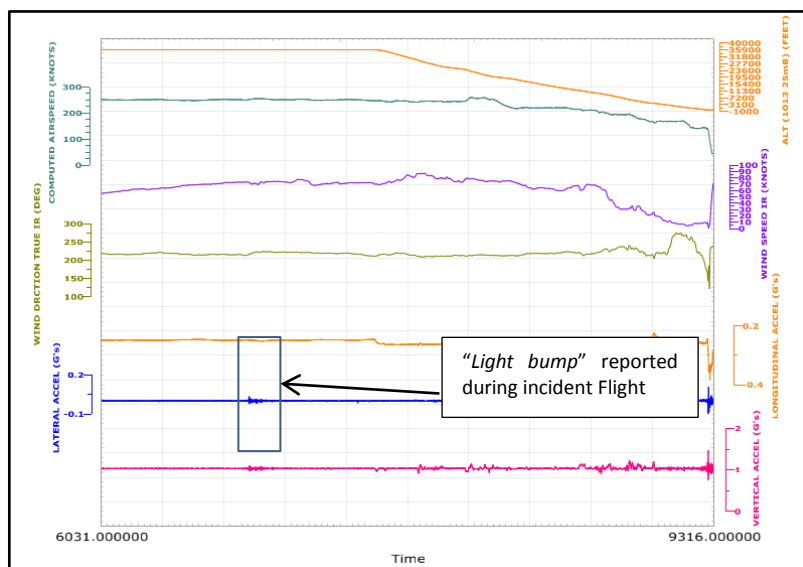
Figure No. 3: OFDM accelerations recorded during incident flight

The Operator was unaware of the event for three weeks after it had occurred, by which time data from the Flight Data Recorder (FDR) and Cockpit Voice Recorder (CVR) had been overwritten. However, data was available from the Operational Flight Data Monitoring (OFDM) system and was provided to the Investigation by the Operator. This data showed no evidence of an encounter with significant turbulence during the subject flight. At a point approximately 41 minutes before landing, the data showed a minor disturbance with a maximum recorded vertical acceleration of 1.11 g and a maximum recorded lateral acceleration of 0.033 g (**Figure No. 3**). It is possible that this disturbance was the “light bump” or “short bump” described by the No. 1 and No. 2 CCMs.

At no point during the flight or prior to completion of the duty did any member of the cabin crew report the fall or injury to the Commander. Although the injury seemed minor and was reported as such by the CCM to his colleagues, it would be considered good practice in crew resource management to report it to the Commander. It also prevented the Operator from obtaining further information at the time of the occurrence to determine the nature and extent of the injury. The interval between the incident flight and the reporting of this occurrence to the Operator meant that any form of contemporaneous information that could have been gathered / recorded (such as the CVR/FDR data or a medical examination) were unavailable to the Investigation. The OFDM data indicated a maximum vertical acceleration of 1.11 g and a lateral acceleration of 0.033 g which would not be considered indicative of turbulent conditions.
