# **Air Accident Investigation Unit Ireland**

**SYNOPTIC REPORT**

**SERIOUS INCIDENT**

**BAe 125-800B, N1310H**

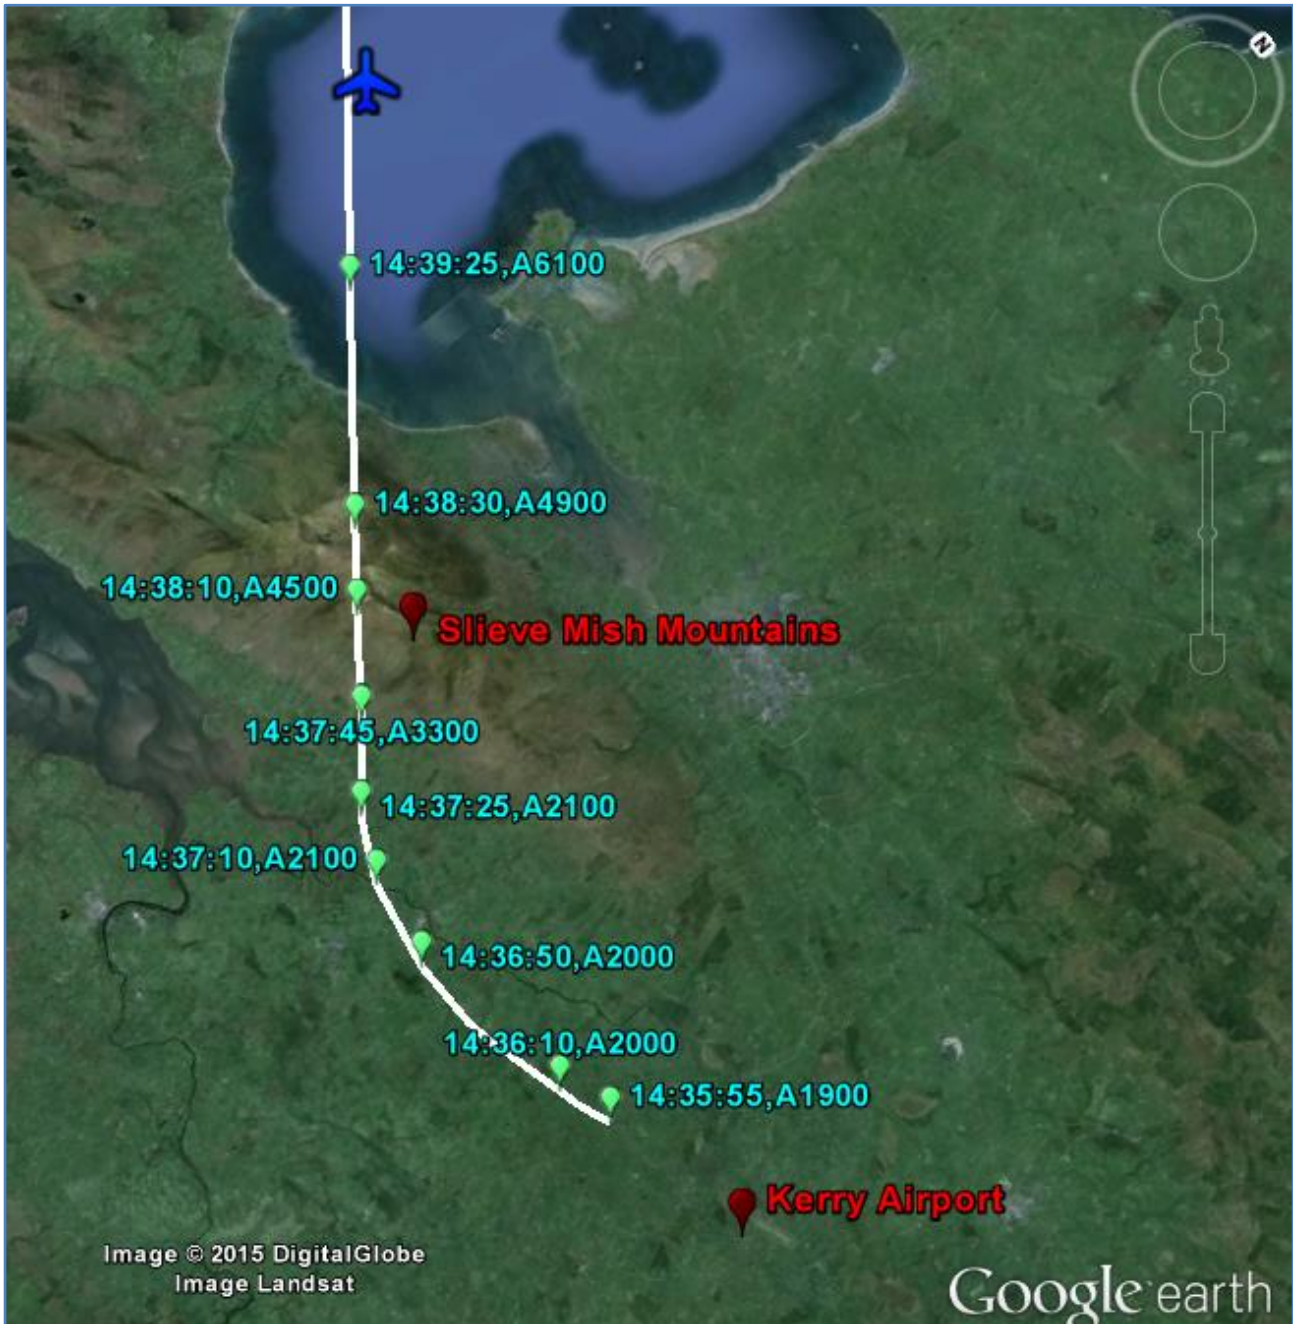
## Appendix A

Shannon ATC provided the Investigation with the data files from its ATM (Air Traffic Management) Surveillance Tracker And Server (ARTAS). The Investigation extracted the data for N1310H and used it to produce an image of the aircraft's track as it departed from EIKY (Appendix A).

Flight path (from ARTAS data) of N1310H as it departed EIKY
