Air Accident Investigation Unit Ireland

PRELIMINARY REPORT

Laser Z200, PH-LSR

20 March 2016

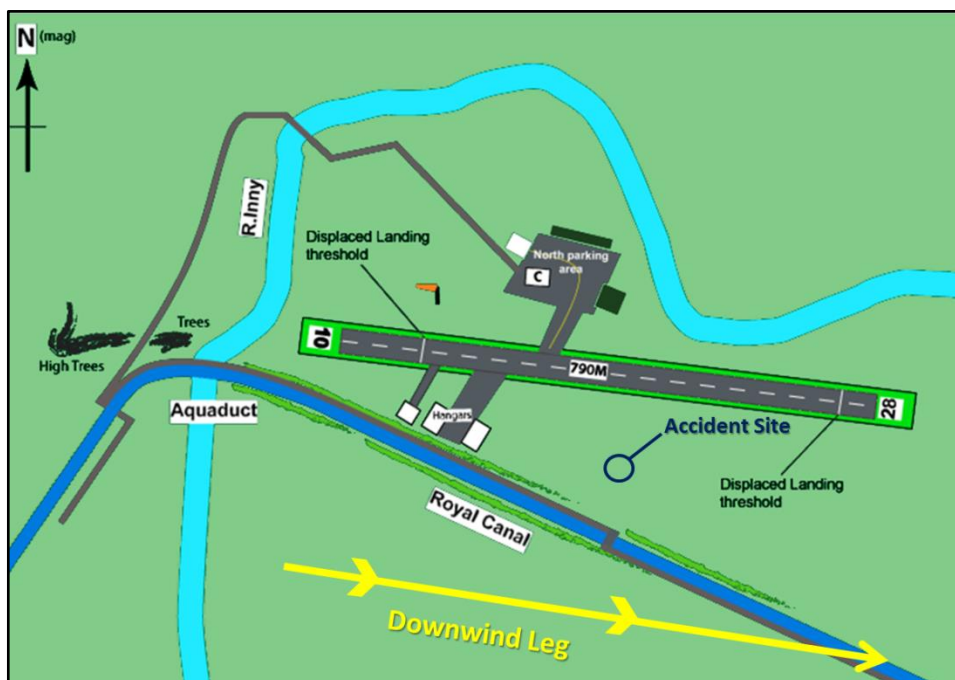
Figure No. 1: Abbeyshrule Aerodrome diagram including orientation of the 'downwind leg' for RWY 28 (from EIAB website, not to scale)

The accident site was located in an agricultural field adjacent to the southern perimeter fence of the aerodrome (**Figure 1**). It was 130 metres south of the runway centreline and 280 metres from the displaced threshold of RWY 28 at EIAB.

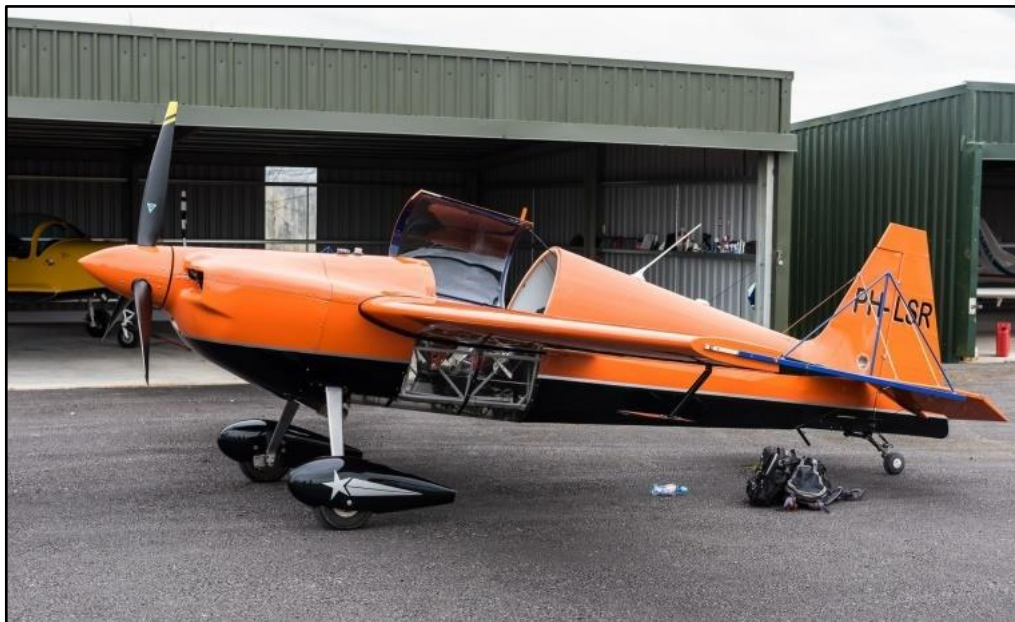
The aircraft (**Photo No. 1**) was first registered in the United Kingdom (UK) on 15 June 1995. It was originally built in the UK and issued with an Airworthiness Approval by the *Popular Flying Association* (PFA) on behalf of the *UK Civil Aviation Authority* (CAA) on 29 June 1996.

Photo No. 1: The accident aircraft, March 2016 (Source: K. Donohoe)
