Air Accident Investigation Unit Ireland

FACTUAL REPORT

SERIOUS INCIDENT

**Bombardier DHC 8-402 G-FLBB
Shannon FIR, near point OLAPO
31 July 2015**

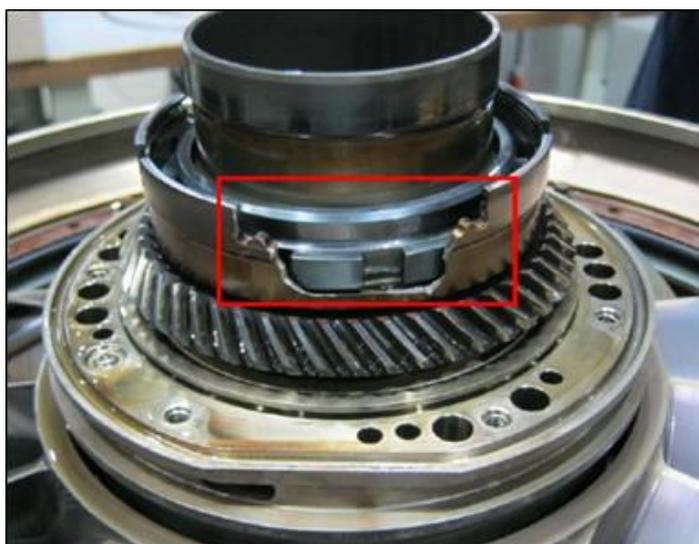
Following this event, the engine and its associated modules were sent to an approved maintenance facility in Hamburg for overhaul, Service Bulletin compliance and replacement of the Life-Limited Parts (LLPs). The approved maintenance facility provided a full strip report on completion of the work. Inspection of the engine identified No. 4 Bearing Key washer distress (**Photo No. 1**) and the following finding was made: *'high unbalance of the HP rotor resulted in distress of the carbon seals resulting in oil leak into the gas path'*.

Photo No. 1: No. 4 Bearing Key washer from Engine S/N FA0492 exhibiting distress and fracture (*Pratt & Whitney Canada*)

The cause of the washer wear (distress) was identified as stress in the fillet radius of the key washer which may initiate cracks that could propagate until there is material release.

An improved key washer with an 'infinite life' was designed by the Engine Manufacturer and was made available from 29 February 2016. In the interim period until such replacements were made, the Engine Manufacturer developed and implemented several actions aimed to reduce the incidence of events related to the distress of the Key washer component.

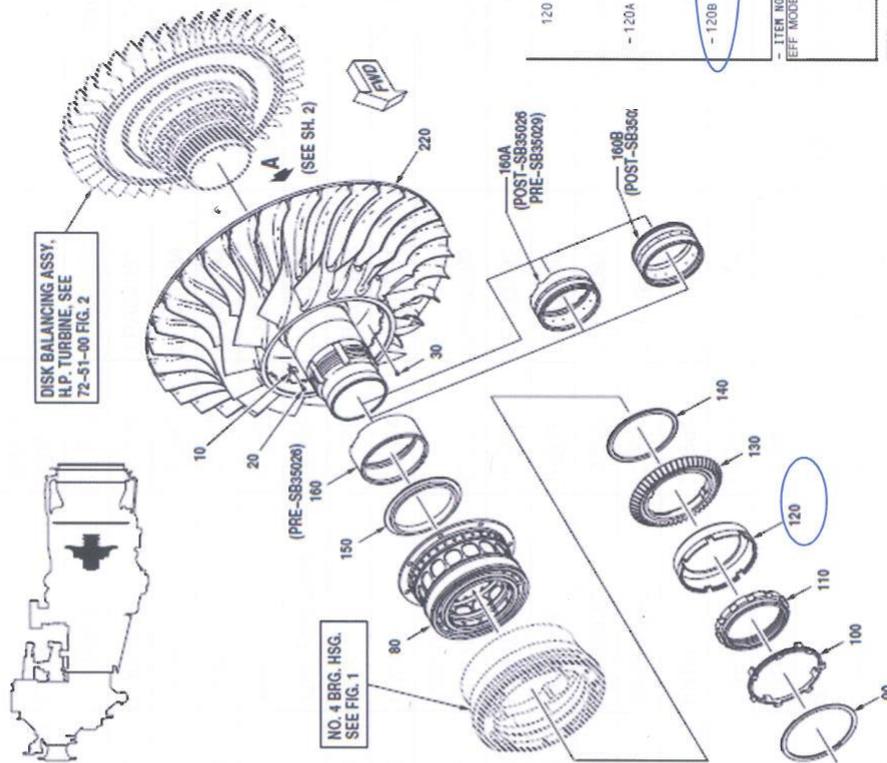
No. 4 Key Washer P/N 3071663-01

A diagram from the PW150A *Illustrated Parts Catalog* showing the High Pressure (HP) Turbine assembly and the No. 4 Bearing Key washer is reproduced in **Appendix A**.
