Air Accident Investigation Unit Ireland

FACTUAL REPORT

**Raj Hamsa X-Air Mk. 2 Falcon, EI-DBI
Kiltyclough, Co. Galway
28 February 2016**

AAIU Report No: 2016 – 010
 State File No: IRL00916019
 Report Format: Factual Report
 Published: 4 July 2016

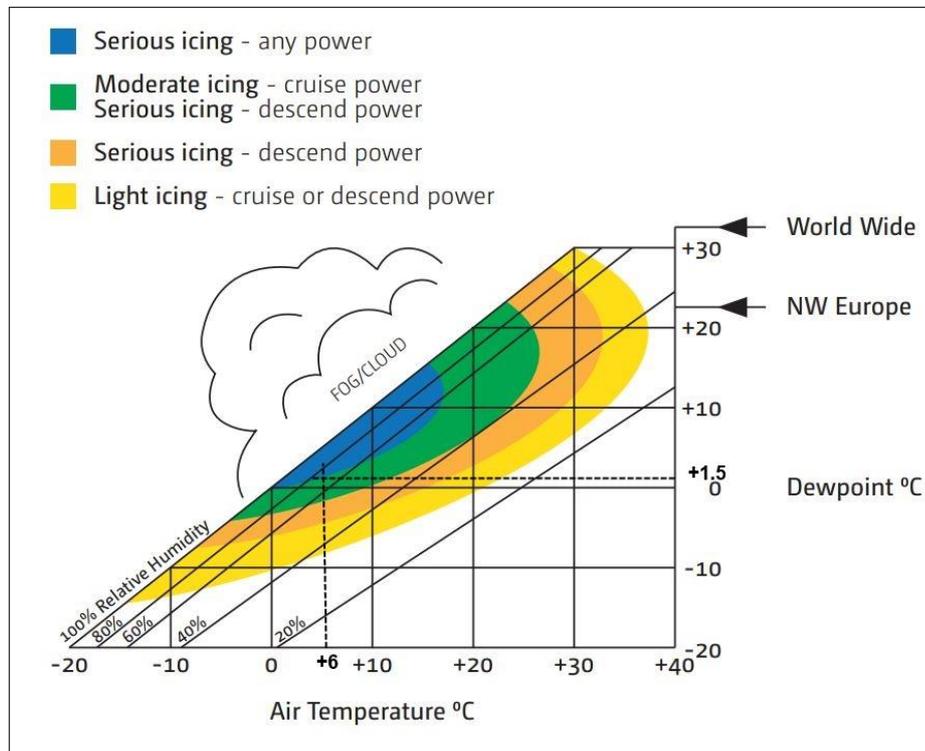
Figure No. 1: Risk of Induction Icing – Temperature v Dewpoint (EGAST)

EGAST Leaflet GA 5 also provides an indicative chart to highlight the severity of the carburettor icing risk, based on ambient temperature and dewpoint, for Avgas (Aviation Gasoline, typically 100/130 grade). In **Figure No. 1** the Investigation has plotted the conditions that pertained at the time of the event; this clearly shows that even using Avgas there was a serious icing risk at any power.

According to EGAST Leaflet GA 5, an air temperature of 6 °C and a dew point of 1.5 °C (the prevailing conditions on the day) lies in the *'serious icing at any power'* range. Use of Unleaded 95 RON or Mogas would increase the likelihood of carburettor icing.

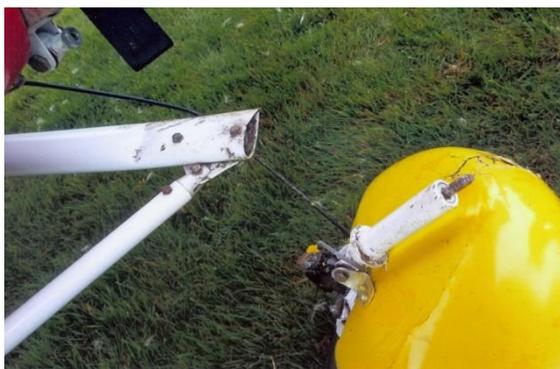
The Pilot reported that the left main gear stub axle had fractured (**Photo No. 1**) and the side of the fuselage pod had some crush damage (**Photo No. 2**). He took a number of photographs which he forwarded to the AAIU along with an AAIU Report Form.

Photo No. 1: Fractured stub axle

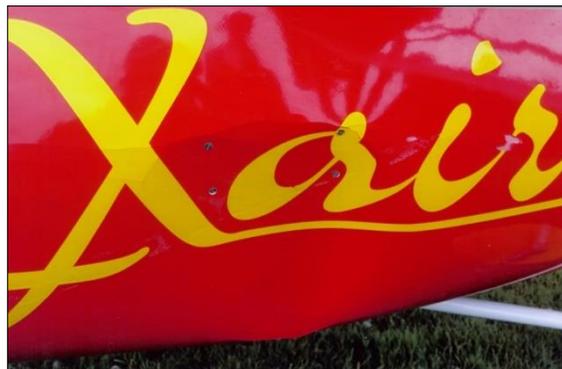
Photo No. 2: Pod crush damage (*Pilot photos*)
