Air Accident Investigation Unit Ireland

FACTUAL REPORT

Airbus A319-112, D-AIBC

27 November 2015

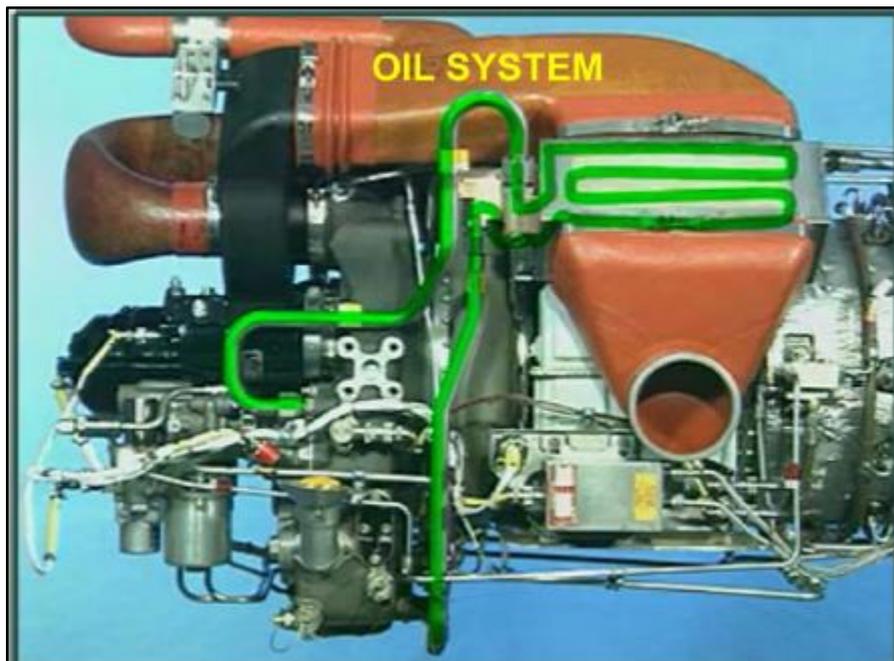
The APU has an integral oil system which cools, cleans and lubricates the APU bearings, accessory gearbox and gearbox-mounted generator. During normal operation the oil, which becomes heated while cooling the APU components, is directed through an oil/air cooler (Photo No. 1).

Photo No. 1: APU Oil System; the path of oil flow through Oil/Air Cooler is highlighted in Green (Airbus)

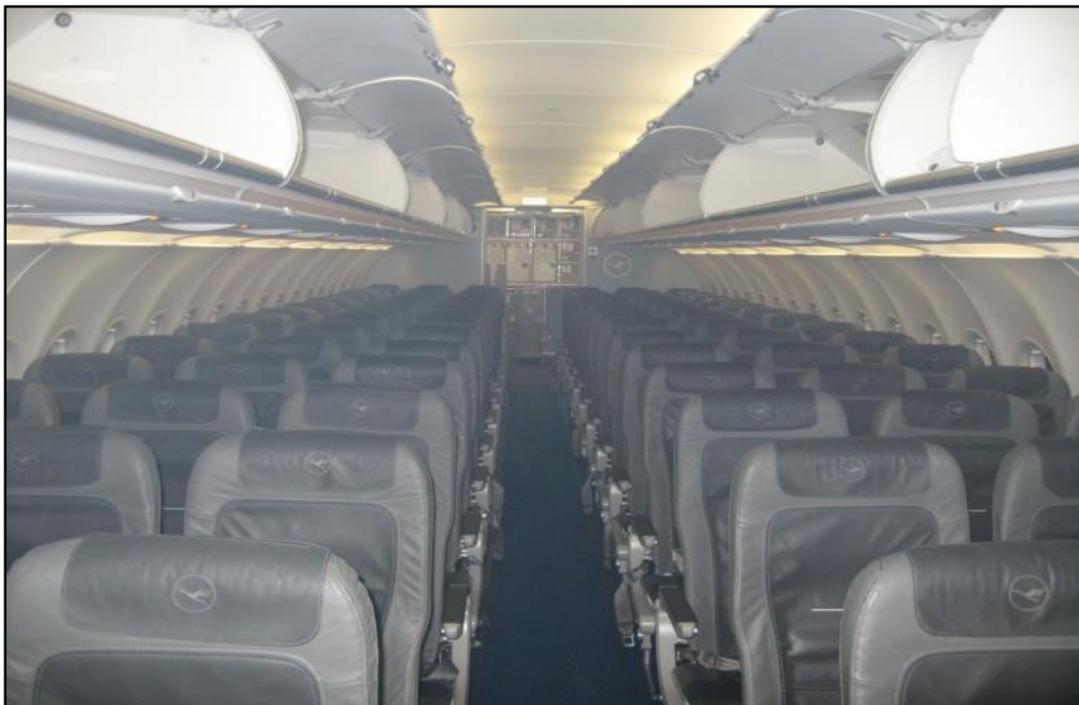
The maintenance personnel decided to start the APU. The APU was started again in the presence of the AFS, as the APU fire bottle had previously been discharged by the Commander. Although the APU started successfully, during the process the cabin filled with smoke (see **Photo No. 2**). The APU was shut down. There was no indication of exterior damage to the APU. However, it was noted that there was oil visible on the outside of the rear fuselage and APU compartment door.

Photo No. 2: The aircraft cabin approx. one hour after the APU test was conducted

The APU was declared unserviceable in order to prevent the possibility of further smoke entering the cabin. The aircraft was flown to a suitable facility where a number of maintenance actions were carried out by the Operator. These included removal and replacement of the APU and a post-maintenance test flight. The aircraft was returned to service and the Investigation was informed by the Operator that there have been no further reports of smoke in the cabin during subsequent flights.

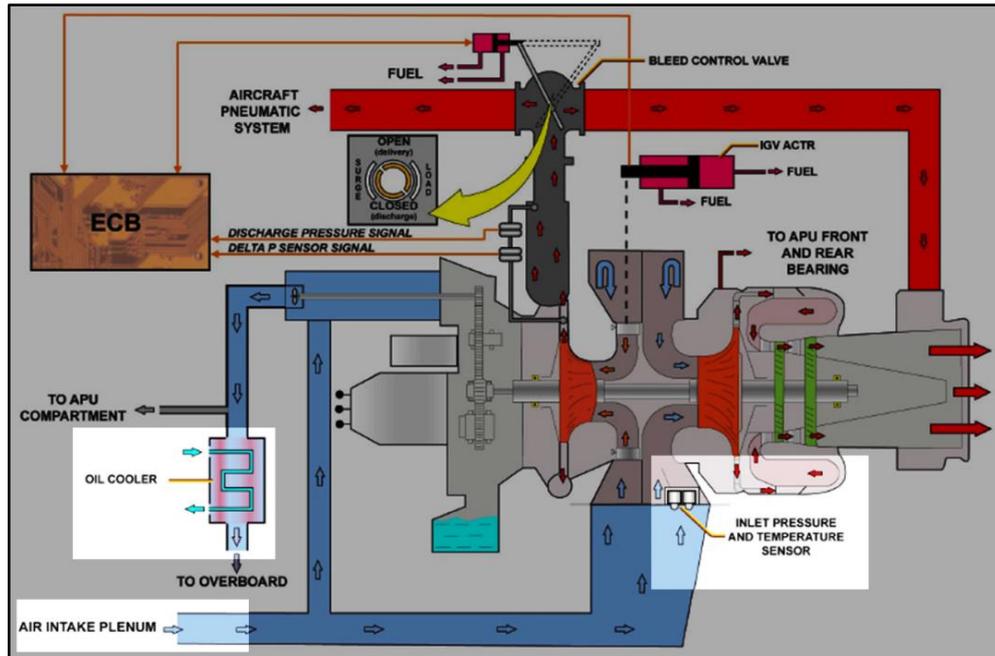
The Operator conducted a further inspection of the removed APU at the Operator's APU overhaul facility in order to identify the source of the smoke. Oil contamination was found in the intake plenum⁷, APU lines and ducts (See **Figure No. 1**) and the LOP⁸ tube. The APU was disassembled in order to access and replace the plenum, APU ducts and LOP tube. Following a test run of the APU, it was noted that there was oil leaking in the area of the oil cooler. A gearbox lip seal was replaced and the APU was successfully run without further leakage.

Figure No. 1: APU Schematic highlighting the air intake plenum, oil cooler and inlet pressure and temperature sensor (Airbus)

It is probable that the leaking oil from the area of the oil cooler was sucked into the airflow by the load compressor and entered the air conditioning system.
