# Air Accident Investigation Unit Ireland

FORMAL REPORT

Cessna T182T, N247P  
Blackstairs Mt., Co. Carlow, Ireland

24 May 2015

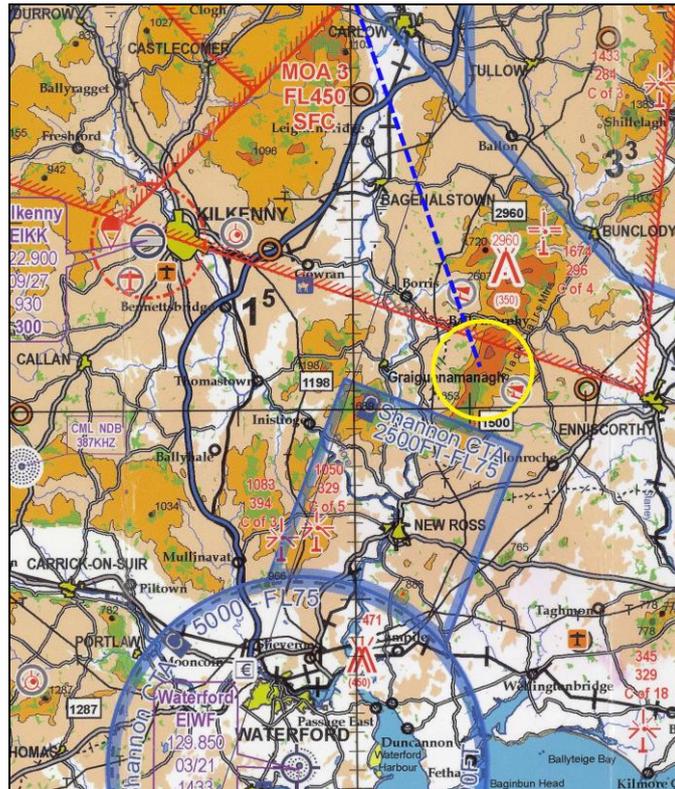
**Figure No. 5:** IRELAND (2172) Edition 05, flight path and position of impact. The destination, ILAS Field is situated at the bottom of the illustration near Taghmon.

While the elevation of the lighted obstacle (a communications mast) on Mt. Leinster is depicted as 2,960 ft AMSL on the IRELAND 2172 chart; no elevation data is depicted for the peak at Blackstairs Mt. The only method of assessing the elevation of Blackstairs Mt. on this, or the current chart, is by comparing the contour colour (hypsochromic tint) with the legend on the chart.

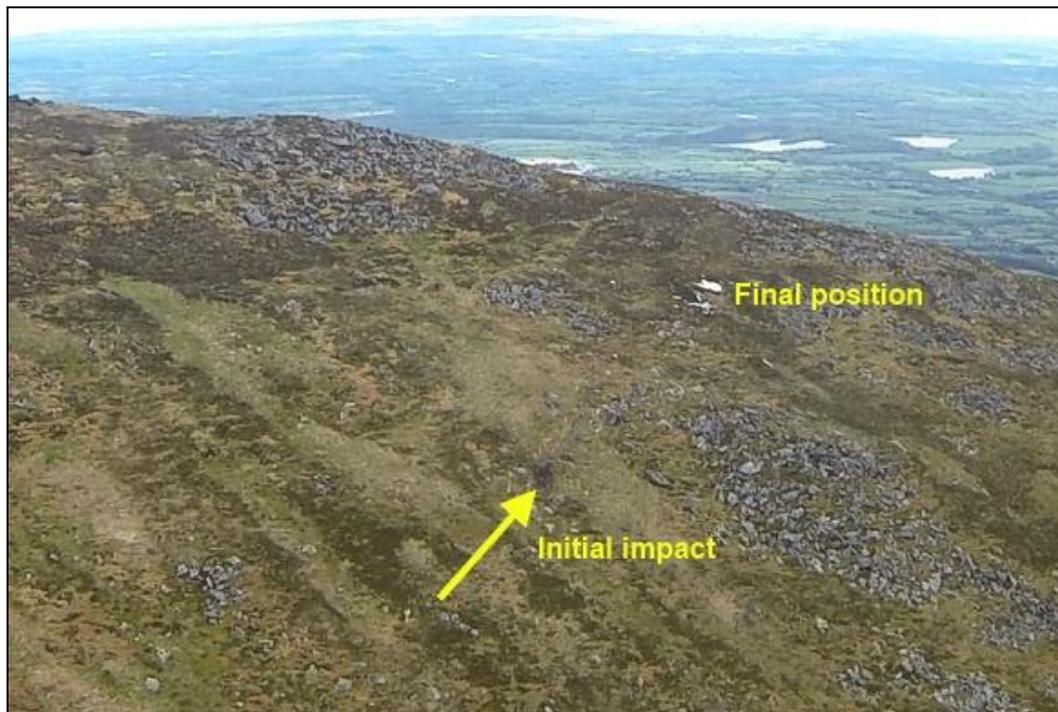
The aircraft impacted at an elevation of approximately 2,150 ft in steeply rising terrain. Ground scars at the initial impact point indicate that the aircraft attitude was approximately wings level and slightly nose-up. From the initial impact point, the Investigation found numerous items of scattered wreckage comprising of components such as engine bearer pieces, engine accessories, propeller blades, cabin contents and furnishings, doors, acrylic fragments, and undercarriage components. A diagram showing the layout of the wreckage is reproduced in **Appendix B**.

**Photo No. 6:** Initial impact point and location of main wreckage

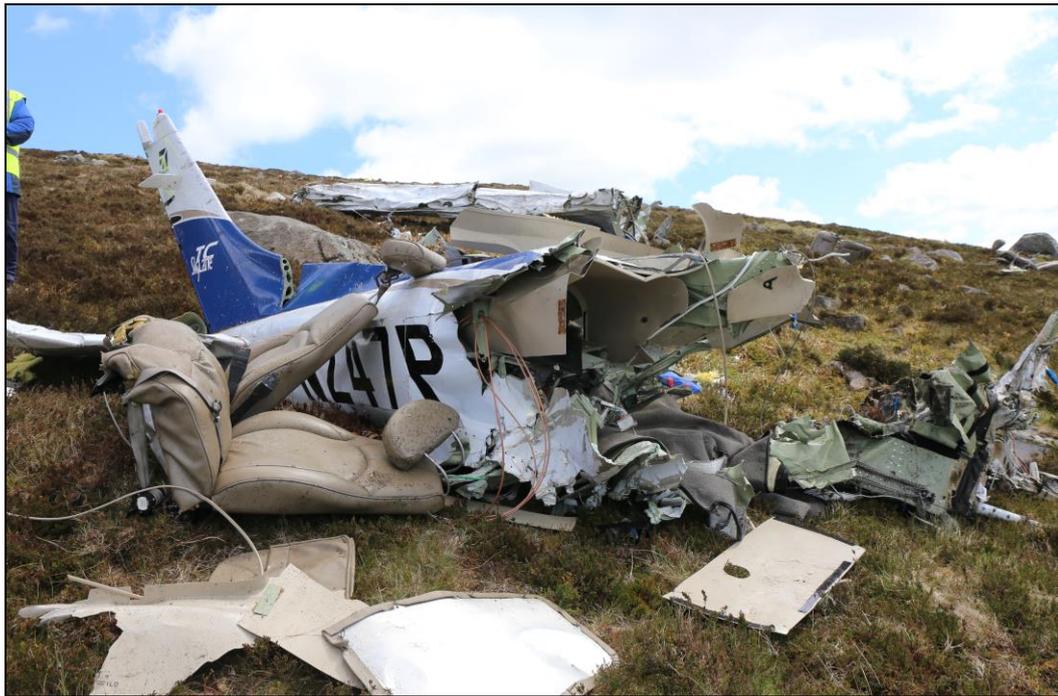
The level and nature of the damage suffered by the turbocharger impeller vanes was consistent with high rotational speed at the time of impact. The final position of the empennage and wings is illustrated in **Photo No. 7**.

**Photo No. 7:** Main wreckage with both wings in the background

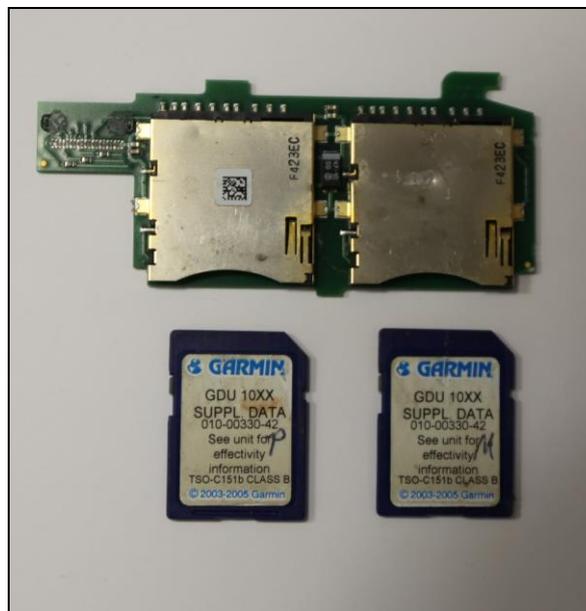
**Photo No. 8:** SD Cards as recovered from the MFD bezel. The upper slot and card are on the right-hand side of the photo

Both cards recovered from the MFD were identical and labelled 'Garmin GDU10XX SUPPL DATA 010-00330-42'. The card in the upper slot was found to be annotated 'M' on the face and 'MFD' on the back.

This card was inserted in test equipment and while the card itself was readable it contained no data. The second card, which was located in the lower SD slot, was found to be annotated 'P' on the face and 'PFD' on the back. The position of this card in the lower slot of the MFD identified this as likely to be the flight data logging card. This card was also inserted in test equipment however the card could not be read.

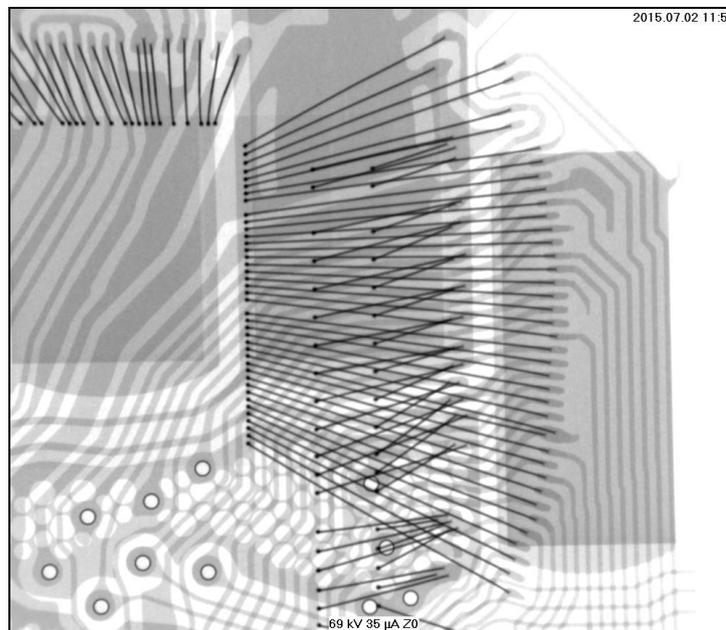
**Photo No. 9:** A sample X-ray image of the SD card from the lower slot on the MFD showing no visible damage to the internal circuitry

The SD Card was also sent to a Dublin based company which specialises in critical data recovery. They stated that unlike earlier flash drives with separate components, this type of device utilises a 'monolithic chip' for memory storage with all components integrated into the chip itself. Unfortunately, the internal memory of the chip could not be detected either through conventional or diagnostic interfaces. The specialist report stated that monolithic drives may fail for a number of reasons. They are typically sensitive to bending and pressure and they are also susceptible to the same faults as traditional flash drives such as sudden power loss and damage due to wear.

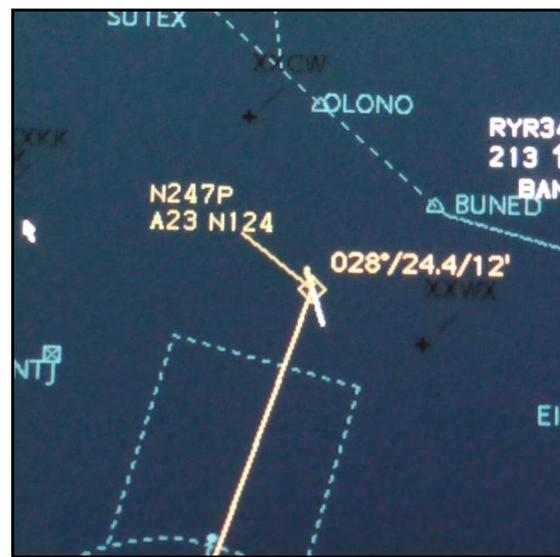
During the period of terrain masking, data from the portable Garmin 296 shows a shallow climb was commenced at 09.25:07 hrs. At 09.28:26 hrs, the aircraft reappeared on radar on the same track towards ILAS Field passing an altitude of 2,000 ft in a shallow climb at a groundspeed of 149 kts (**Photo No. 12**). The return shows the transponder code of 7000 which was immediately replaced by the aircraft registration once the Mode S radar head identified the aircraft. The final radar returns showed the aircraft at an altitude of 2,300 ft, 'A23' in **Photo No. 13**.

**Photo No. 13:** Last radar image with altitude data at 09.30:05 hrs
