# **Air Accident Investigation Unit Ireland**

**FACTUAL REPORT**

**TL 3000 Sirius, EI-FSA  
Cregboy, Co. Galway**

**16 August 2016**

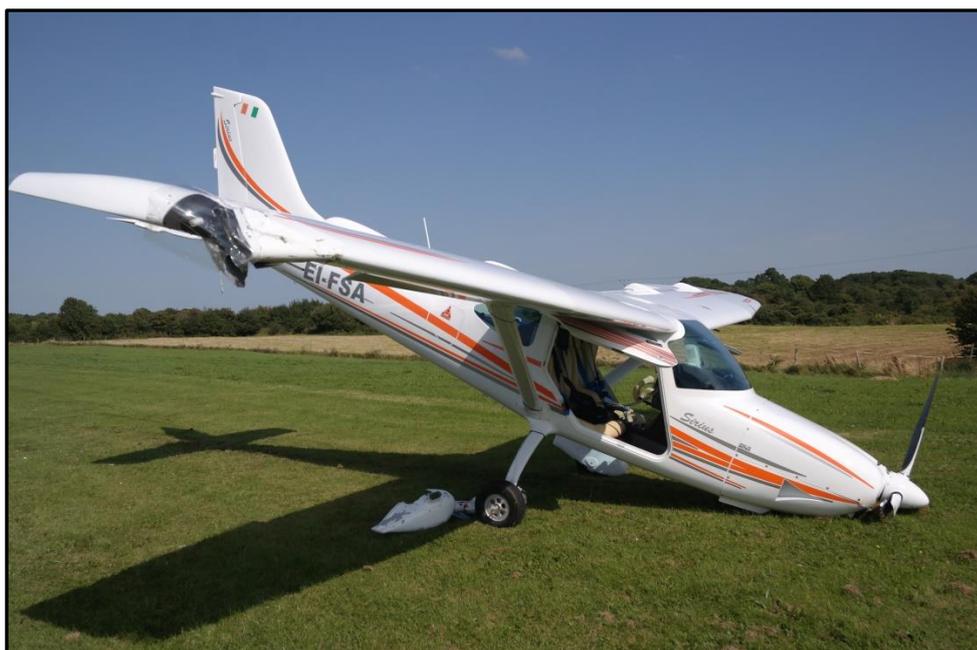
The Pilot supplied details of the damage to the aircraft, including a number of photographs, one of which is reproduced below as **Photo No. 1**. The reported damage included, but was not limited to, complete separation of the nose gear, resulting from a fracture of the nose gear tube; severe damage to the propeller and damage to the lower engine cowling as the aircraft nose section contacted the ground; damage to the right wing tip and outer section of the right wing leading edge; damage to the right wing root; damage to the fuselage at the right wing root mounting points; and a crack sustained on left portion of the main windscreen.

**Photo No. 1:** EI-FSA in its final resting position (Courtesy of Owner)

Whilst light aircraft such as the TL 3000 Sirius possess good lift and aerodynamic characteristics, they are low in mass. Consequently, they are more susceptible to sudden changes in wind direction and velocity. Just south of the runway threshold there was an area of bushes and trees. The Pilot noted that there was a crosswind of 14 kts. The crosswind would have been blowing over this area of bushes and trees, and may have generated an area of turbulent air, including possible downdrafts, at the point over the runway where the Pilot began to flare the aircraft for landing. It is possible that this could have caused the 'sudden drop' experienced by the Pilot as he attempted to land the aircraft.
