Air Accident Investigation Unit Ireland

SYNOPTIC REPORT

**Ozone, Speedster 28, Paramotor
Gormanston Beach, Co. Meath**

4 June 2016

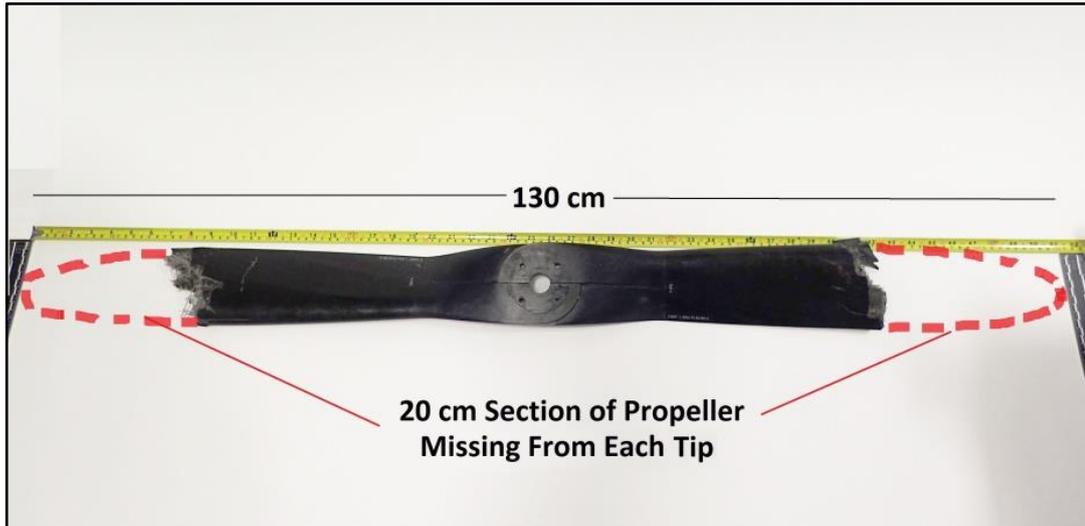
Thrust was provided by a carbon fibre 2-bladed, fixed pitch, propeller that originally measured 130 cm in length. The propeller from the accident aircraft was found to measure approximately 90 cm, with approximately 20 cm missing from each tip, **Photo No. 2**. No propeller strike damage was found on the propeller cage, harness, or pilot's helmet. The damage to the propeller was consistent with contact with the surface of the water and/or wet sand, whilst under significant engine power.

Photo No. 2: Damaged carbon fibre propeller

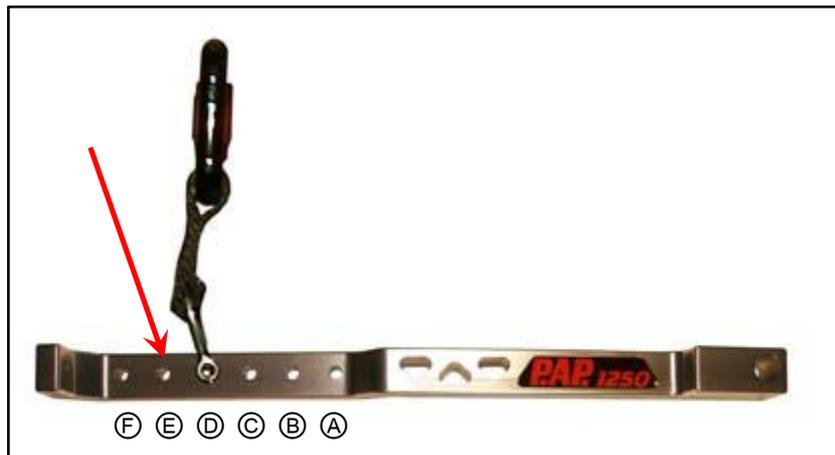
The Investigation could not determine if this was done, but the carabiners were found attached to point 'E' on the Active System Arms. This was within the weight range for the Pilot. An extract from the user manual for the 'Active System Arms,' is given in **Appendix B**.

Figure A1: Extract from P.AP. manual showing Active System Arm

Figure A1, which is taken from P.AP. Manual, illustrates the shackle attachment at position D. On the Active System Arms of the accident paramotor, the shackle was found in position E as shown by the red arrow.
