# **Air Accident Investigation Unit Ireland**

**SYNOPTIC REPORT**

**Westland Gazelle HT Mk.3 (SA 341), G-BXTH  
Abbeyshrule, Co. Longford, Ireland**

**15 July 2015**

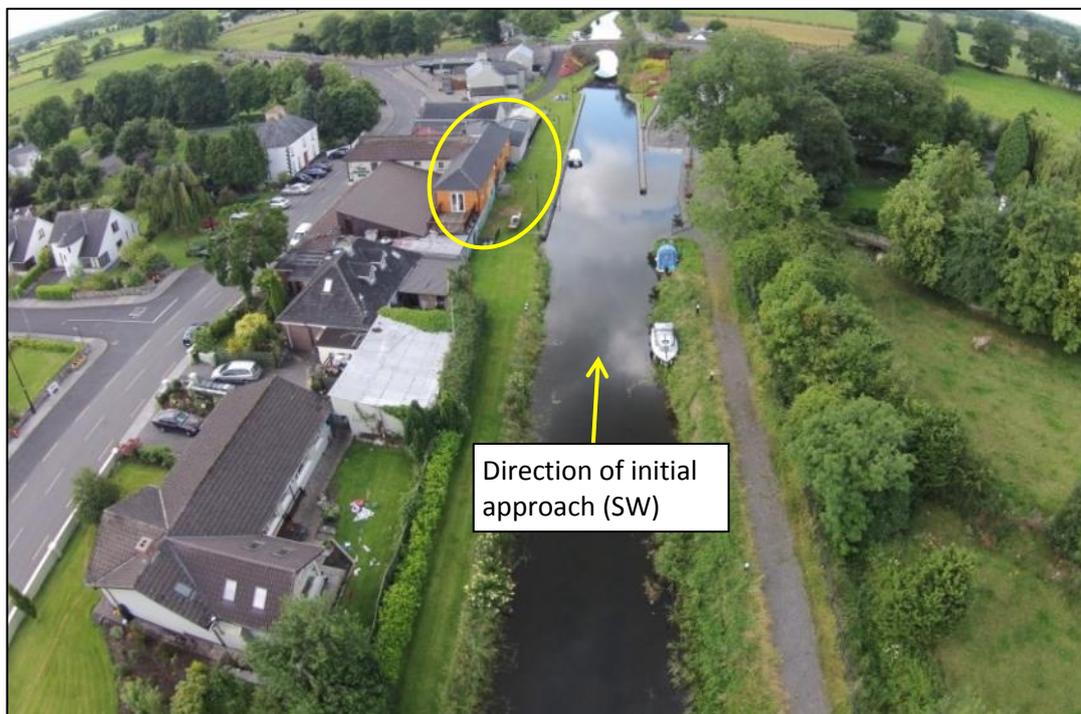
The helicopter arrived in the vicinity of the restaurant/guesthouse in Abbeyshrule at approximately 20.16 hrs<sup>6</sup>. As it approached the restaurant/guesthouse, the helicopter descended and flew low in a south-westerly direction along the canal (**Photo No. 1**).

**Photo No. 1:** Aerial photograph, showing the restaurant/guesthouse in Abbeyshrule (circled) and the direction of initial approach

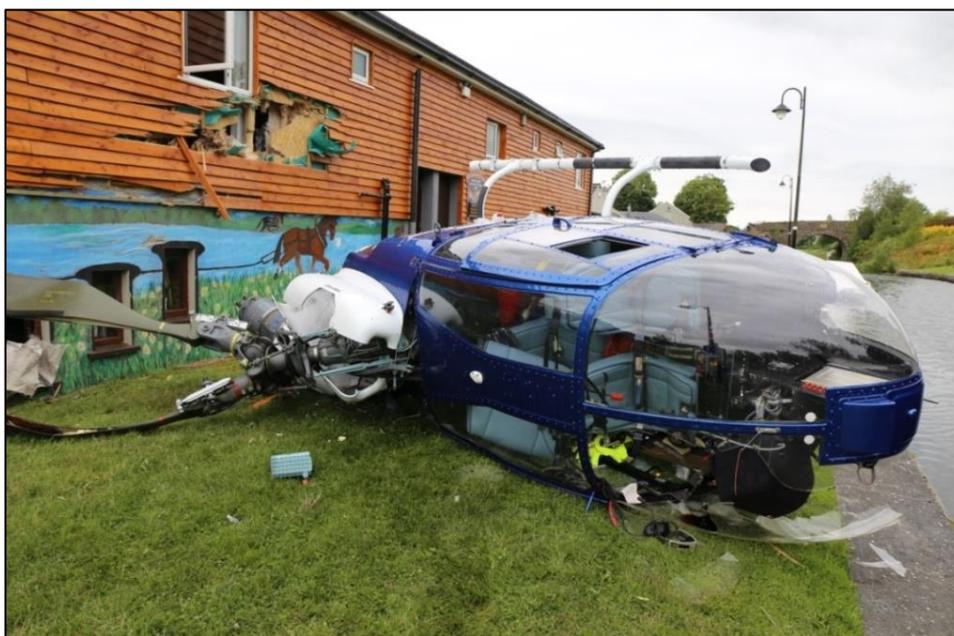
As the helicopter was being manoeuvred to align it parallel to the canal bank and the wall of the building (on a north easterly heading), while at the same time descending and moving closer to the building wall, the main rotor blades made contact with the timber-clad section of the wall. This caused the tail of the helicopter to swing rapidly towards the wall and collide with it. The tail boom separated, broke apart and came to rest in the canal. The helicopter rolled to the right and impacted the canal bank, breaking the right hand cockpit canopy. The main rotor blades, although badly damaged, remained attached to the rotor hub. Debris was scattered over the canal and the canal bank adjacent to the building. The helicopter came to rest on its right hand side on the canal bank, on a heading of approximately 320 degrees magnetic (**Photo No. 2**).

**Photo No. 2:** Final position of G-BXTH (Post event date in daylight conditions)

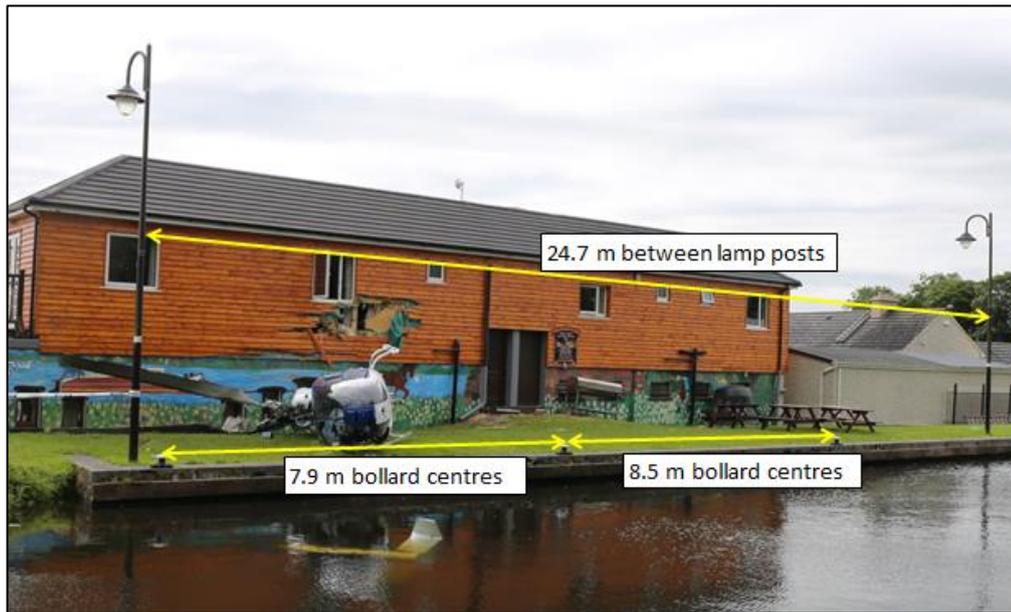
A section of the timber-clad portion of the building wall sustained substantial damage (**Photo No. 3**). A window in the ground floor function room was broken, with glass and debris being thrown into the function room. A radiator in a first floor bedroom was torn from its wall mounts by the force of the impact.

The AAIU carried out a detailed survey of the accident site (**Photo No. 3**). The canal bank adjacent to the restaurant/guesthouse at the site of the attempted landing was grass-covered and reasonably level. However, the ground rose in the vicinity of the emergency exit doors situated in the middle of the northwest facing wall of the property. This wall was parallel to the canal. Two lamp posts 24.7 m apart, framed the site. A paving strip 0.55 m wide ran along the edge of the canal bank. Mooring bollards, 0.2 m in height, were fitted to this paving strip. The distance between the two bollards at the site of the attempted landing was 7.9 m. The bollard to the right (southwest) was a further 8.5 m away. The inner edges of the bollard mounting plates were approximately 0.225 m from the edge of the canal bank (**Photo No. 4**).

**Photo No 3:** Damage to building wall, distance between lamp posts and distance between mooring bollards

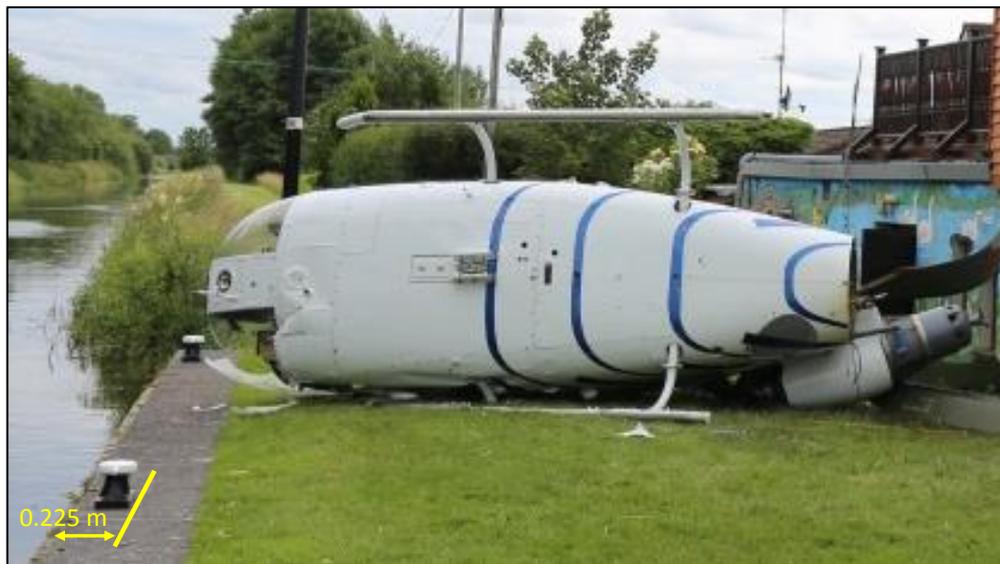
**Photo No 4:** Inner edge of mooring bollard 0.225 m from edge of canal bank

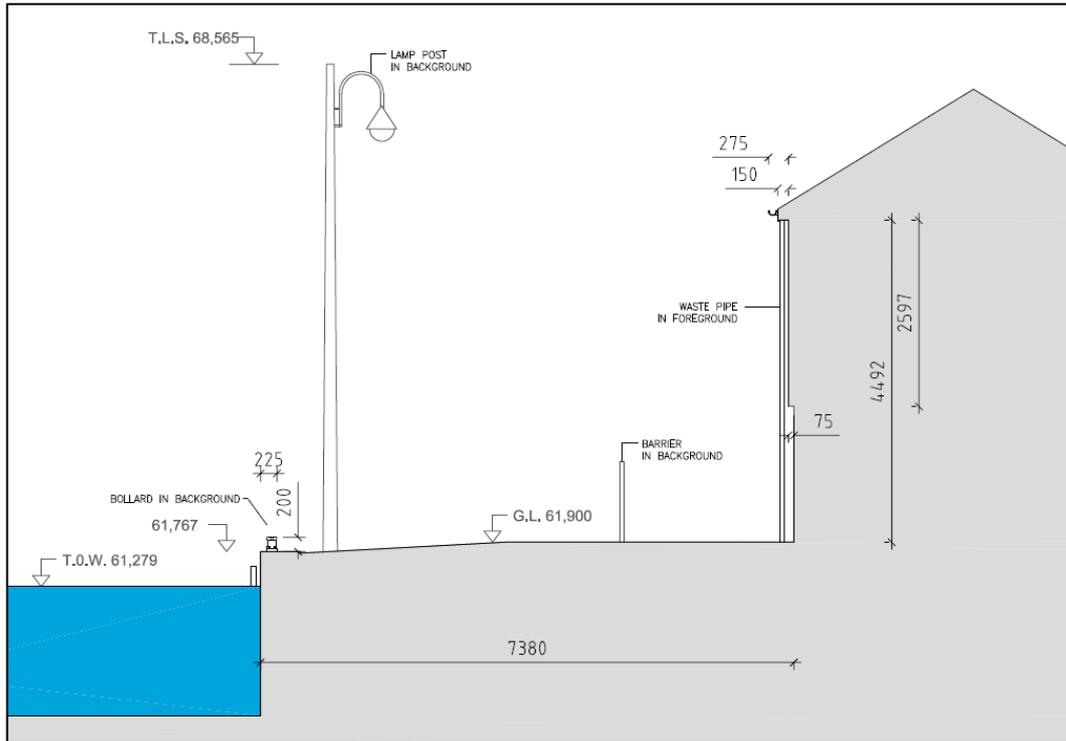
The AAU also commissioned an architectural firm to carry out a site survey. **Figure No. 2** below is based on the architectural survey. It shows that at the accident site, the width of the canal bank from the edge of the bank to the lower part of the building wall was 7,380 millimetres (mm) (7.38 m). The depth of the timber cladding was 75 mm (0.075 m). The eave of the roof is shown to overhang the timber-clad wall by 150 mm (0.15 m). The drawing also shows a gutter, attached to this eave, which increased the overhang to 275 mm (0.275 m).

**Figure No. 2:** Dimensions of building and canal bank at site of attempted landing

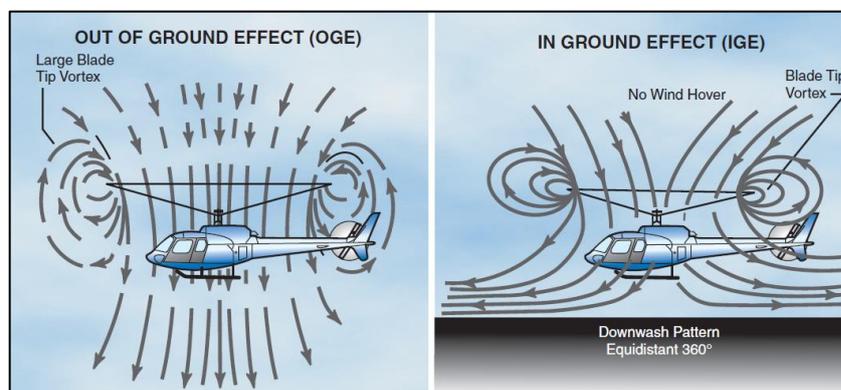
When a helicopter hovers, blade tip vortices are generated which can adversely affect hover performance. When the hover is near the ground (usually at a height equal to or less than the main rotor diameter), a phenomenon known as ‘*Ground Effect*’ occurs. Ground effect results in the generation of more lift for a given blade angle and a reduction in the magnitude of the blade tip vortices (**Figure No. 3**). According to the ‘*Rotorcraft Flying Handbook*’, published by the Federal Aviation Administration (FAA) in 2000, “*Ground effect is at its maximum in a no-wind condition over a firm, smooth surface. Tall grass, rough terrain, revetments<sup>10</sup>, and water surfaces alter the airflow pattern causing an increase in rotor tip vortices*”.

**Figure No. 3:** Effects on airflow due to hovering (*FAA Rotorcraft Flying Handbook*)

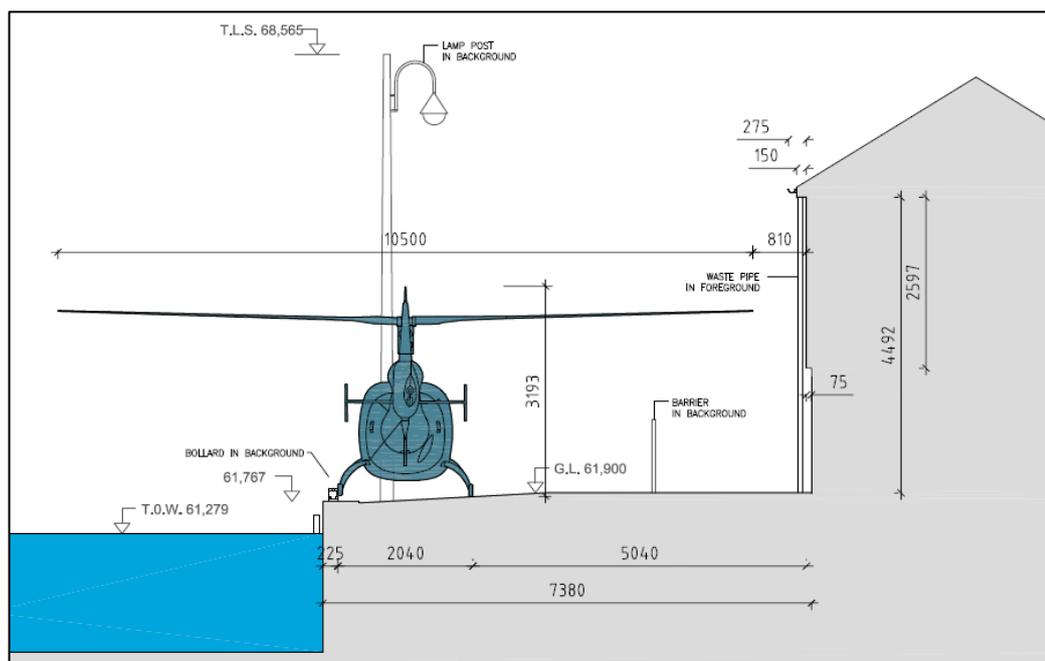
In the latter stages of the attempted landing, the Pilot was trying to ensure that the left hand landing skid of the helicopter was clear of the mooring bollards, while at the same time trying to maintain adequate blade tip clearance between the main rotor blades and the wall of the building. If the helicopter was positioned with the left hand skid just touching the inside edge of the bollard mounting plate, the maximum clearance available, between the main rotor blades and the timber-clad section of the wall of the building, would have been 0.81 m (810 mm), excluding the overhang of the eave and gutter (**Figure No. 4**).

**Figure No. 4:** Maximum blade tip clearance available (810 mm), if landing skid of helicopter was placed touching the inside edge of the bollard mounting plate

The Pilot said that he was concentrating on the location of the bollards with reference to the helicopter's left hand skid, and lost concentration regarding the position of the main rotor blades. The helicopter moved towards the building and due to the limited clearance available, the main rotor blades made contact with the timber-clad wall, and control of the helicopter was lost.
