Air Accident Investigation Unit Ireland

PRELIMINARY REPORT

**Sikorsky S-92A, EI-ICR
Black Rock, Co. Mayo, Ireland**

14 March 2017

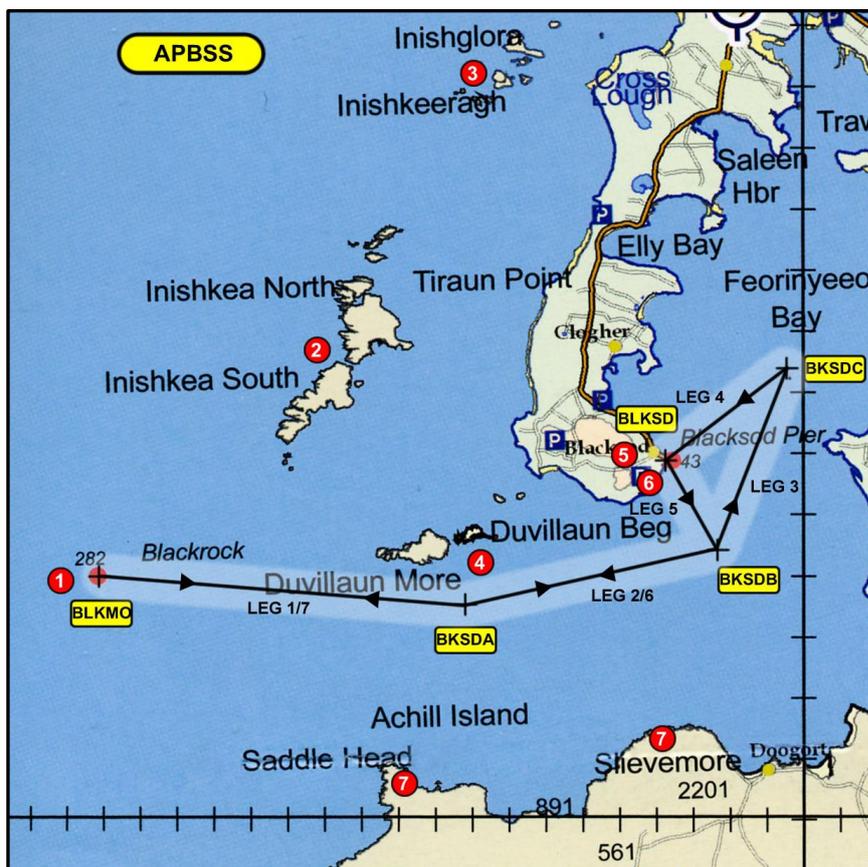
Figure No. 4: Operator's Route Guide for APBSS

Figure No.4 shows the Operator's Route Guide for Blacksod (designated 'APBSS¹⁶ (Blacksod South) Route') which the Crew of R116 was using at the time of the accident. The Route Guide includes an associated separate page of text setting out, *inter alia*, waypoint designations and coordinates, hazards and obstacles and other general comments. This page identified a lighthouse at Black Rock with an associated height of 310'.

However, the recorded data indicates that the Flight Crew was using an Operator-specific route guide and the Investigation is of the opinion that a review of the Operator's Route Guides is warranted. Consequently, a Safety Recommendation is made in that regard (See **Section 8**).

As the Flight Crew was using an Operator-specific route guide it is appropriate that the Operator should review all such route guides. Accordingly, the Investigation recommends that:

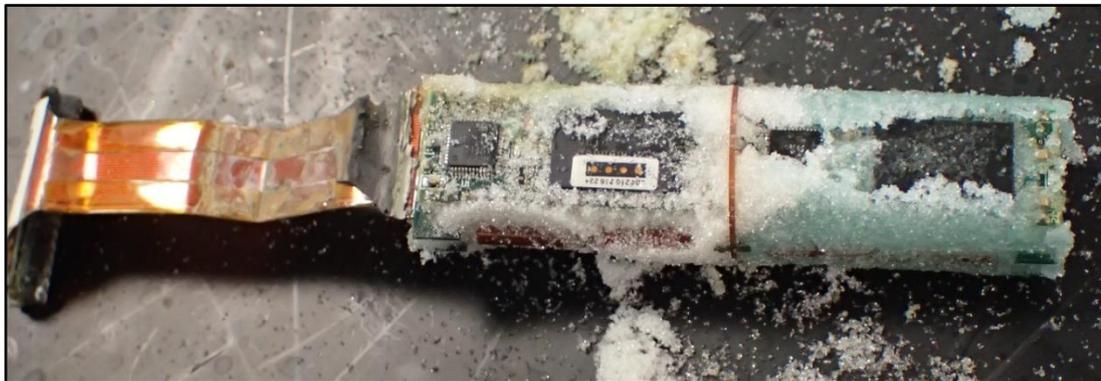
Photo No. 5: MPFR Memory Board showing water ingress

It was noted that water had entered the inside of the crash protected enclosure.

Photo No. 5 shows the CVR and FDR memory board following removal. Examination of the memory board showed evidence of corrosion on the contacts of several of the memory devices. Electrical testing revealed short circuits which necessitated additional measures to recover the CVR and FDR recordings. These measures included de-soldering individual memory devices and re-installing them on a functional memory board provided by the manufacturer of the MPFR. The process of validating the data is ongoing.

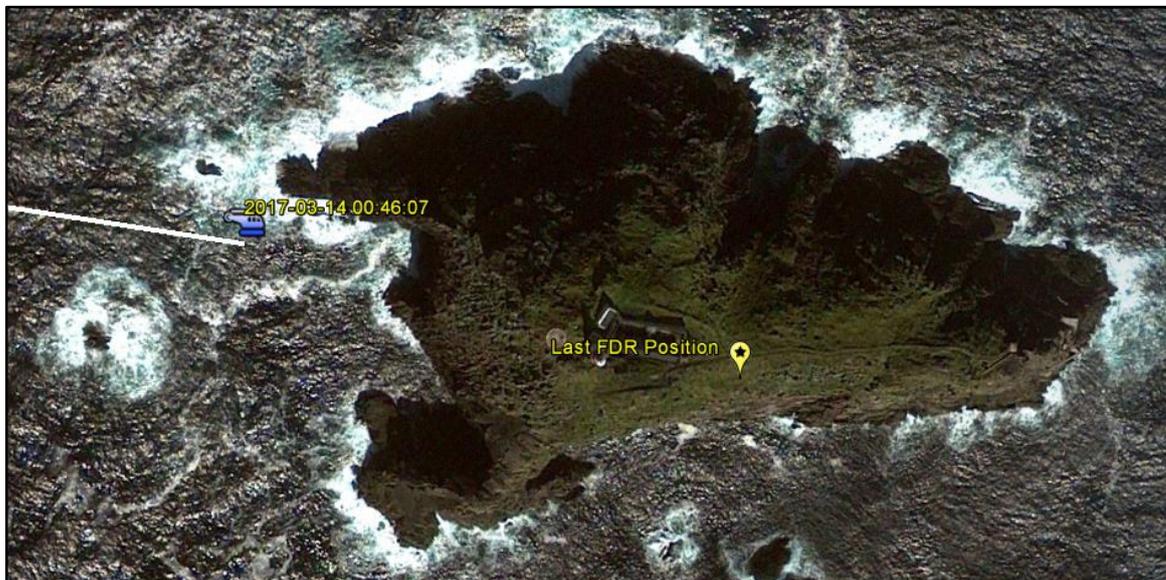
Figure No. 6: Final seconds of helicopter track and Black Rock

Flight data recorded on the Health and Usage Monitoring System (HUMS) card and the FDR, showed that the helicopter was in stable level flight at 200 ft Radio Altitude, 75 kts Indicated Airspeed, helicopter heading 120 degrees magnetic (approximately) on a track towards waypoint BLKMO. In the final seconds, the helicopter pitched up rapidly, impacted with terrain at the western end of Black Rock and departed from controlled flight.

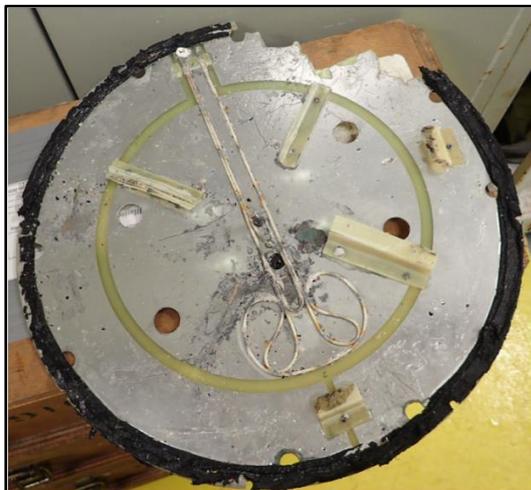
Photo No. 6: Fractured and separated base plate from the ADELT

- The fractured and separated base plate of the Automatic Deployable ELT (ADELT) System was located in the vicinity of the main wreckage (**Photo No. 6**).
