Air Accident Investigation Unit Ireland

FACTUAL REPORT

**BRM Land Africa, EI-FMO
Limetree Airfield, Co. Laois**

24 May 2017

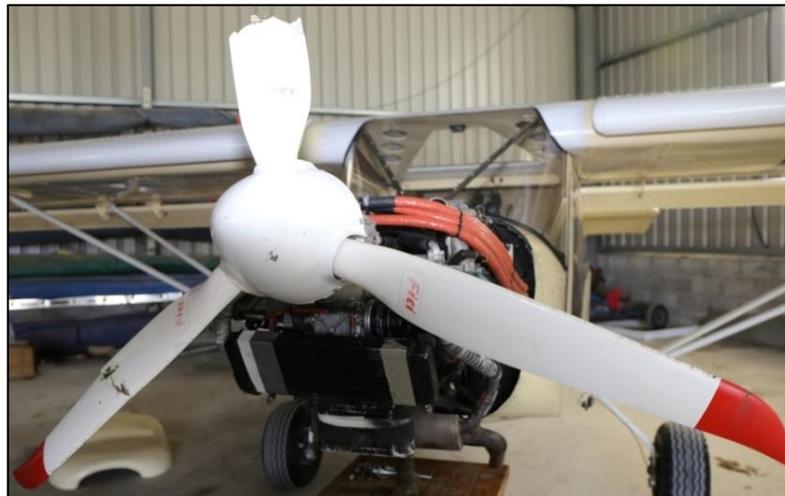
- The nose wheel and mounting frame were bent rearwards and separated from aircraft;
- One broken propeller blade with a significant portion separated;
- One cracked propeller blade;
- Damage to the leading edge of the third propeller blade.

A detailed inspection of the engine was not carried out, but it is deemed likely that the engine suffered shock load damage when the propeller impacted the ground.

The aircraft was recovered to a local hangar for inspection by the AAIU. **Photo No. 1** shows the propeller blade damage.

Photo No. 1: Propeller blade damage

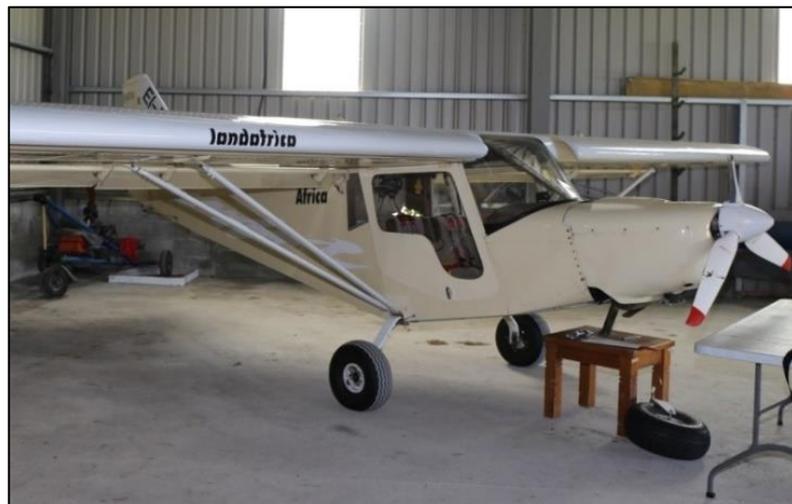
Figure No. 2: EI-FMO after recovery to hangar
