Air Accident Investigation Unit Ireland

FACTUAL REPORT

Colibri MB-2, EI-EWZ

ILAS Airfield, Taghmon, Co. Wexford

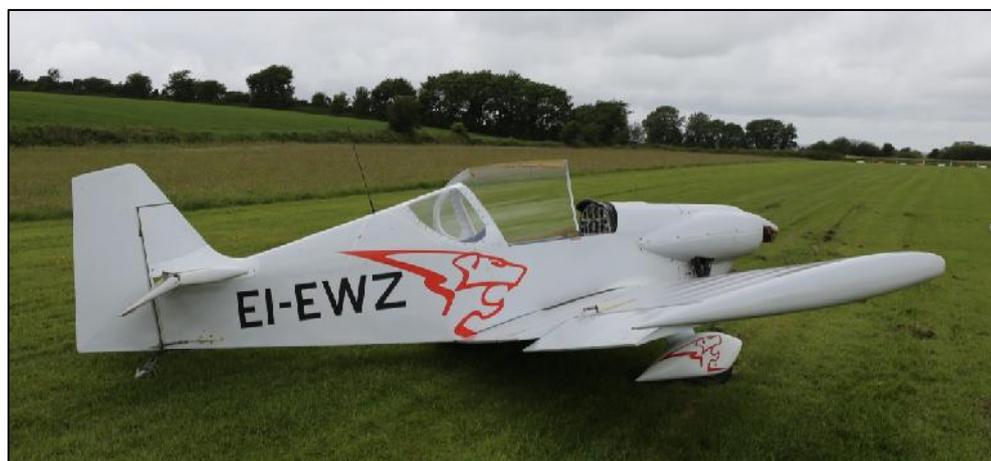
With only one hand available to operate the stick and throttle, control of the aircraft was difficult. The Pilot stated that the aircraft crossed the threshold of RWY 18, and in his estimation *'flared slightly too high (5 ft approx.)'*. The subsequent loss of airspeed resulted in a hard landing which caused the left wheel to become detached from the aircraft. Approximately 7 metres (m) after the aircraft first made contact with the runway the propeller impacted the ground, breaking both propeller blades. The aircraft then swivelled approximately 120° in an anti-clockwise direction before coming to rest (**Photo No. 1**).

Photo No. 1: EI-EWZ Final Resting Position

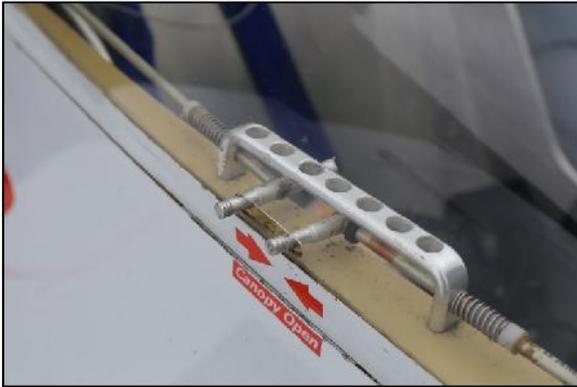
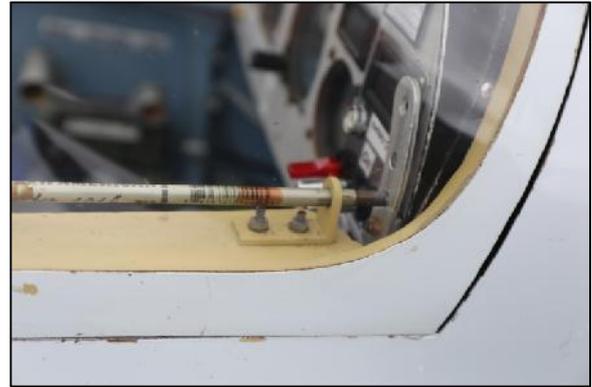
Two Inspectors from the AAIU travelled to ILAS Airfield shortly after the accident. The landing site and the aircraft were inspected. The canopy locking mechanism was found to be fully functional. The locking mechanism is shown in **Photos No. 2 and 3**.

Photos No. 2 and 3: Detail of Canopy Locking Mechanism

Both the Pilot and aircraft were appropriately licensed for the flight. There was no evidence or report of a pre-existing mechanical problem with the aircraft, and on inspection the canopy locking mechanism appeared to be fully functional. The Pilot is currently undertaking repairs to the aircraft and has confirmed to the Investigation that the canopy locking mechanism will be modified. Any work on the aircraft will be subject to approval by an ILAS inspector.

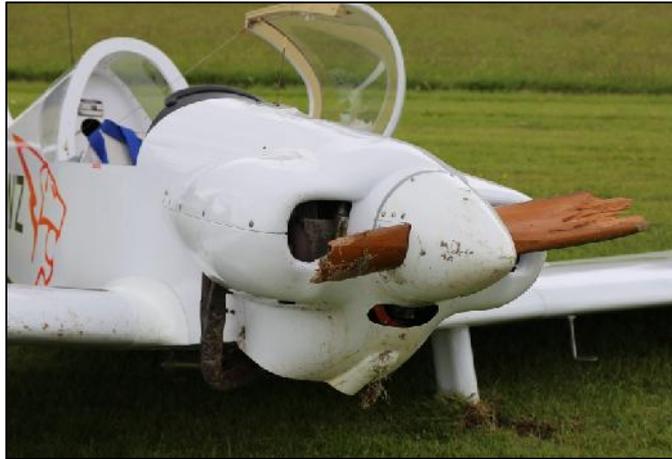
The aircraft sustained significant damage shown in **Photo No. 4** which included:

- Two broken propeller blades
- Separation of the left wheel from undercarriage leg
- Damage to left wheel shock absorber
- Damage to right wheel shock absorber
- Left wing rib cracked at joint

Photo No. 4: Damage to EI-EWZ
