# Air Accident Investigation Unit Ireland

ACCIDENT

Rutan Long-EZ, EI-CPI  
Knockahavaun, Co. Waterford, Ireland

27 March 2017

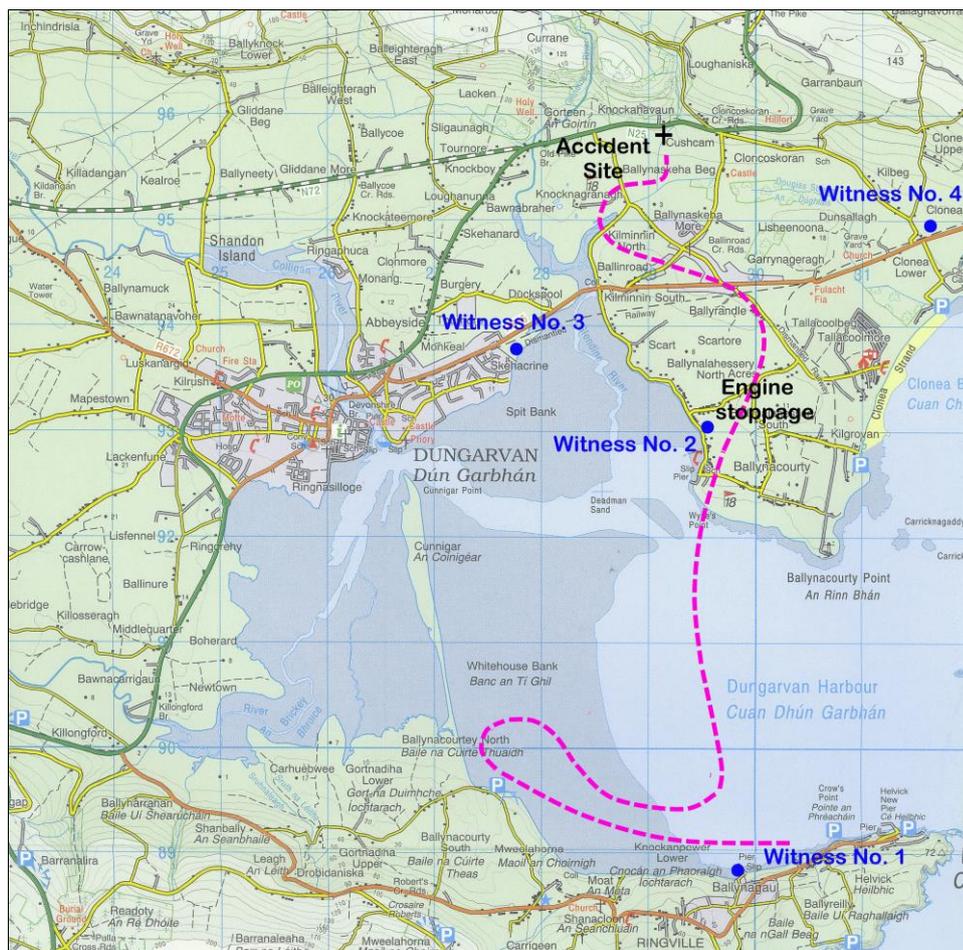
**Figure No. 1:** Location of witnesses and reconstructed flightpath of EI-CPI

**Witness No. 1** was situated at Ballynagaul pier on the south side of Dungarvan Bay. He observed the aircraft flying past and that the engine sounded normal. The aircraft headed towards the Cunnigar spit but turned right and headed back towards him at Ballynagaul before turning left and proceeding across Dungarvan Bay towards the coast at Ballynacourty. At this time he heard the engine make what he described as *'two bangs or backfires'*.

**Witness No. 2** was in his garden shed on the Gold Coast Road at Ballynalahessery South, to the east of Dungarvan. He heard a high-pitched sound from an aircraft and went out to look for it. Although high-pitched it *'sounded normal'*. He observed the aircraft crossing Dungarvan Bay towards his house in a north-easterly direction. As it came overhead he heard the engine splutter and cough a few times, after which the engine stopped. He looked at his watch and noted it was 16.15 hrs (local time) and stated that the engine had stopped about one minute previously. He went to a nearby gate to get a better view. The Witness said that the aircraft initially *'veered to the left for Crooked Bridge before making a definite turn in a westerly direction towards Dungarvan golf course'* and that it was now so low that he lost sight of it behind some trees. It then came into view again heading east, followed by a turn back to a westerly direction at which point he lost sight of it as it continued to descend.

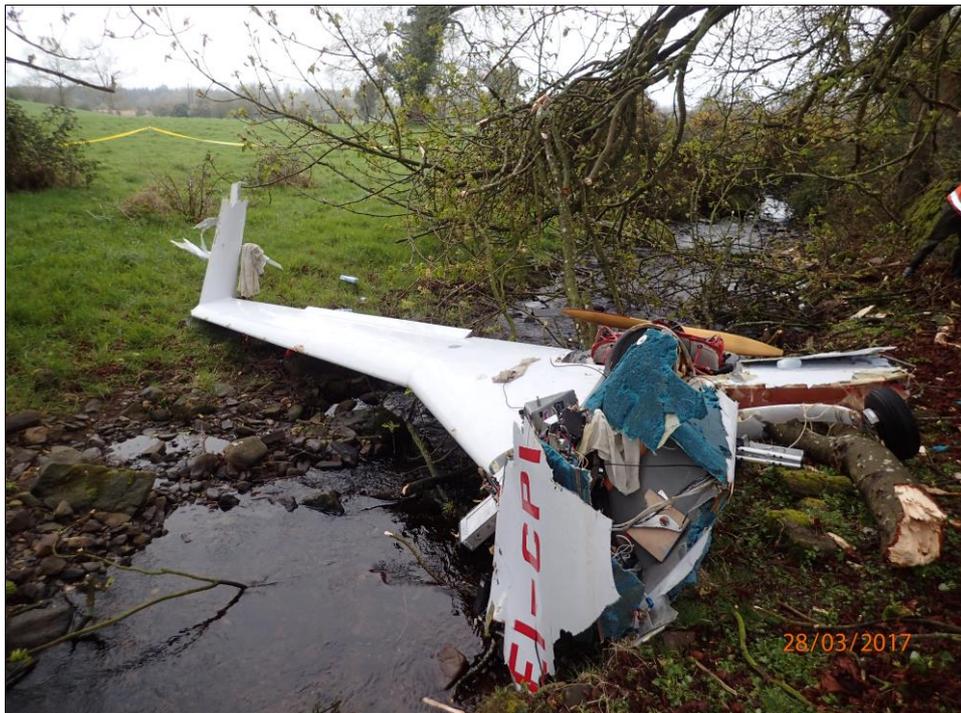
The entire left wing was found embedded in the branches of a tree approximately 4.4 m above the ground with evidence of heavy impact on the trunk of the tree at the same level. The wreckage of the aircraft came to rest entangled in heavy branches which had broken away from the tree following impact. The forward fuselage sustained severe impact damage which resulted in its complete disintegration as far as the rear cockpit seat. The battery, which was split in two, was recovered 14 m beyond the impact point. Debris, consisting of glass fibre pieces and rigid foam, was scattered across the area.

The left wing fuel tank had disintegrated completely with the loss of the left wing. The right wing fuel tank was disrupted and no fuel remained. There was a strong smell of fuel at the site and the inside of the right tank was wet with fuel.

The propeller was intact but exhibited some surface damage on one blade face; there was no damage to the propeller leading edges or blade tips. **Photo No. 2** shows the main wreckage prior to recovery the following day.

**Photo No. 2:** Main wreckage prior to recovery on 28 March 2017

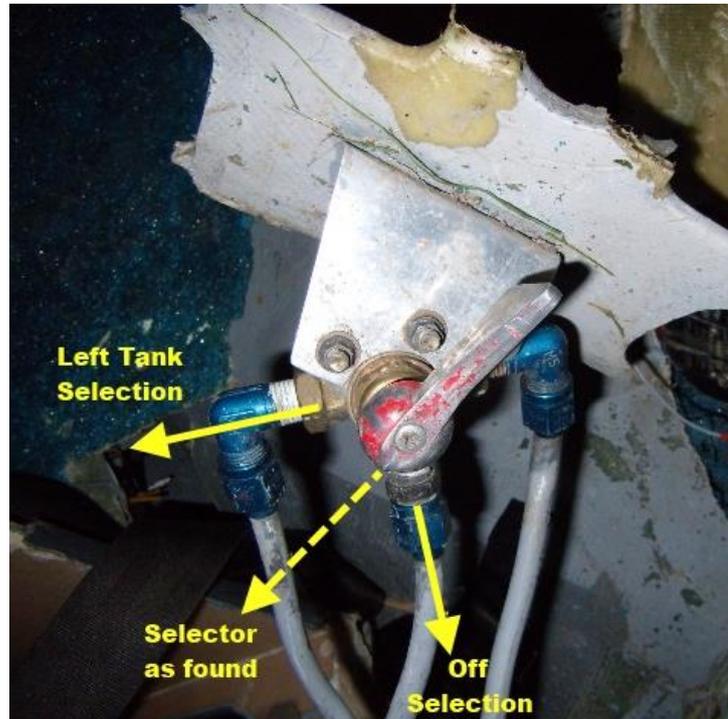
The engine controls (carburettor heat, throttle and mixture) were all in the forward position with tension on the three actuating cables. The fuel selector was found in an intermediate position between the LEFT and OFF tank selections (**Photo No. 3**).

**Photo No. 3:** Fuel selector position as found, between LEFT and OFF positions

On first inspection at the accident site, the fuel tank selector was found in an intermediate position. The selector was situated in the floor of the aircraft, in front of the Pilot seat. The fuel selector was checked for proper function and was observed to provide positive locking in all of the selected positions. Due to its protected position, it is considered unlikely that the Pilot inadvertently moved the selector whilst in flight.

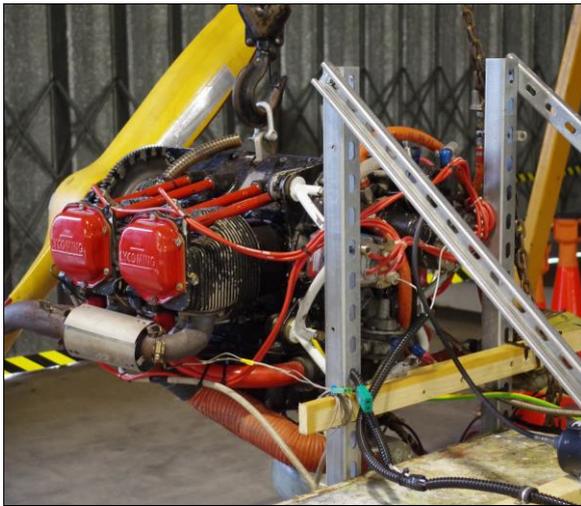
A test-rig was constructed to enable testing of the engine out of the airframe using, where possible, the original components from EI-CPI. The engine and its bearer were removed from the airframe and suitably secured on a bench test-rig (**Photo No. 4**).

**Photo No. 4:** Engine mounted in test-rig

Once mounted, the engine was first turned over by hand to confirm that no mechanical-type failures were present. The spark plugs were installed in the same positions and condition as they were found. The engine was then turned over by means of the starter motor with the ignition switches off, again to check if any mechanical failures were present. The engine rotated and no mechanical failures were evident.

The engine was primed by means of the electric fuel pump and with the pump off the engine was started with minimal cranking with the Left (impulse) magneto selected 'ON'. For this first run the engine was stabilised at 1,200 RPM for approximately 30 seconds and then shut down. The security of the engine on the rig was checked and no problems or defects were evident.

For the next test, the original air filter was installed and the engine stabilised again at 1,200 RPM. The throttle position was unchanged in this condition. A magneto drop test was performed by switching off one magneto at a time and observing the RPM drop. Operation on the Left and Right magnetos individually showed an RPM drop of 100 - 120 RPM compared to (normal) operation on both magnetos. The engine ran smoothly on the Left magneto but exhibited some roughness while operating on the Right magneto.

For the final series of runs the normal air intake was blocked to restrict the airflow to explore if a rich-cut would occur. Despite several runs with both the normal and carburettor heat intakes fully blocked, the engine continued to run with only slight evidence of backfiring due to an over-rich mixture. Leaning of the mixture returned the engine to smooth running. As air was clearly entering the carburettor from some source, the air filter box was disassembled. On inspection, a crack (due to impact damage) was observed across the top of the box allowing the engine to function despite having its normal and alternate air supplies restricted.

Following the initial series of run tests, the spark plugs were again removed and inspected. One plug exhibited oily deposits. When this plug was cleaned, operation on the Right magneto alone was satisfactory. An additional test was conducted to verify the fuel flow with the fuel selector in an intermediate position similar to the 'as found' position. It was found that the engine continued to run with the fuel selector in this position.

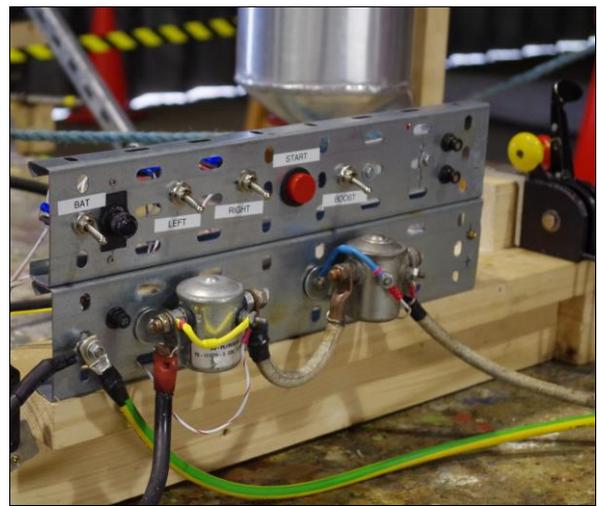
**Photo No. 5:** Test-rig control panel

A control panel was built incorporating the original master and starter relays, switching and ancillary electrical components (**Photo No. 5**). A purpose-built aluminium fuel tank was fabricated by an ILAS member specifically for the test. Following repair of minor damage to the propeller (sufficient for test purposes) the propeller was mounted to the hub flange. Instrumentation consisted of the tachometer and carburettor temperature gauge from the aircraft. The engine control quadrant, consisting of carb heat, throttle and mixture controls, was connected using newly-fabricated Bowden cables. A replacement 12 V lead-acid battery was sourced and connected to the control panel. The engine was grounded to the electrical system using 35 mm<sup>2</sup> bonding cable of similar cross-section to that of the starter cable. For safety reasons the master switch, magneto switches and fuel pump switches were replaced with new single-throw units. The Alternator was left disconnected as it was not required. The fuel supply was re-instated using components recovered from the aircraft: the fuel selector, gascolator, fuel pump and associated fuel lines. For safety reasons an additional fuel shut-off valve was installed as close as possible to the engine-driven fuel pump to facilitate stopping of the engine in case the magnetos could not be grounded<sup>16</sup>.

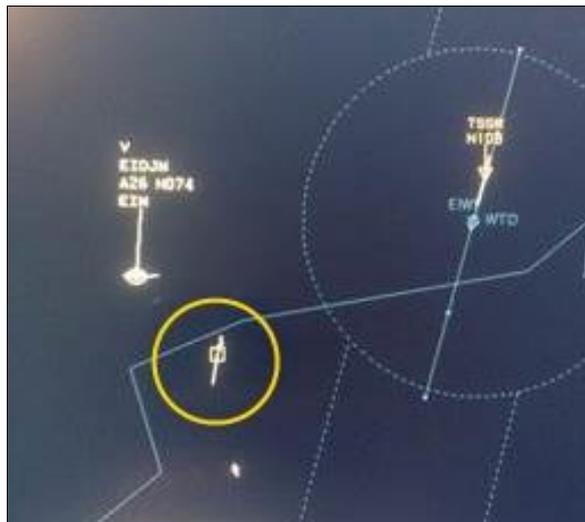
A review of the ATC radar tapes was conducted shortly after the accident and ATC confirmed an intermittent return in the vicinity of Dungarvan at 15.07 hrs as belonging to EI-CPI. The screenshot in **Photo No. 6** shows EI-CPI on a south-westerly heading approximately 7 minutes prior to the accident.

**Photo No. 6:** Screenshot of ATC radar showing return from EI-CPI (circled yellow).

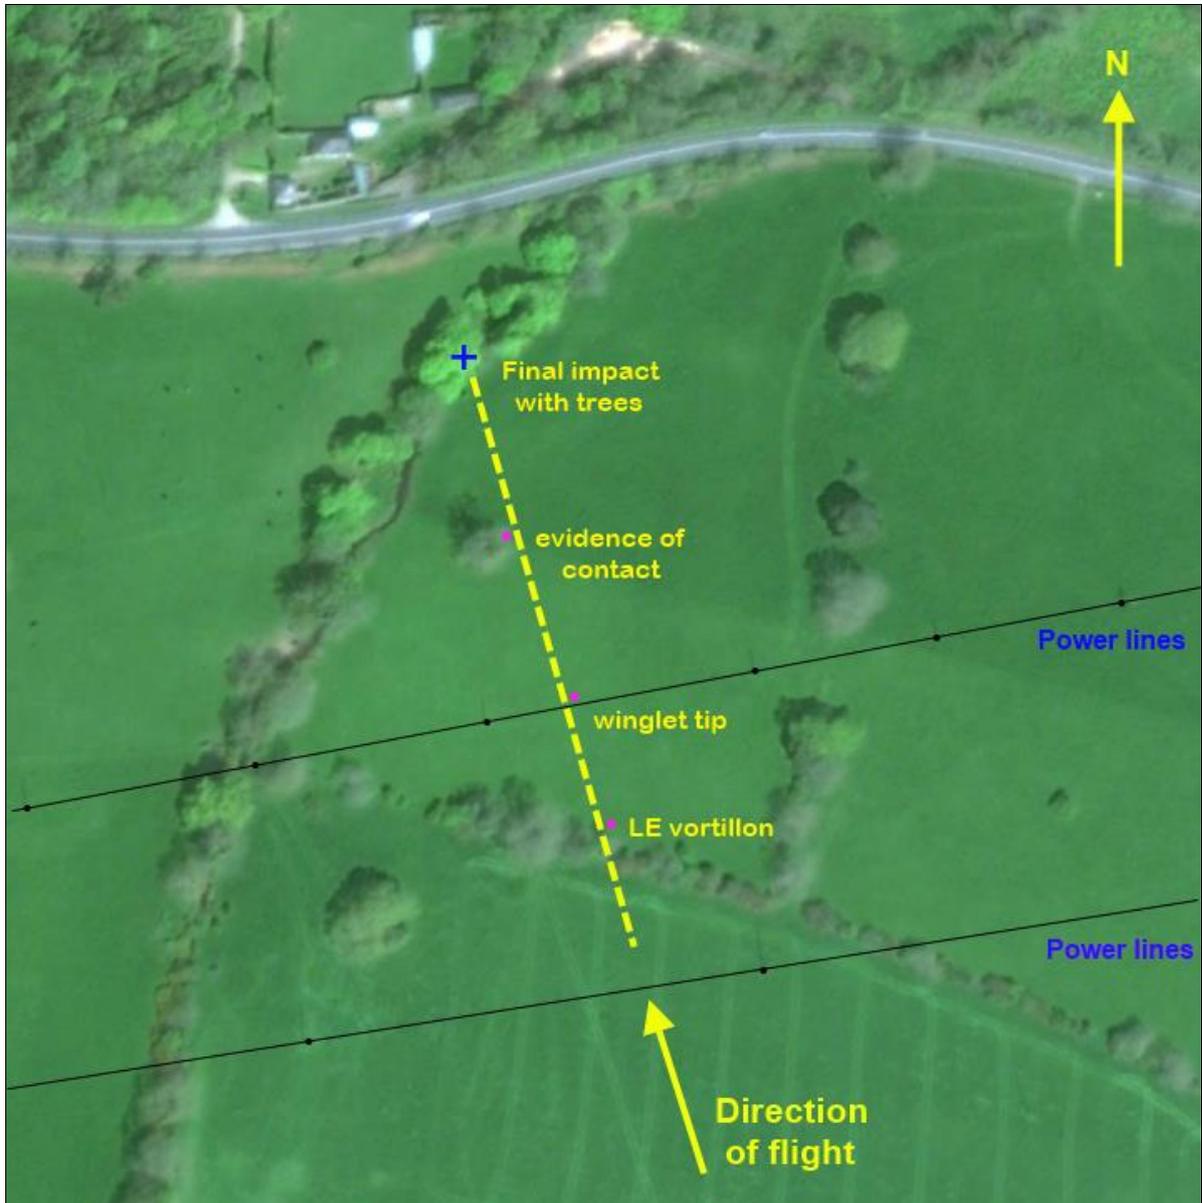
### Probable final flight path of EI-CPI

Witness marks/debris (indicated with magenta dots) show first contact was made over the hedge where a leading edge Vortillon was located, the tip of the right winglet was found under the power lines. There was evidence of contact with the solitary tree but no debris; final impact was made with the line of trees at the field boundary.

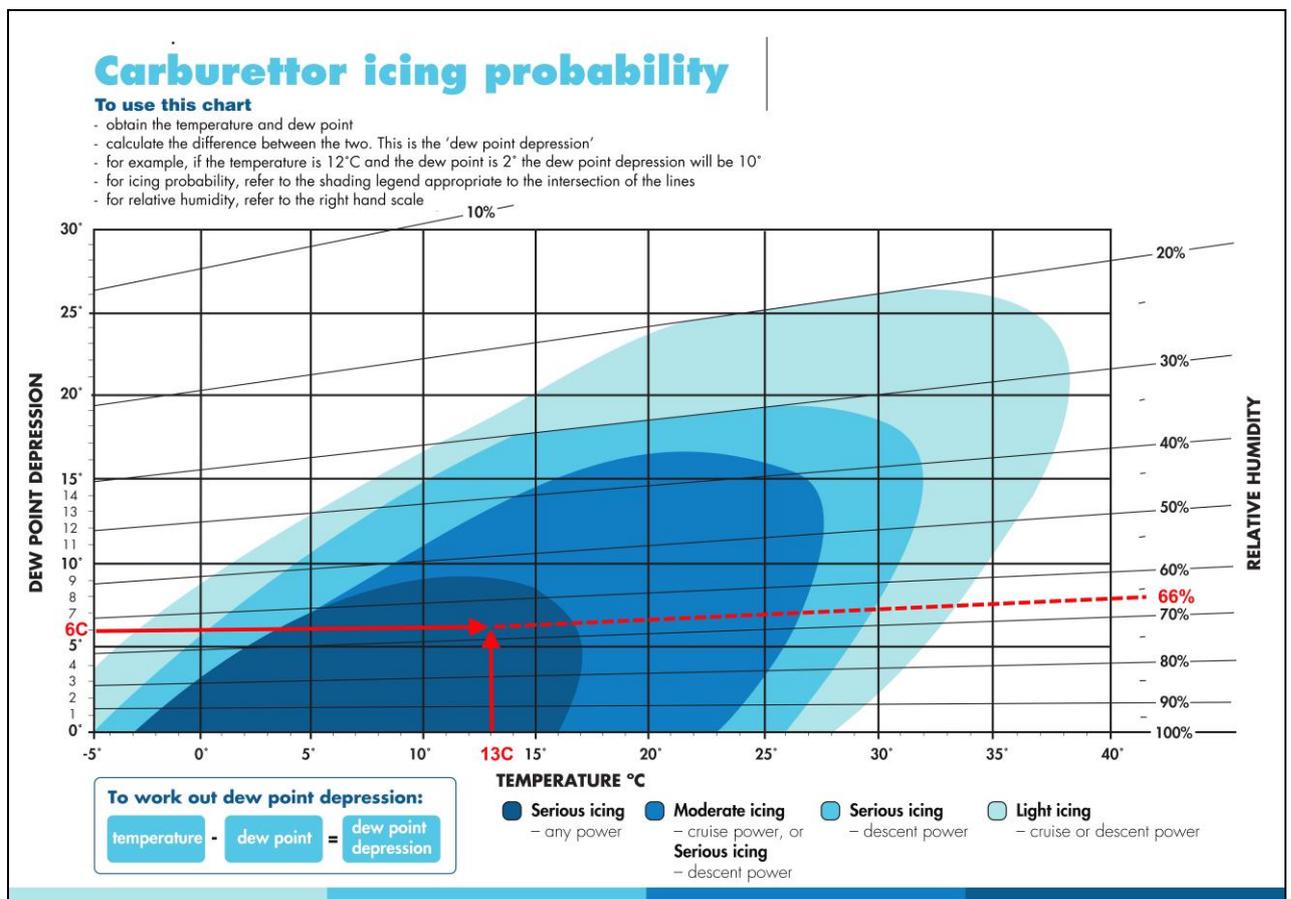
Carburettor Icing Probability Chart (Civil Aviation Safety Authority, Australia)

Plotting the outside air temperature and dew point on a Carburettor Icing Probability chart (**Appendix B**) shows that the engine was operating in conditions where there was a risk of '*serious icing at any power*' with a corresponding relative humidity of 66%. Operation in such conditions may lead to a variety of outcomes, singly or in combination, that include a gradual loss of power, rough running, vibration and engine stoppage. The conditions were compatible with the formation of 'fuel icing' where ice forms in the carburettor as a result of moisture in the intake air freezing due to the effects of the fuel vapourisation. Such icing usually occurs when the relative humidity is greater than 50% and at temperatures between 4 °C to 27 °C.

This chart is based on studies and information published by the Civil Aviation Safety Authority of Australia. The **Dew Point Depression** is equal to the **Outside Air Temperature** minus the **Dew Point Temperature** ( $13^{\circ}\text{C} - 7^{\circ}\text{C} = 6^{\circ}\text{C}$ ). Enter the Chart on the left-hand vertical scale with the **Dew Point depression of  $6^{\circ}\text{C}$** . Plot this value against the **Outside Air Temperature** on the bottom (horizontal) scale of  **$13^{\circ}\text{C}$** . The intersection of these two values lies within the 'Serious icing - any power' area. The plotted value extended to the right-hand scale shows a **Relative Humidity of 66%**.
